Annual Inspection

Suffolk Coastal & Waveney Norse

Waldringfield Play Area

Inspection Ref: 365051

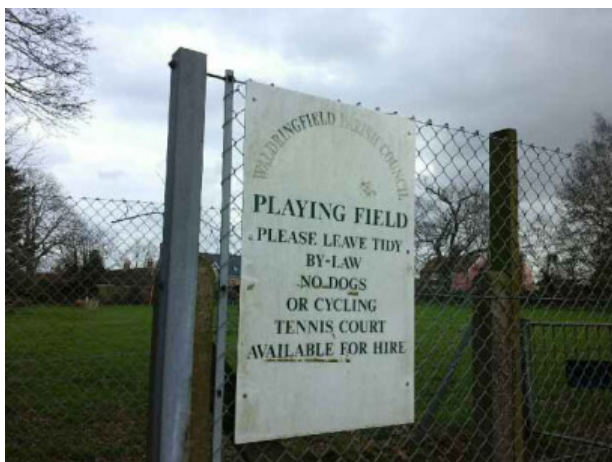
Item: Ancillary Items - Sign
Manufacturer: Owner/Operator
Surface Type: N/A
Equipment Compliance: N/A
Surface Area Compliance: N/A
Ref/Part Number:
Total Findings: 1

It is recommended that information signs with emergency contact details are installed at each entrance/exit point to the playground - Provide in accordance with the recommendations set out in BS EN 1176

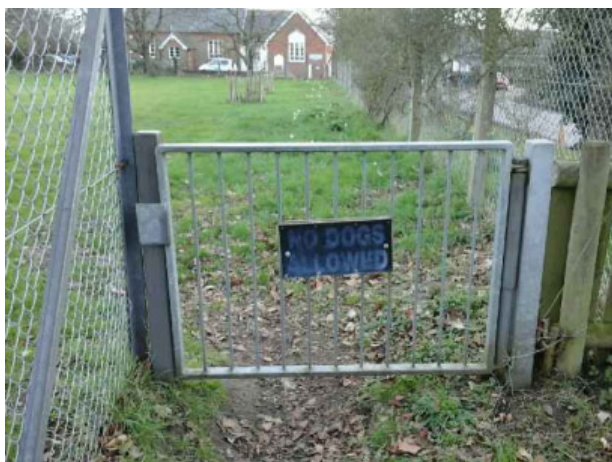
Item: Ancillary Items - Gate - Self Closing
Manufacturer: Not Identified
Surface Type: Grass
Equipment Compliance: N/A
Surface Area Compliance: N/A
Ref/Part Number:
Total Findings: 4

The gate is not a contrasting colour to the fencing making it difficult for users with impaired sight to distinguish it from the fence - We would recommend that the gates are painted a distinguishable colour to that of the fence

The area under the gate has eroded leaving uneven areas, or the concrete foundations exposed, resulting in trip hazards at the entrance/exit to the playground - Reinstate to level with surrounding surfaces

The opening between the gate and the post is less than 12mm and could trap users fingers - Adjust gate to ensure a 12mm opening all around

The gate is closing too quickly (less than 4 seconds) - Take corrective action to ensure that the gate closes in 4-8 seconds

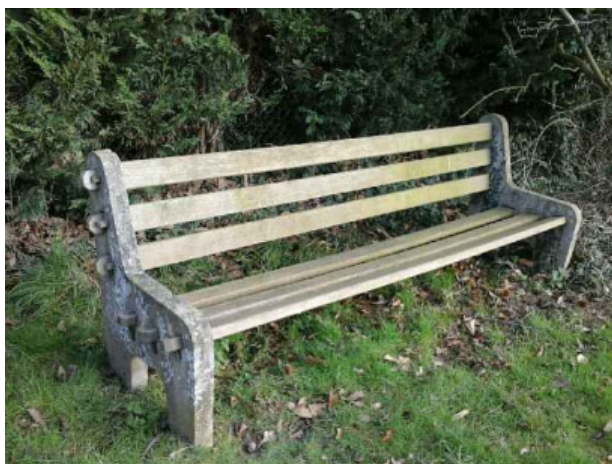
Item: Ancillary Items - Bench
Manufacturer: Owner/Operator
Surface Type: Grass
Equipment Compliance: N/A
Surface Area Compliance: N/A
Ref/Part Number:
Total Findings: 1

The bench is not securely fixed to the surface and there is some possibility of the item tipping or rolling over - Secure the bench to the ground

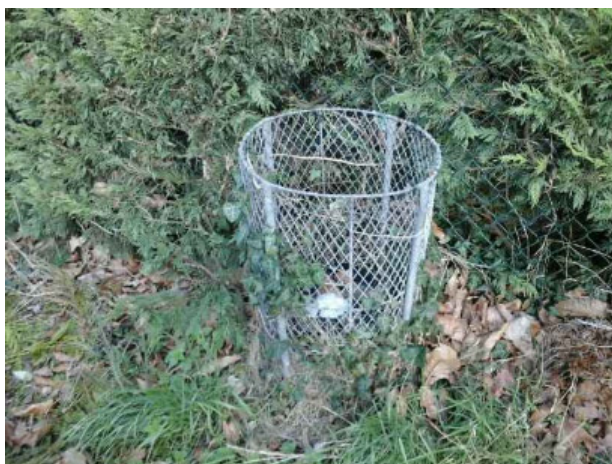
Item: Ancillary Items - Litter Bin
Manufacturer: Owner/Operator
Surface Type: Grass
Equipment Compliance: N/A
Surface Area Compliance: N/A
Ref/Part Number:
Total Findings: 2

The bin is not securely fixed to the surface and there is some possibility of the item tipping or rolling over - Secure the bin to the ground

The adjacent foliage has overgrown the item - Cut back and maintain

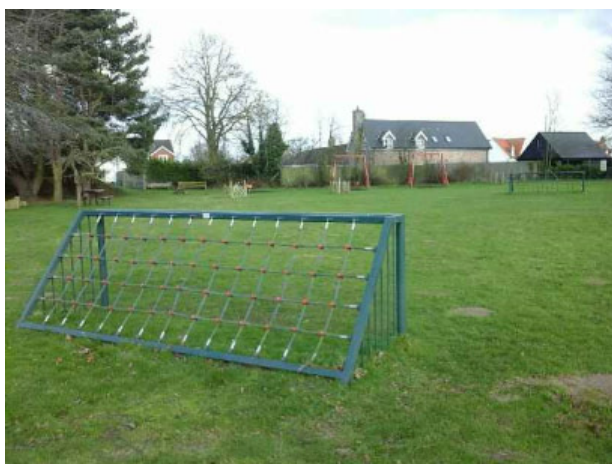
Item: Multi Use Games Area - 5 a side Goals
Manufacturer: Not Identified
Surface Type: Grass
Equipment Compliance: Yes
Surface Area Compliance: N/A
Ref/Part Number:
Total Findings: 1

The paintwork on this item has been damaged or worn exposing the metal underneath which is rusting - Treat any rusting components and repaint

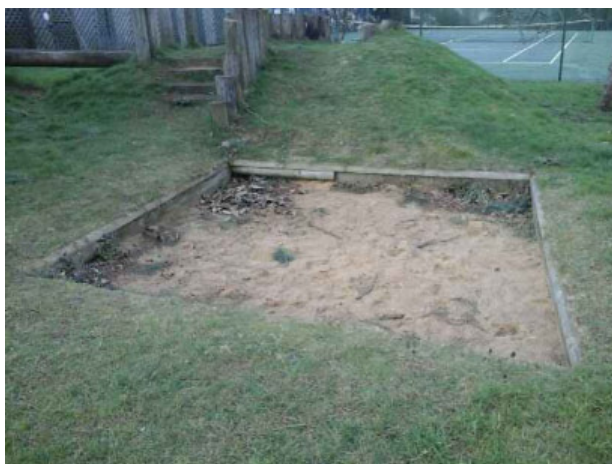
Item: Other - Sand Box
Manufacturer: Owner/Operator
Surface Type: Sand
Equipment Compliance: N/A
Surface Area Compliance: N/A
Ref/Part Number:
Total Findings: 2

There is some tree debris on the surfacing - Remove and maintain

There are weeds/vegetation growth between or around the edges of the surfacing - Remove weeds/vegetation growth

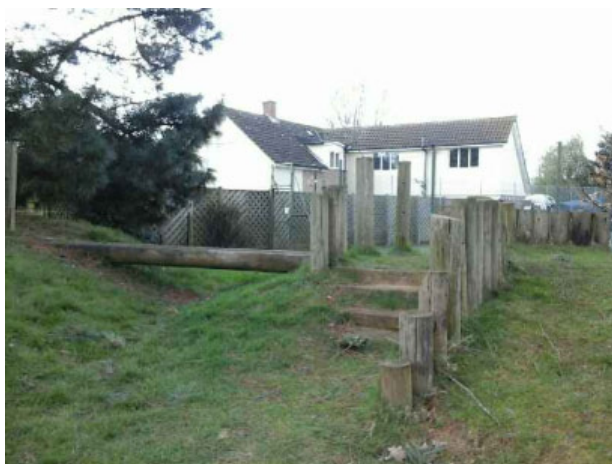
Item: Other - Natural Play Feature
Manufacturer: Not Identified
Surface Type: Grass
Equipment Compliance: Yes
Surface Area Compliance: Yes
Ref/Part Number:
Total Findings: 4

A number of The palisade logs have rotted - Replace all affected timbers

The tree canopy overhangs the equipment and is less than 2.0m away - Lift tree canopy to ensure a minimum clearance of 2.0m from the equipment

There is algae or moss on the surface of the equipment
- Clean and treat appropriately

There is some evidence of rot in the timber balance beams - Monitor for any further deterioration and replace as required

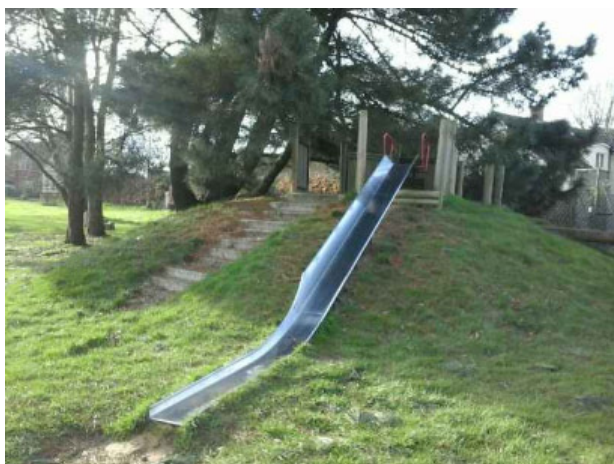
Item: Other - Embankment Slide
Manufacturer: Not Identified
Surface Type: Grass
Equipment Compliance: No
Surface Area Compliance: Yes
Ref/Part Number:
Total Findings: 6

The tree canopy overhangs the equipment and is less than 2.0m away - Lift tree canopy to ensure a minimum clearance of 2.0m from the equipment

The concrete and timber edging forms a hard object within the falling space of the equipment in contravention of the requirements of BS EN 1176 Part 1 - Monitor use

A number of timber posts have rotted on the barriers - Replace all affected timbers

The slide start section incline is not in the direction of travel; it should slope towards the direction of the sliding surface - Monitor use

The paintwork on this item has been damaged or worn exposing the metal underneath which is rusting - Treat any rusting components and repaint

The surface has eroded in some areas - Reinststate the surface

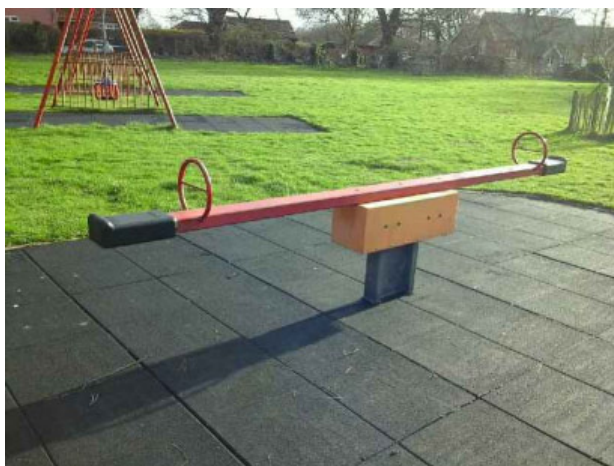
Item: Rocking Equipment - See Saw
Manufacturer: GL Jones
Surface Type: Rubber Tiles
Equipment Compliance: Yes
Surface Area Compliance: Yes
Ref/Part Number:
Total Findings: 1

There are gaps opening in between the tiles - Monitor for any further deterioration and repair as required

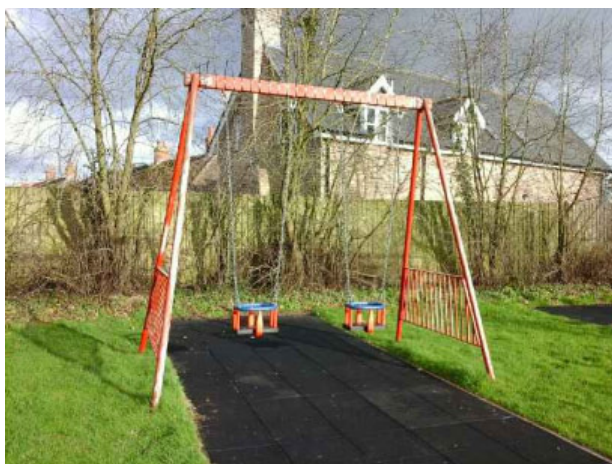
Item: Swings - 1 Bay 2 Seat (Cradle)
Manufacturer: Playquip
Surface Type: Rubber Tiles
Equipment Compliance: Yes
Surface Area Compliance: No
Ref/Part Number:
Total Findings: 3

The surfacing width under each seat is less than 1.75 metres and fails the requirements of BS EN 1176 Part 2 - Monitor use

The paintwork on this item has been damaged or worn exposing the metal underneath which is rusting - Treat any rusting components and repaint

There are gaps opening in between the tiles - Monitor for any further deterioration and repair as required

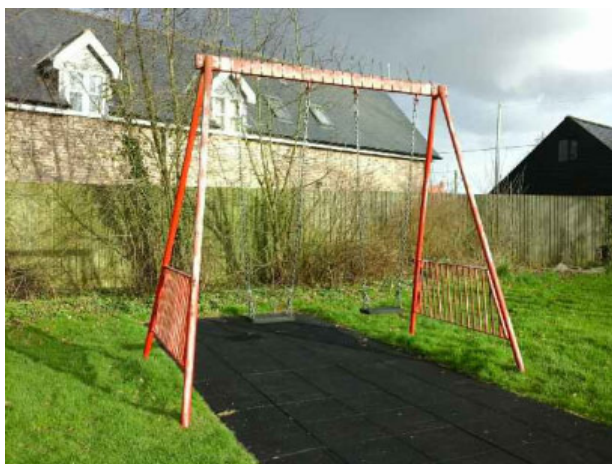
Item: Swings - 1 Bay 2 Seat (Flat)
Manufacturer: Playquip
Surface Type: Rubber Tiles
Equipment Compliance: No
Surface Area Compliance: No
Ref/Part Number:
Total Findings: 5

The chain openings are in excess of the 8.6mm as recommended by BS EN 1176 - Monitor use and replace with compliant chains during next maintenance cycle.

There is some chain wear - Monitor for any further deterioration and replace when 40% worn

The seat has minor damage or wear - Monitor for any further deterioration and replace as required

The surfacing width under each seat is less than 1.75 metres and fails the requirements of BS EN 1176 Part 2 - Monitor use

The paintwork on this item has been damaged or worn exposing the metal underneath which is rusting - Treat any rusting components and repaint

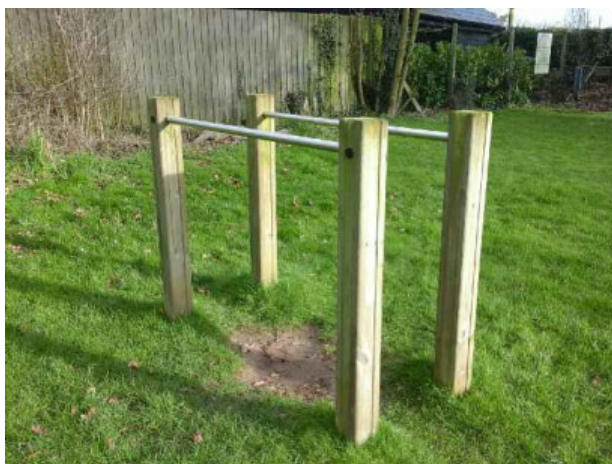
Item: Activity Equipment - Parallel Bars
Manufacturer: Not Identified
Surface Type: Grass
Equipment Compliance: Yes
Surface Area Compliance: Yes
Ref/Part Number:
Total Findings: 3

The surface has eroded in some areas - Reinstate the surface

There is some strimmer damage apparent on the posts, this can penetrate the preservative applied to the timber and accelerate the rotting process - Monitor for any deterioration (rot) and replace as required

There is some evidence of rot in the timber - Monitor for any further deterioration and replace as required

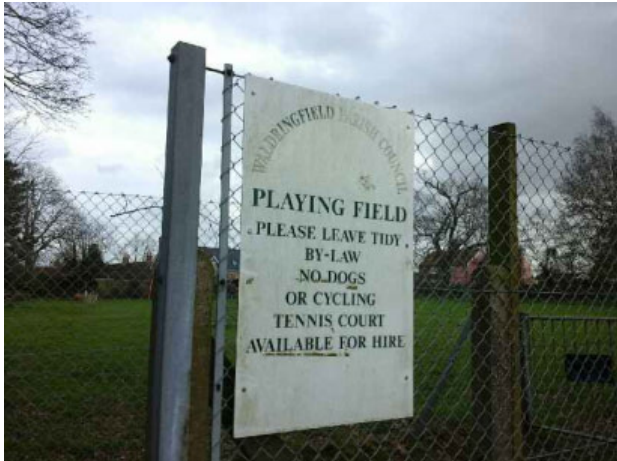
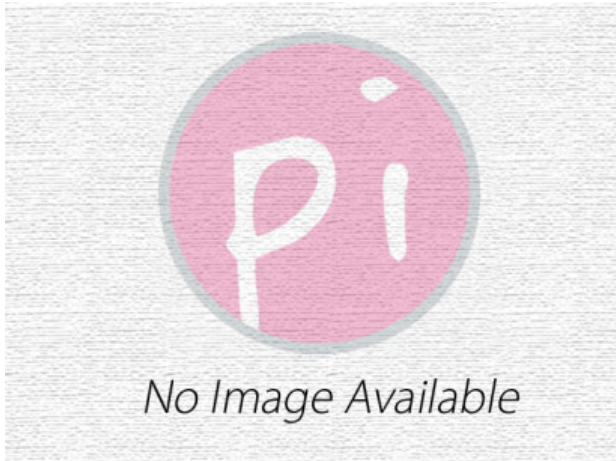
2 - Very Low Risk (Finding 1)			
Item:	Ancillary Items - Sign	Risk Level:	V - Very Low Risk
Manufacturer:	Owner/Operator	Surface:	N/A

Finding:	It is recommended that information signs with emergency contact details are installed at each entrance/exit point to the playground		
Action:	Provide in accordance with the recommendations set out in BS EN 1176

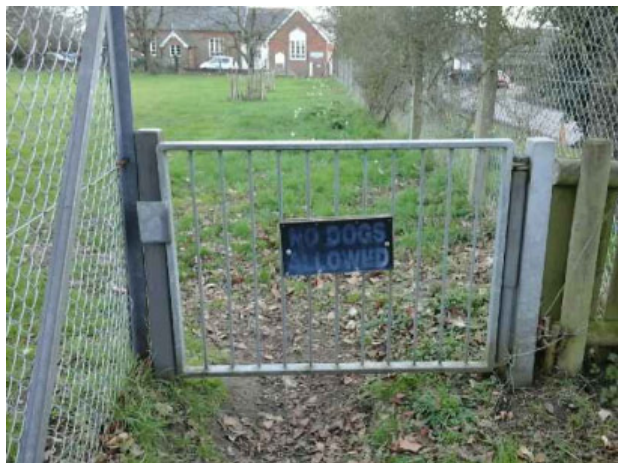
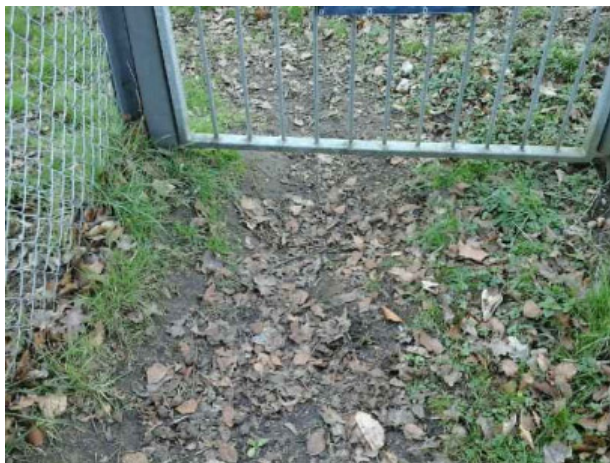
8 - Low Risk (Finding 2)

Finding: The area under the gate has eroded leaving uneven areas, or the concrete foundations exposed, resulting in trip hazards at the entrance/exit to the playground

Action: Reinstate to level with surrounding surfaces

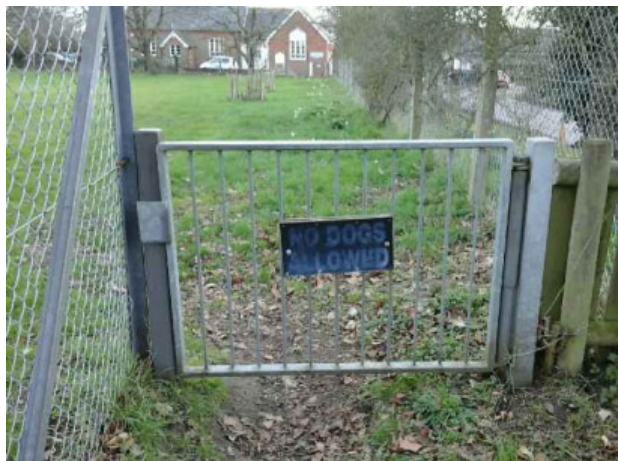
8 - Low Risk (Finding 3)

Finding: The opening between the gate and the post is less than 12mm and could trap users fingers
Action: Adjust gate to ensure a 12mm opening all around

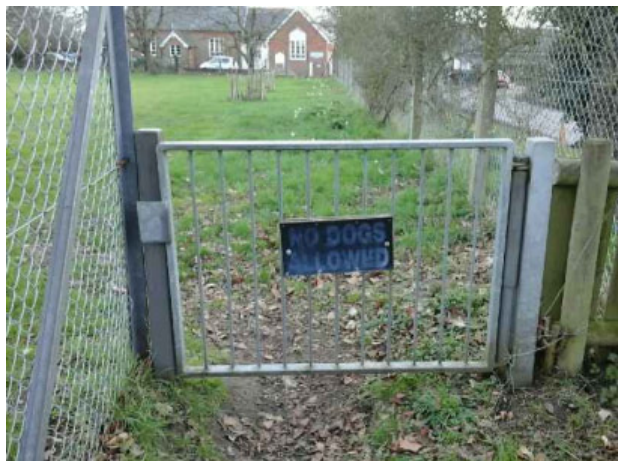
6 - Low Risk (Finding 4)

Finding: The gate is closing too quickly (less than 4 seconds)

Action: Take corrective action to ensure that the gate closes in 4-8 seconds

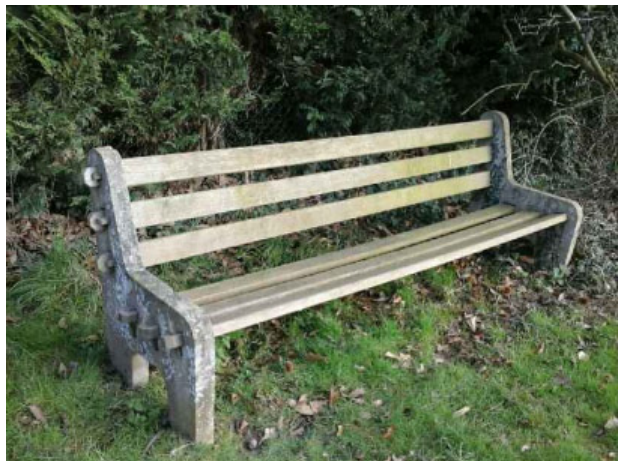
8 - Low Risk (Finding 1)

Finding: The bench is not securely fixed to the surface and there is some possibility of the item tipping or rolling over

Action: Secure the bench to the ground

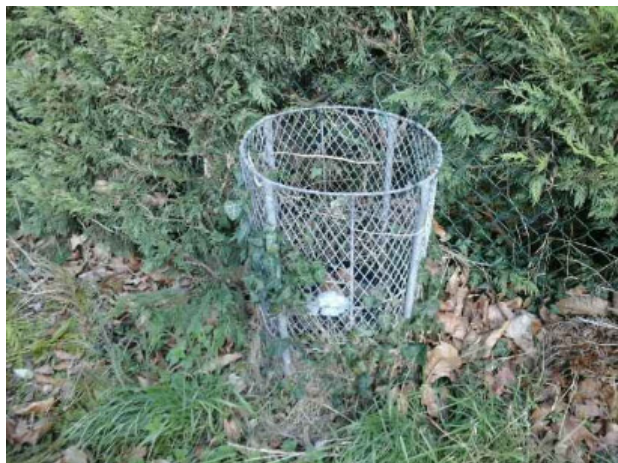
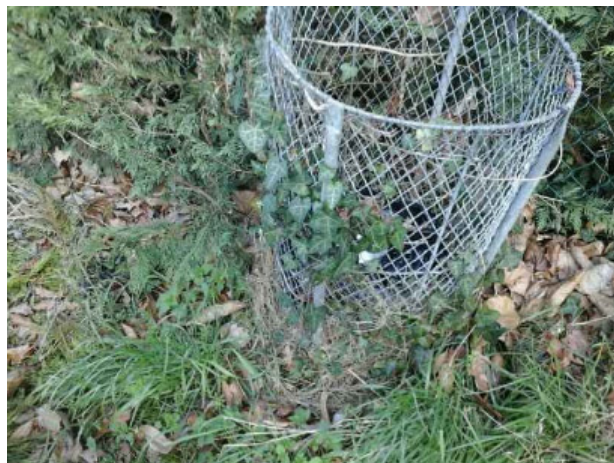
8 - Low Risk (Finding 1)

Finding: The bin is not securely fixed to the surface and there is some possibility of the item tipping or rolling over

Action: Secure the bin to the ground

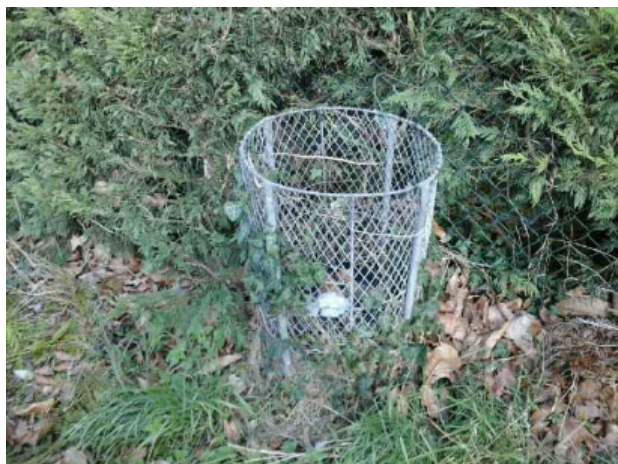
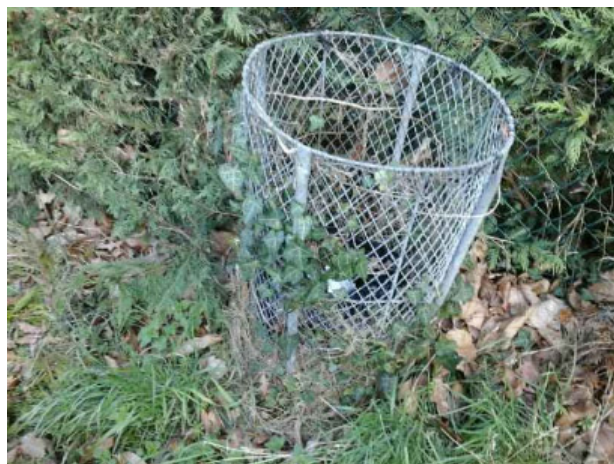
6 - Low Risk (Finding 2)

Finding: The adjacent foliage has overgrown the item

Action: Cut back and maintain

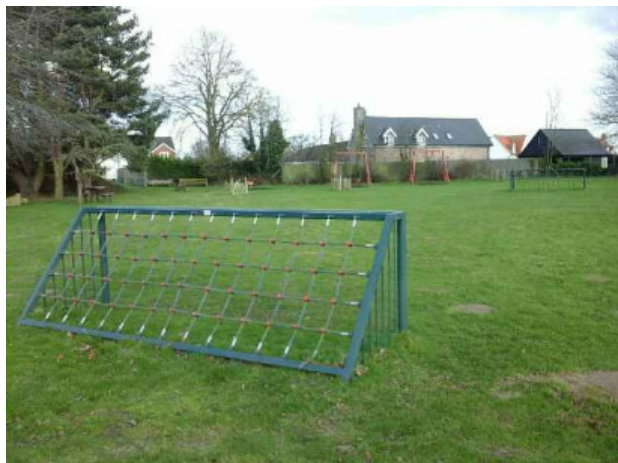
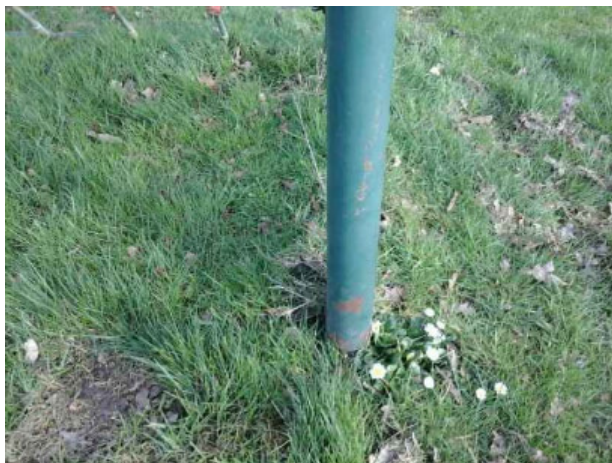
6 - Low Risk (Finding 1)

Finding: The paintwork on this item has been damaged or worn exposing the metal underneath which is rusting

Action: Treat any rusting components and repaint

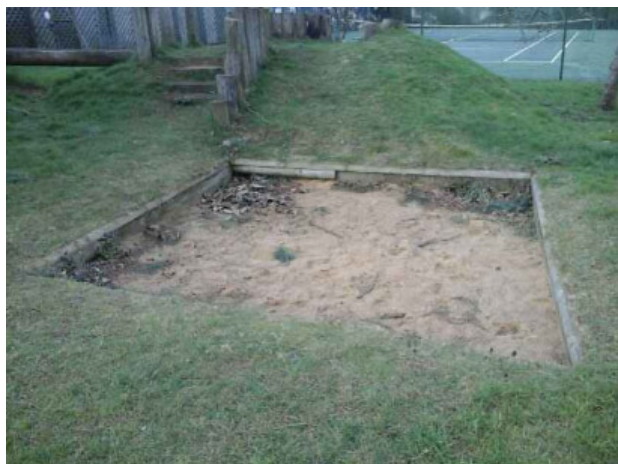
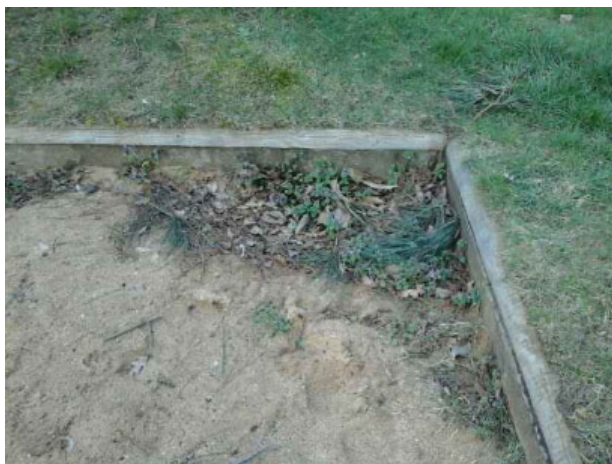
6 - Low Risk (Finding 1)

Finding: There is some tree debris on the surfacing

Action: Remove and maintain

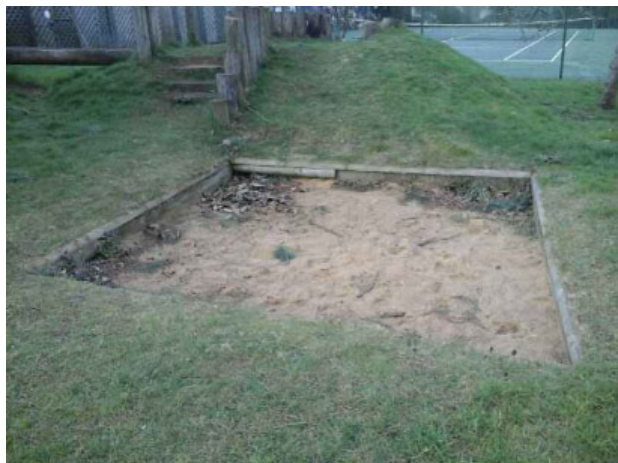
6 - Low Risk (Finding 2)

Finding: There are weeds/vegetation growth between or around the edges of the surfacing

Action: Remove weeds/vegetation growth

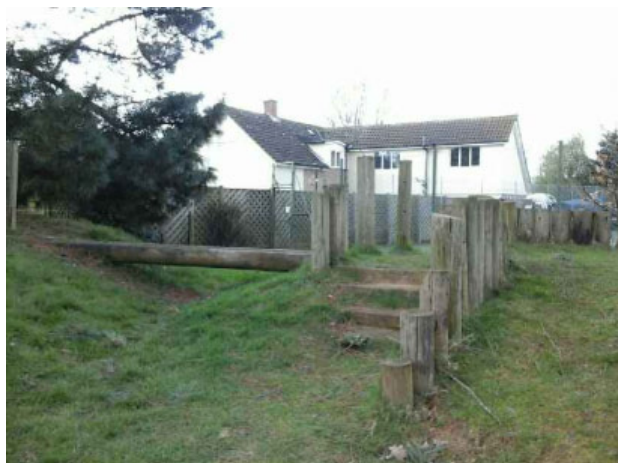
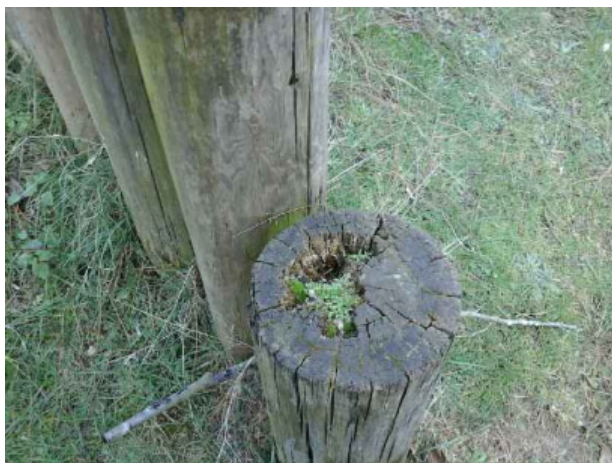
8 - Low Risk (Finding 1)

Finding: A number of The palisade logs have rotted

Action: Replace all affected timbers

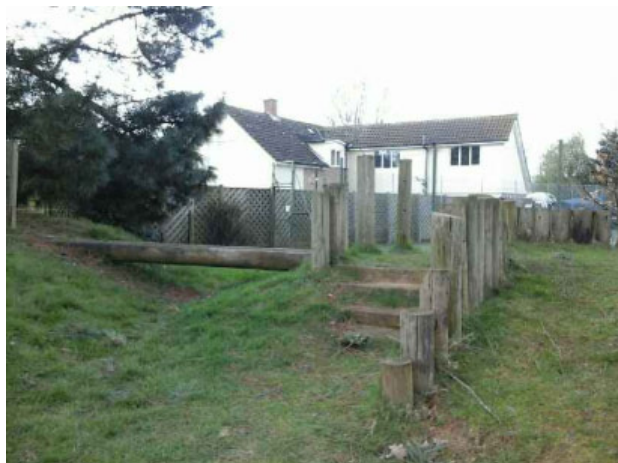
6 - Low Risk (Finding 2)

Finding: The tree canopy overhangs the equipment and is less than 2.0m away

Action: Lift tree canopy to ensure a minimum clearance of 2.0m from the equipment

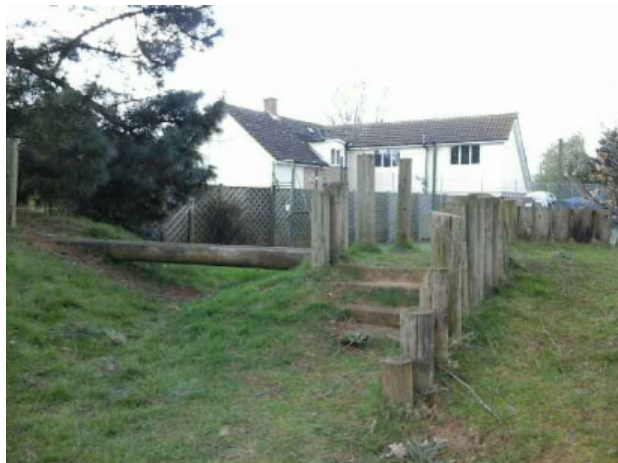
8 - Low Risk (Finding 3)

Finding: There is algae or moss on the surface of the equipment

Action: Clean and treat appropriately

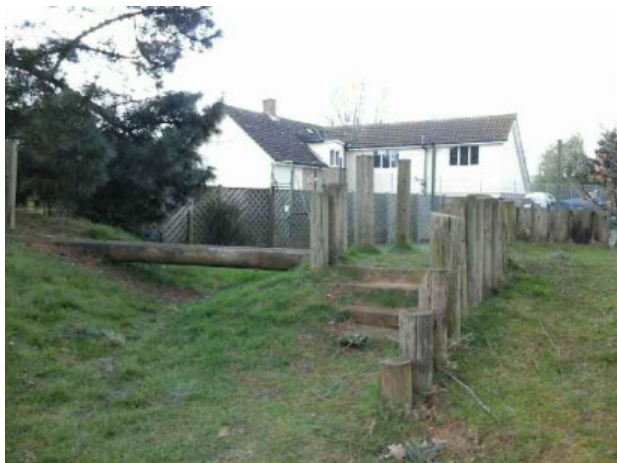
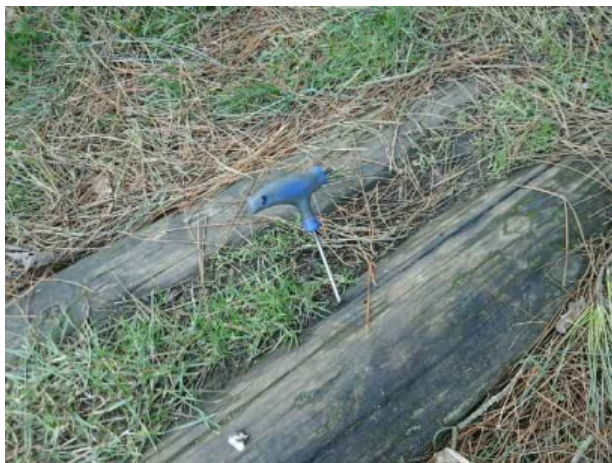
6 - Low Risk (Finding 4)

Finding: There is some evidence of rot in the timber balance beams

Action: Monitor for any further deterioration and replace as required

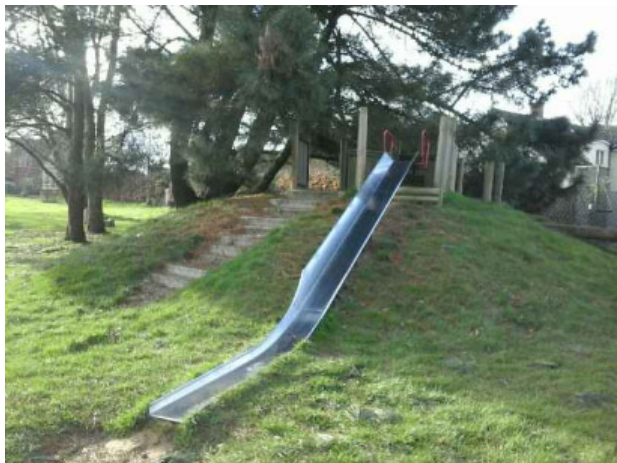
6 - Low Risk (Finding 1)

Finding: The tree canopy overhangs the equipment and is less than 2.0m away

Action: Lift tree canopy to ensure a minimum clearance of 2.0m from the equipment

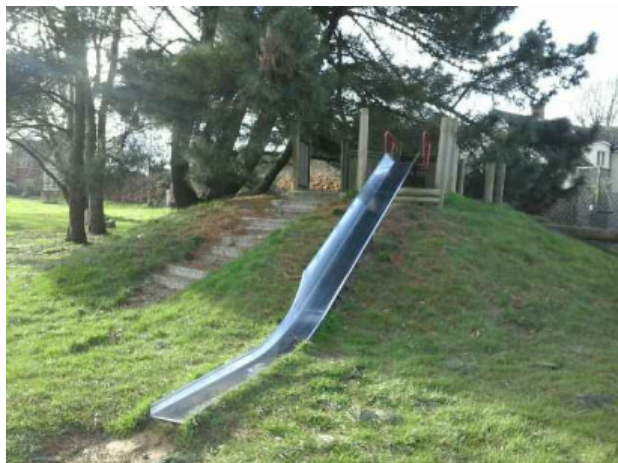
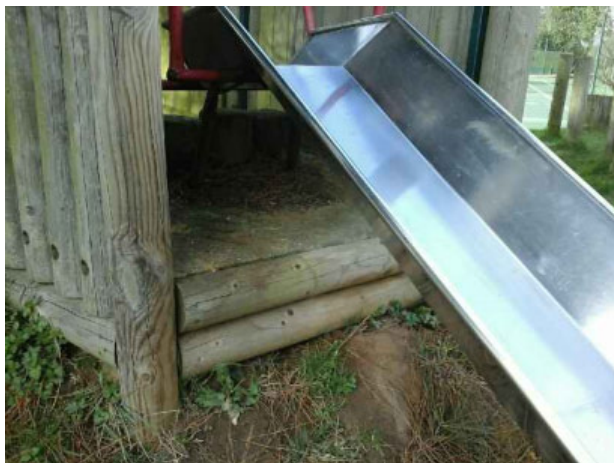
8 - Low Risk (Finding 2)

Finding: The concrete and timber edging forms a hard object within the falling space of the equipment in contravention of the requirements of BS EN 1176 Part 1
Action: Monitor use

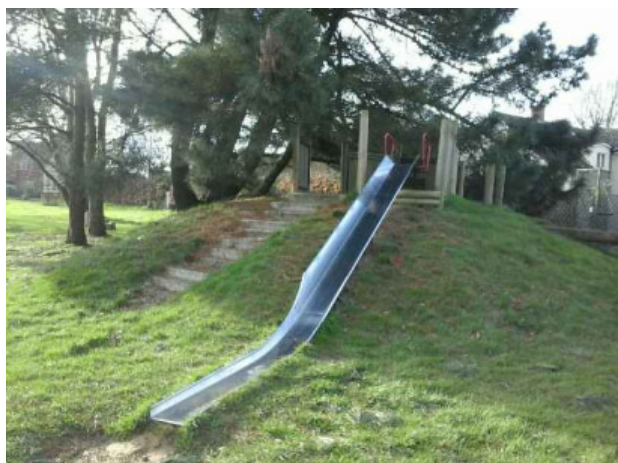
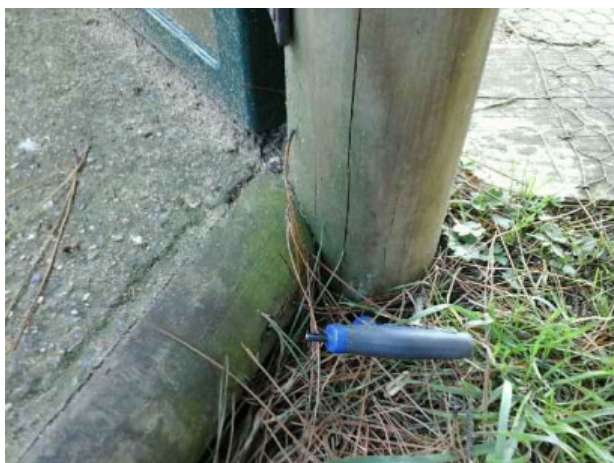
8 - Low Risk (Finding 3)

Finding: A number of timber posts have rotted on the barriers
Action: Replace all affected timbers

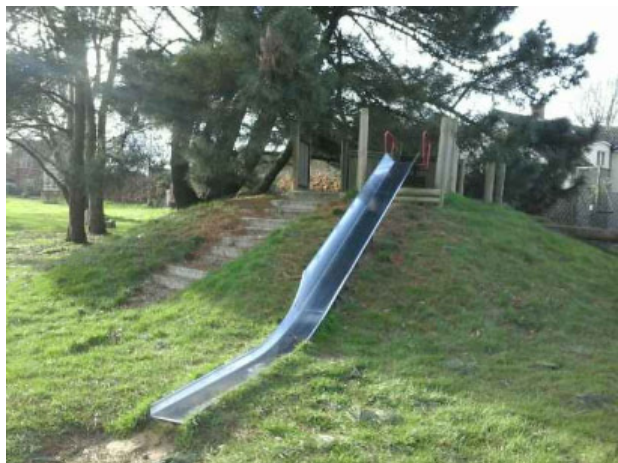
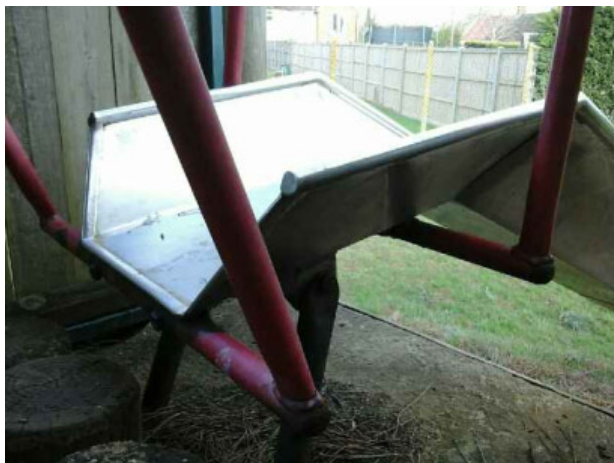
4 - Very Low Risk (Finding 4)

Finding: The slide start section incline is not in the direction of travel; it should slope towards the direction of the sliding surface

Action: Monitor use

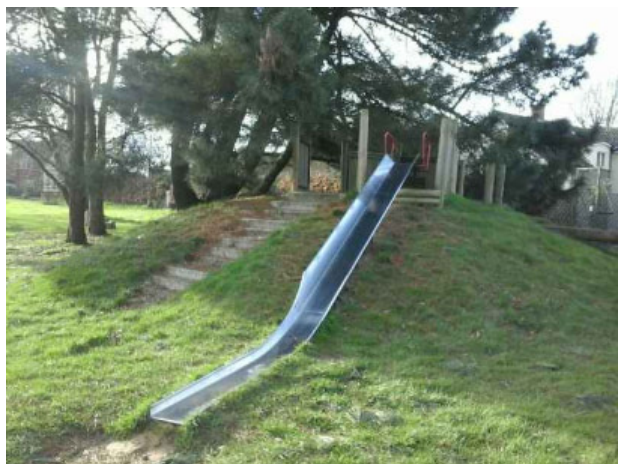
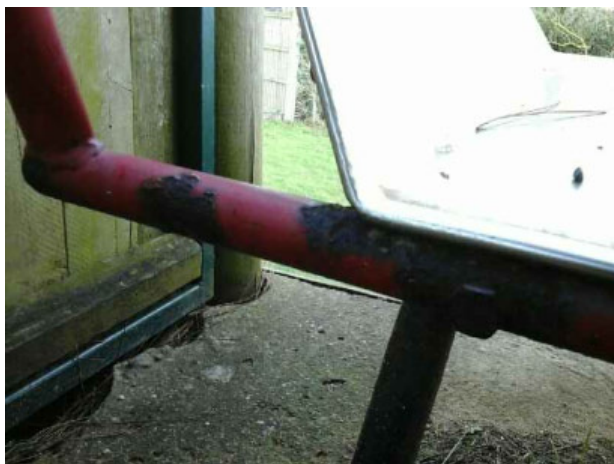
6 - Low Risk (Finding 5)

Finding: The paintwork on this item has been damaged or worn exposing the metal underneath which is rusting

Action: Treat any rusting components and repaint

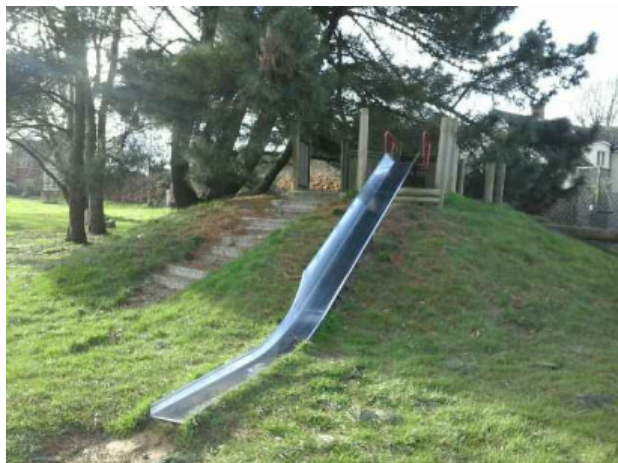
6 - Low Risk (Finding 6)

Finding: The surface has eroded in some areas

Action: Reinstate the surface

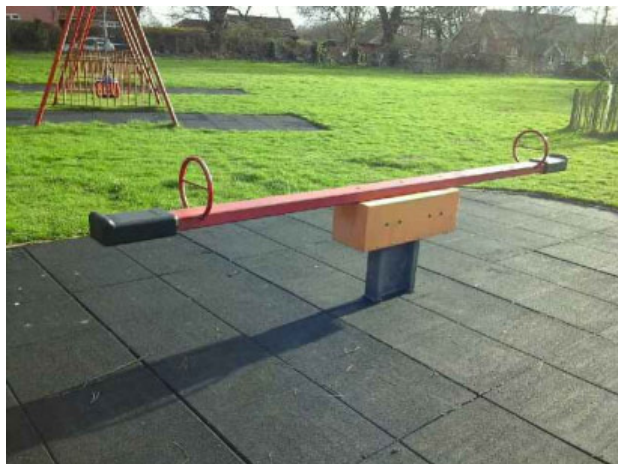
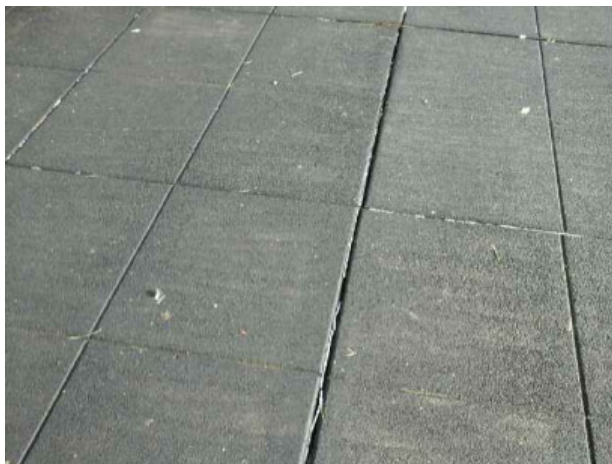
6 - Low Risk (Finding 1)

Finding: There are gaps opening in between the tiles

Action: Monitor for any further deterioration and repair as required

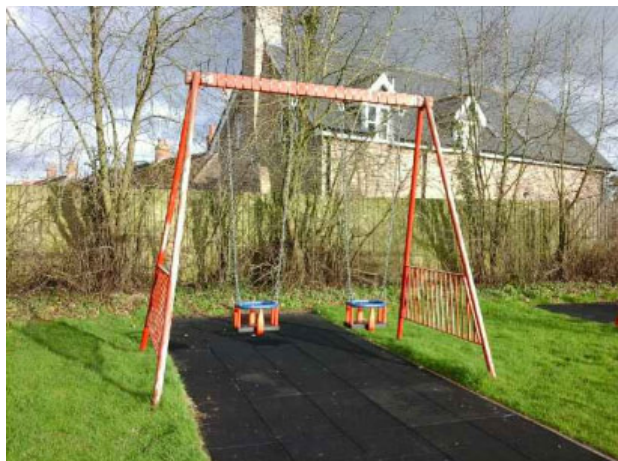
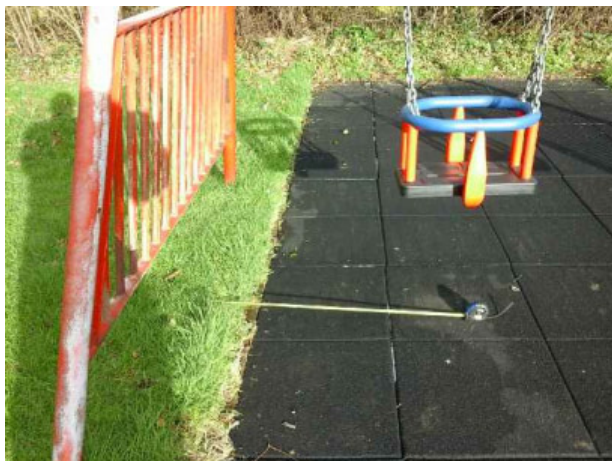
5 - Very Low Risk (Finding 1)

Finding: The surfacing width under each seat is less than 1.75 metres and fails the requirements of BS EN 1176 Part 2

Action: Monitor use

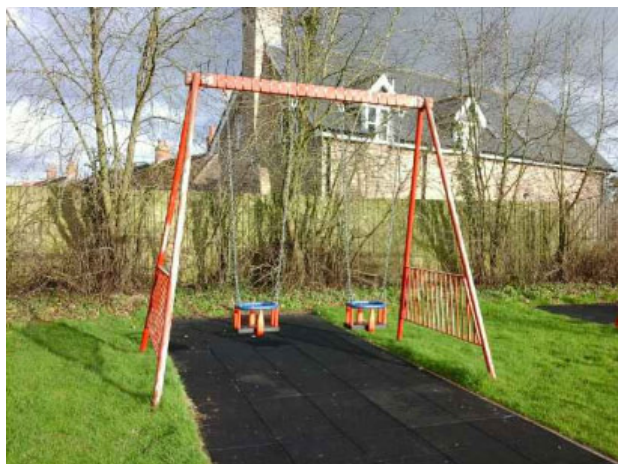
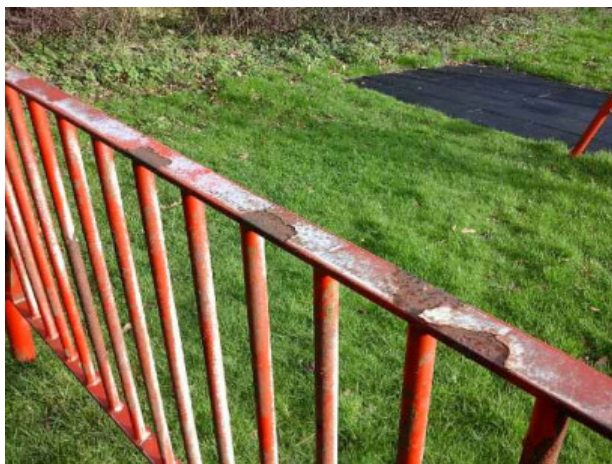
6 - Low Risk (Finding 2)

Finding: The paintwork on this item has been damaged or worn exposing the metal underneath which is rusting

Action: Treat any rusting components and repaint

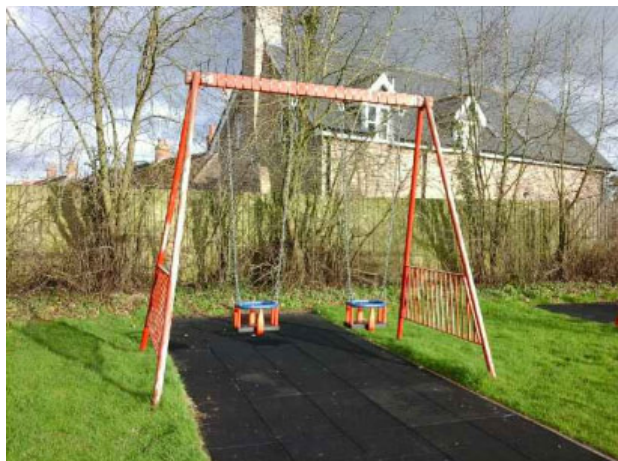
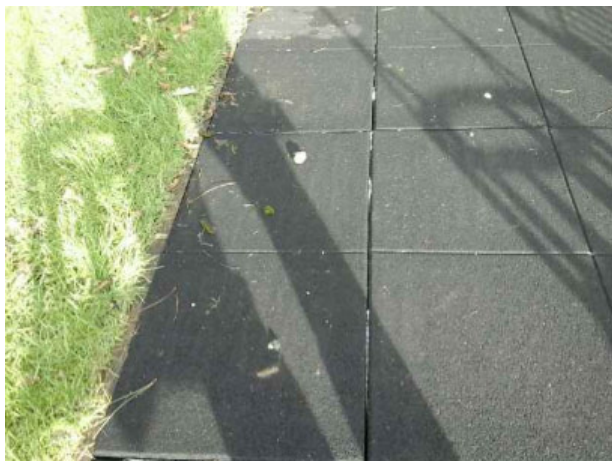
6 - Low Risk (Finding 3)

Finding: There are gaps opening in between the tiles

Action: Monitor for any further deterioration and repair as required

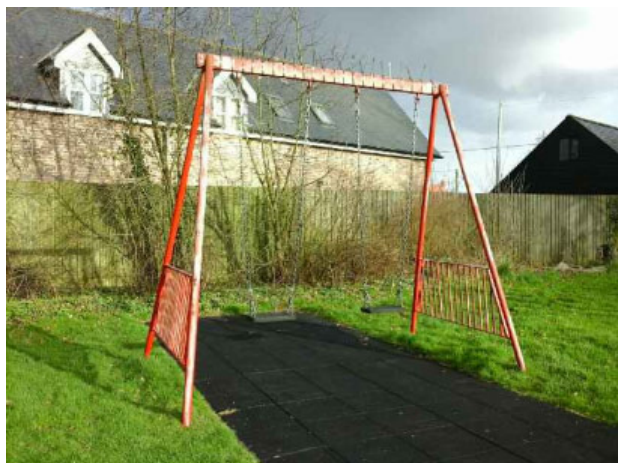
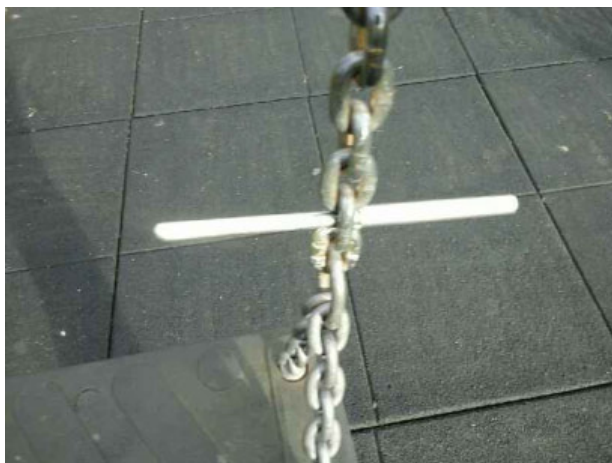
4 - Very Low Risk (Finding 1)

Finding: The chain openings are in excess of the 8.6mm as recommended by BS EN 1176

Action: Monitor use and replace with compliant chains during next maintenance cycle.

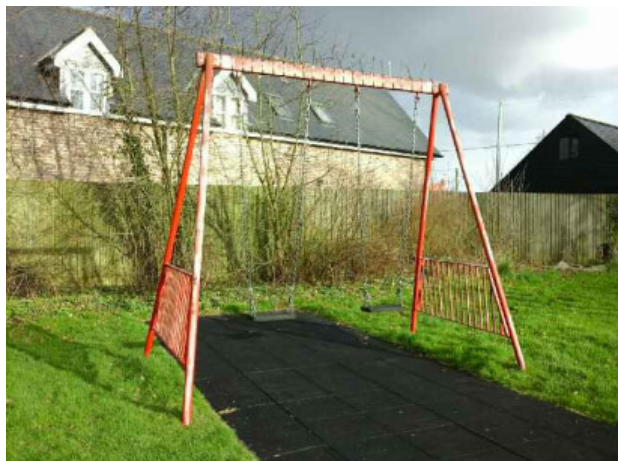
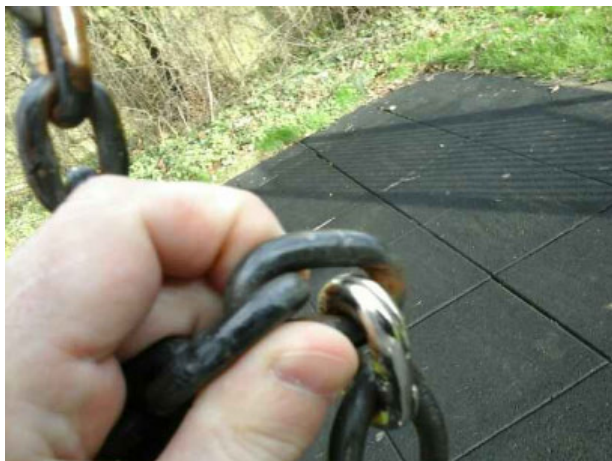
6 - Low Risk (Finding 2)

Finding: There is some chain wear

Action: Monitor for any further deterioration and replace when 40% worn

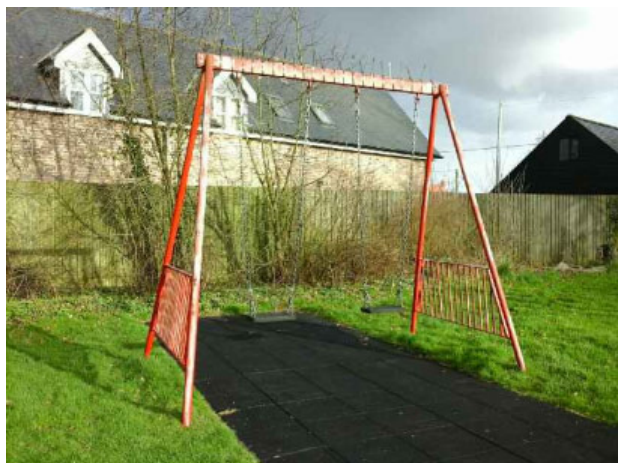
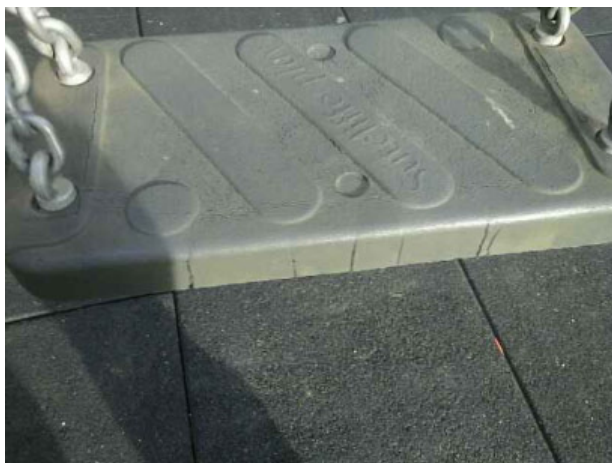
6 - Low Risk (Finding 3)

Finding: The seat has minor damage or wear

Action: Monitor for any further deterioration and replace as required

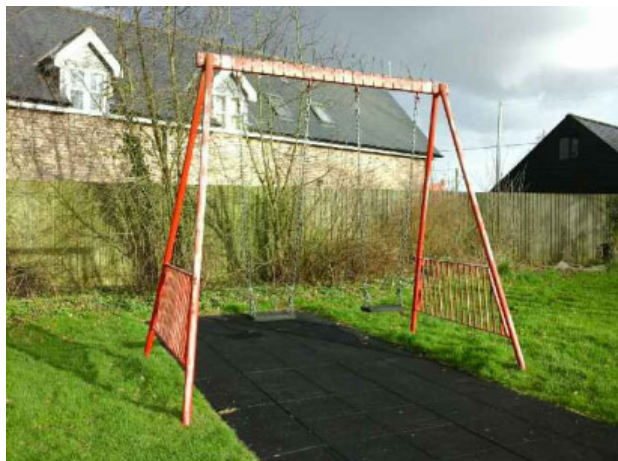
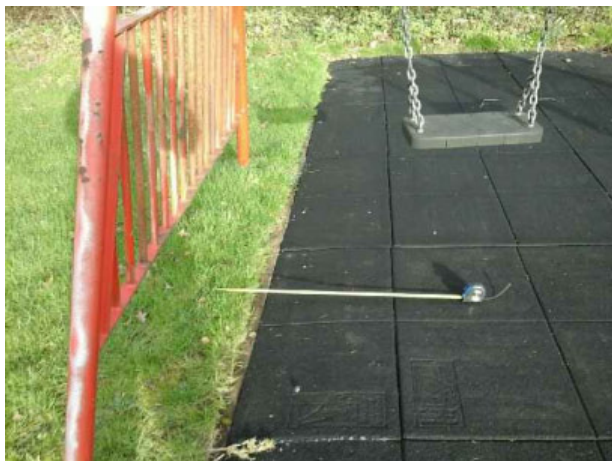
5 - Very Low Risk (Finding 4)

Finding: The surfacing width under each seat is less than 1.75 metres and fails the requirements of BS EN 1176 Part 2

Action: Monitor use

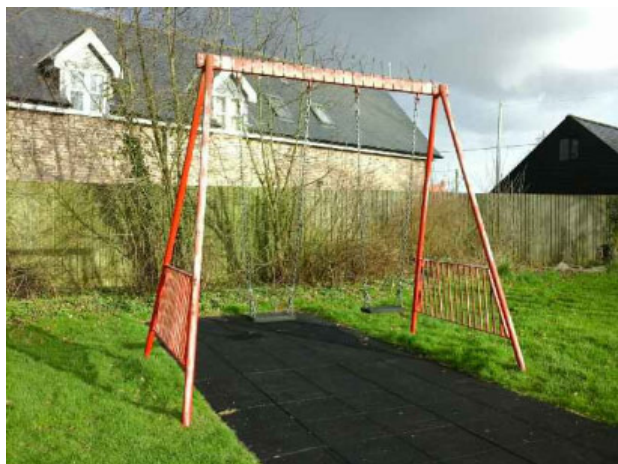
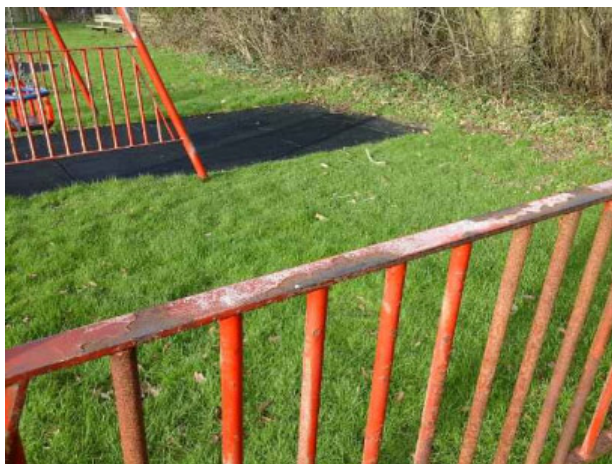
6 - Low Risk (Finding 5)

Finding: The paintwork on this item has been damaged or worn exposing the metal underneath which is rusting

Action: Treat any rusting components and repaint

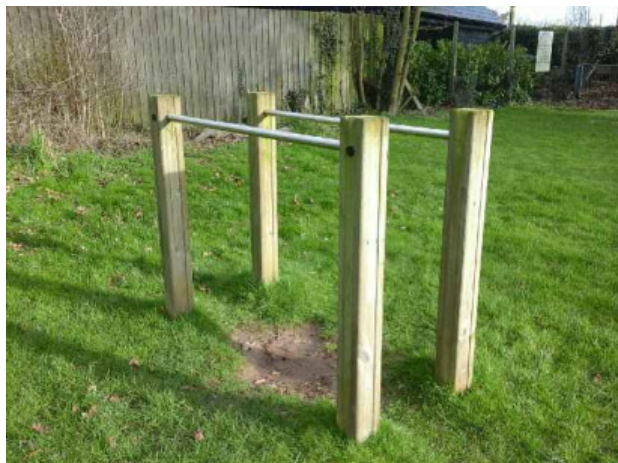
6 - Low Risk (Finding 1)

Finding: The surface has eroded in some areas

Action: Reinstate the surface

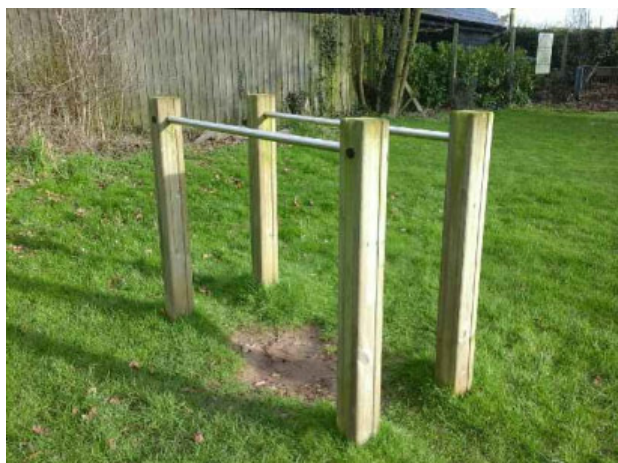
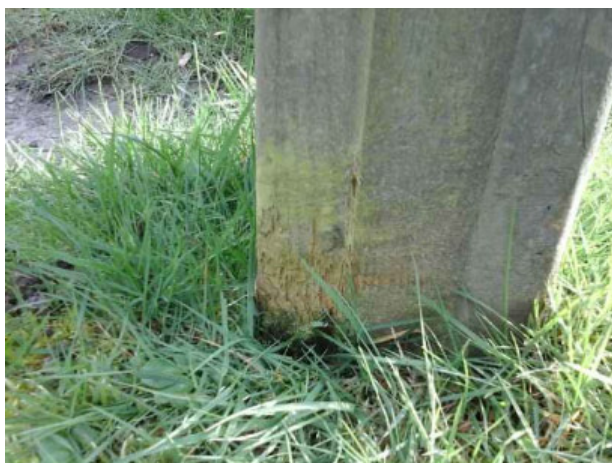
6 - Low Risk (Finding 2)

Finding: There is some strimmer damage apparent on the posts, this can penetrate the preservative applied to the timber and accelerate the rotting process

Action: Monitor for any deterioration (rot) and replace as required

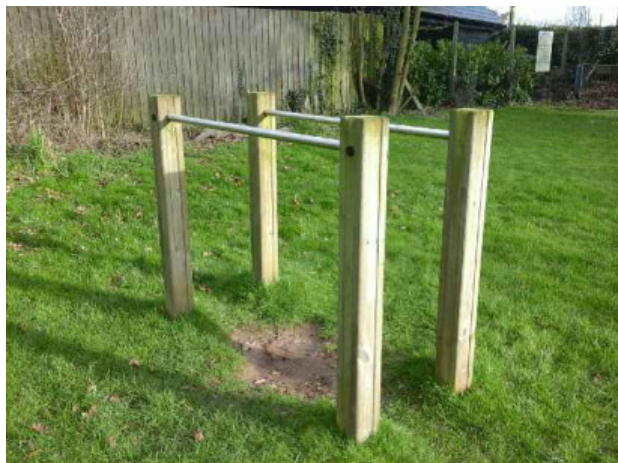
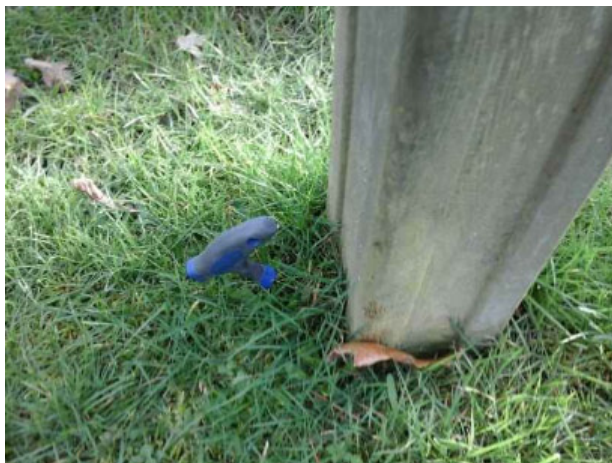
6 - Low Risk (Finding 3)

Finding: There is some evidence of rot in the timber

Action: Monitor for any further deterioration and replace as required
