Annual Inspection

Suffolk Coastal & Waveney Norse

Waldringfield Play Area

Annual Inspection - 03 May 2018 at 15:50 Inspector: David Fagan (RPII Outdoor Annual Inspector)

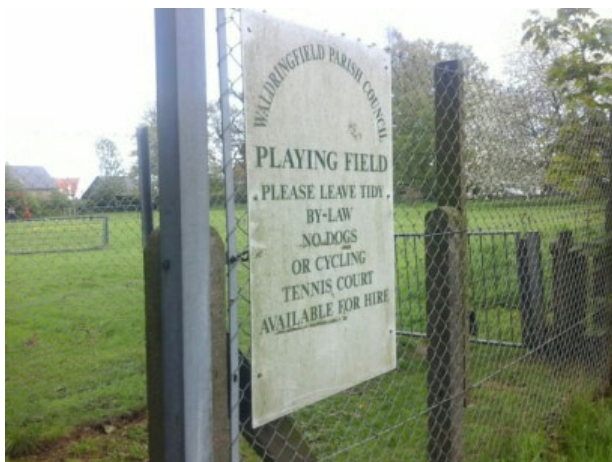
Item: Ancillary Items - Sign
Manufacturer: Owner/Operator
Surface Type: N/A
Equipment Compliance: N/A
Surface Area Compliance: N/A
Ref/Part Number:
Total Findings: 1

It is recommended that information signs with emergency contact details are installed at each entrance/exit point to the playground - Provide in accordance with the recommendations set out in BS EN 1176

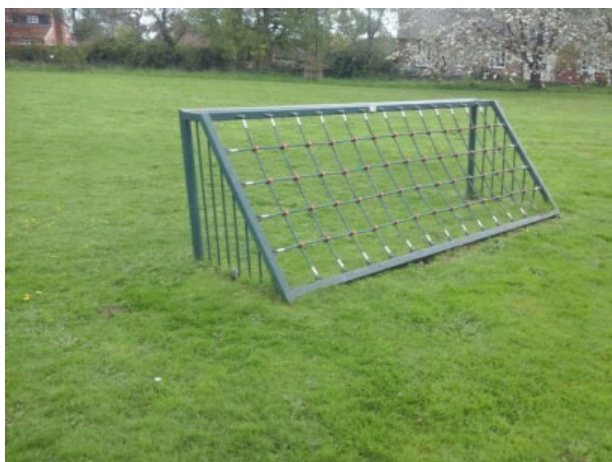
Item: Multi Use Games Area - 5 a side Goals
Manufacturer: Not Identified
Surface Type: Grass
Equipment Compliance: Yes
Surface Area Compliance: N/A
Ref/Part Number:
Total Findings: 1

The paintwork on this item has been damaged or worn exposing the metal underneath which is rusting - Treat any rusting components and repaint

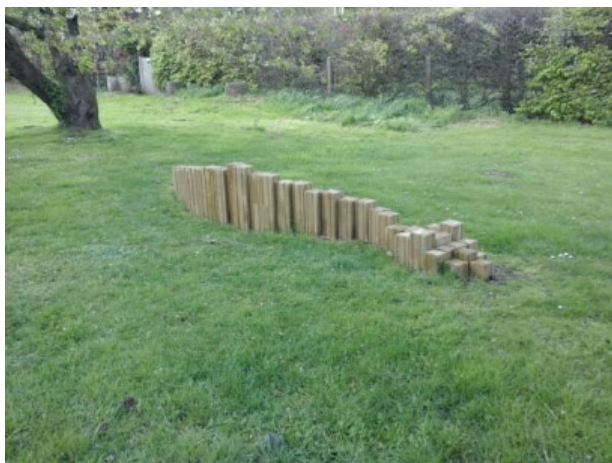
Item: Activity Equipment - Stepping Stones
Manufacturer: Not Identified
Surface Type: Grass
Equipment Compliance: Yes
Surface Area Compliance: Yes
Ref/Part Number:
Total Findings: 2

The surface has eroded and the foundations are exposed - Reinstall surrounding surfaces to cover the foundations

The tree canopy overhangs the equipment and is less than 2.0m away - Lift tree canopy to ensure a minimum clearance of 2.0m from the equipment

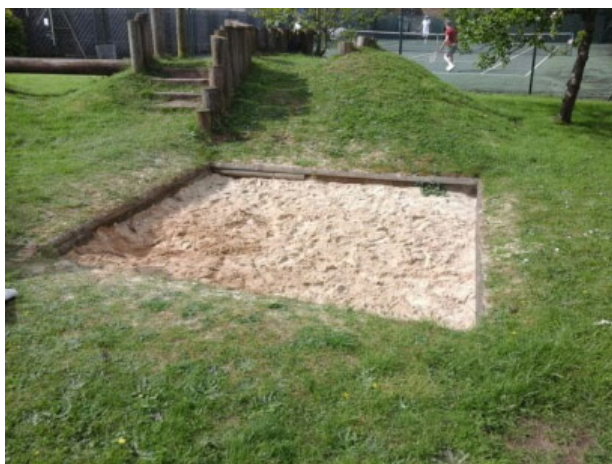
Item: Other - Sand Box
Manufacturer: Owner/Operator
Surface Type: Sand
Equipment Compliance: N/A
Surface Area Compliance: N/A
Ref/Part Number:
Total Findings: 2

The timber surround has rotted - Replace all affected timbers

There are weeds/vegetation growth between or around the edges of the surfacing - Remove weeds/vegetation growth

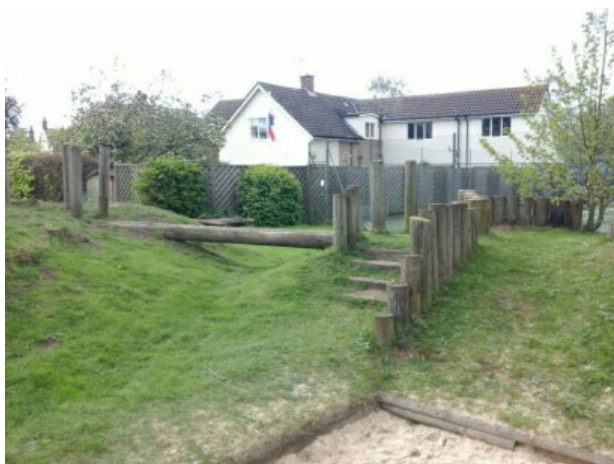
Item: Other - Natural Play Feature
Manufacturer: Not Identified
Surface Type: Grass
Equipment Compliance: Yes
Surface Area Compliance: Yes
Ref/Part Number:
Total Findings: 5

There are areas or parts of the timber logs that have rotted - Replace all affected timbers

The timber has a number of splits (shakes) although these are not considered to be a problem at present - Monitor to ensure the splits do not cross through fixing points of the structure and cause any instability

Parts of the timber are rough or splintered - Remove all rough or sharp edges

The tree canopy overhangs the equipment and is less than 2.0m away - Lift tree canopy to ensure a minimum clearance of 2.0m from the equipment

The timber steps have rotted - Replace affected steps

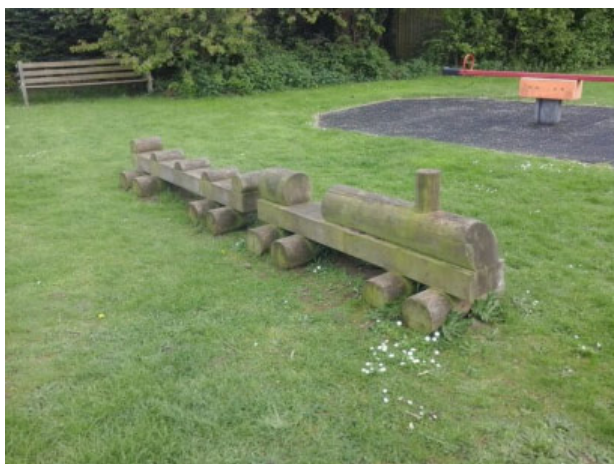
Item: Activity Equipment - Train
Manufacturer: Not Identified
Surface Type: Grass
Equipment Compliance: Yes
Surface Area Compliance: Yes
Ref/Part Number:
Total Findings: 1

The timber has a number of air cracks apparent, the splits will have penetrated the preservative applied to the timber and allow water ingress to the unprotected areas - Monitor for any deterioration (rot) and replace as required

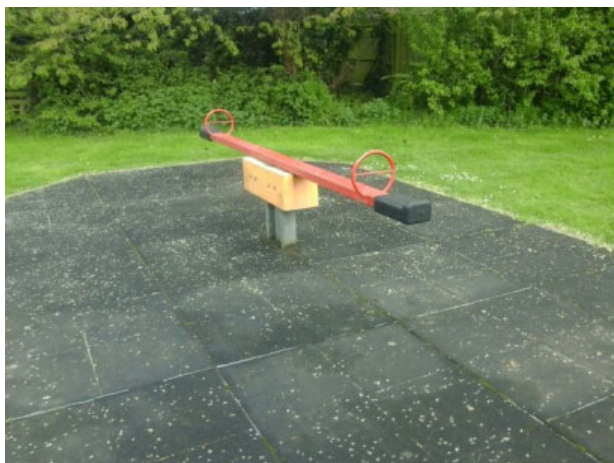
Item: Rocking Equipment - See Saw
Manufacturer: GL Jones
Surface Type: Rubber Tiles
Equipment Compliance: Yes
Surface Area Compliance: Yes
Ref/Part Number:
Total Findings: 2

There are gaps opening in between the tiles - Monitor for any further deterioration and repair as required

There is algae or moss growth on the surface resulting in slippery conditions - Clean and treat appropriately

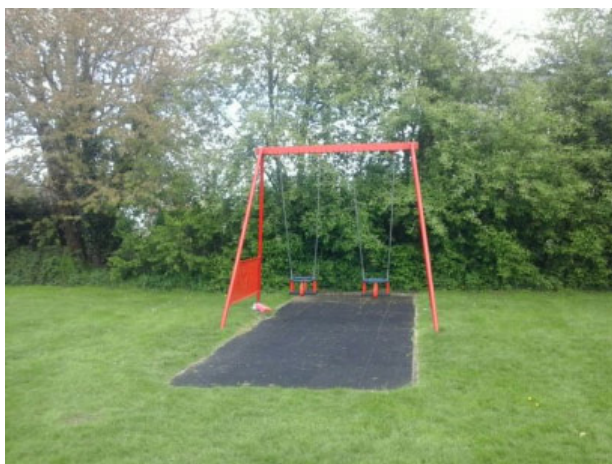
Item: Swings - 1 Bay 2 Seat (Cradle)
Manufacturer: Playquip
Surface Type: Rubber Tiles
Equipment Compliance: Yes
Surface Area Compliance: No
Ref/Part Number:
Total Findings: 3

The surfacing width under each seat is less than 1.75 metres and fails the requirements of BS EN 1176 Part 2 - Monitor use

There are gaps opening in between the tiles - Monitor for any further deterioration and repair as required

There are cable ties present on the crossbar - Remove the cable ties

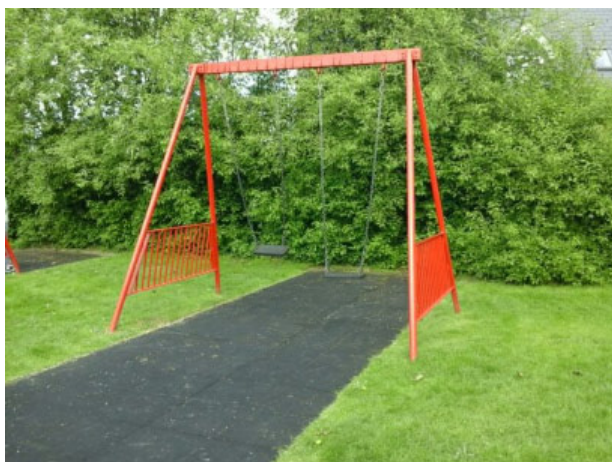
Item: Swings - 1 Bay 2 Seat (Flat)
Manufacturer: Playquip
Surface Type: Rubber Tiles
Equipment Compliance: No
Surface Area Compliance: No
Ref/Part Number:
Total Findings: 8

The chain openings are in excess of the 8.6mm as recommended by BS EN 1176 - Monitor use

The surfacing width under each seat is less than 1.75 metres and fails the requirements of BS EN 1176 Part 2 - Monitor use

The seat has minor damage or wear - Monitor for any further deterioration and replace as required

There is some notable evidence of chain wear - Monitor for any further deterioration and replace when 40% worn

The bushes are showing signs of wear - Monitor for any further deterioration and replace as required

There are cable ties present on the crossbar - Remove the cable ties

There are gaps opening in between the tiles - Monitor for any further deterioration and repair as required

There is algae or moss growth on the surface resulting in slippery conditions - Clean and treat appropriately

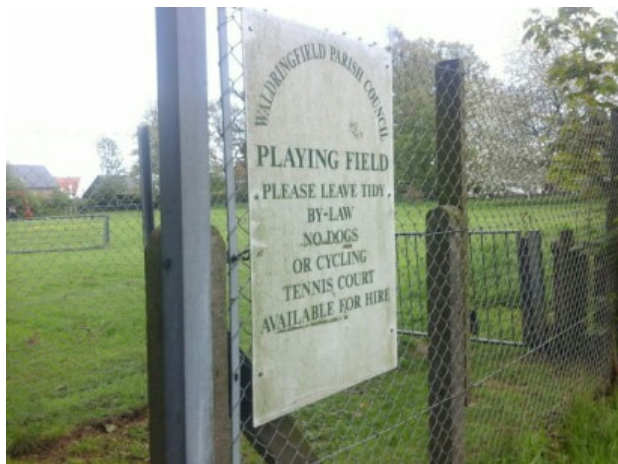
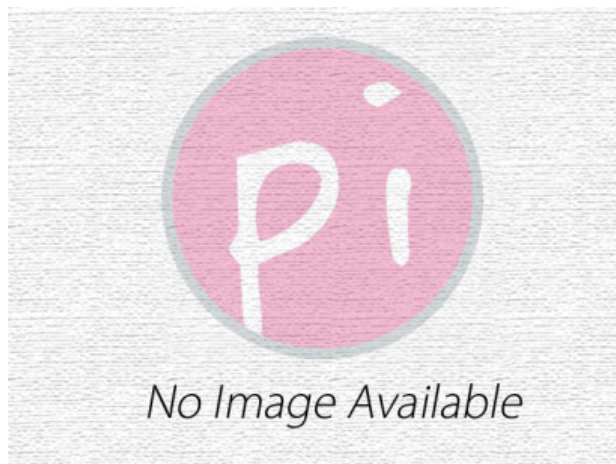
2 - Very Low Risk (Finding 1)			
Item:	Ancillary Items - Sign	Risk Level:	V - Very Low Risk
Manufacturer:	Owner/Operator	Surface:	N/A

Finding:	It is recommended that information signs with emergency contact details are installed at each entrance/exit point to the playground		
Action:	Provide in accordance with the recommendations set out in BS EN 1176

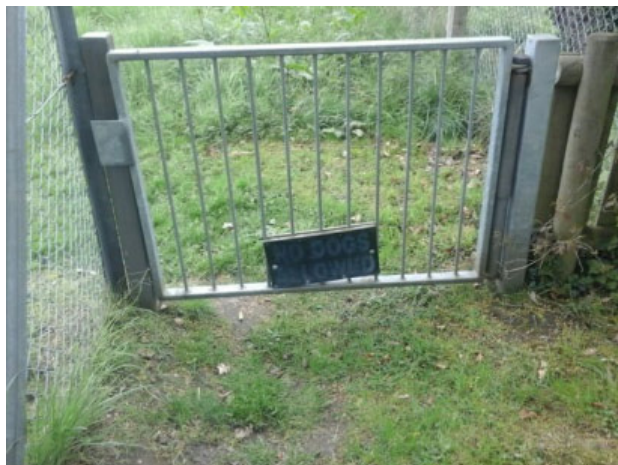
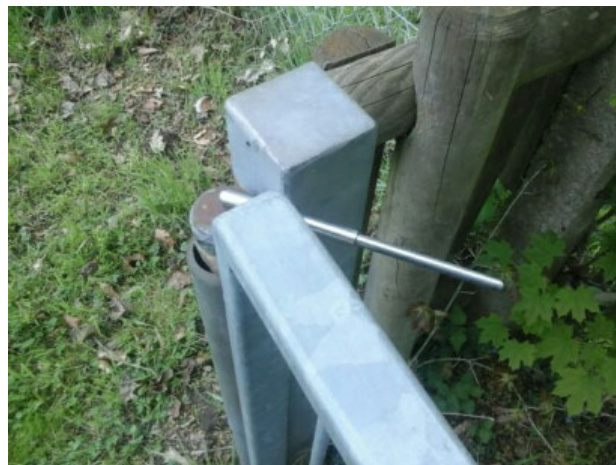
8 - Low Risk (Finding 1)			
Item:	Ancillary Items - Gate - Self Closing	Risk Level:	L - Low Risk
Manufacturer:	Not Identified	Surface:	Grass

Finding:	The opening between the gate and the post is less than 12mm and could trap users fingers		
Action:	Adjust gate to ensure a 12mm opening all around

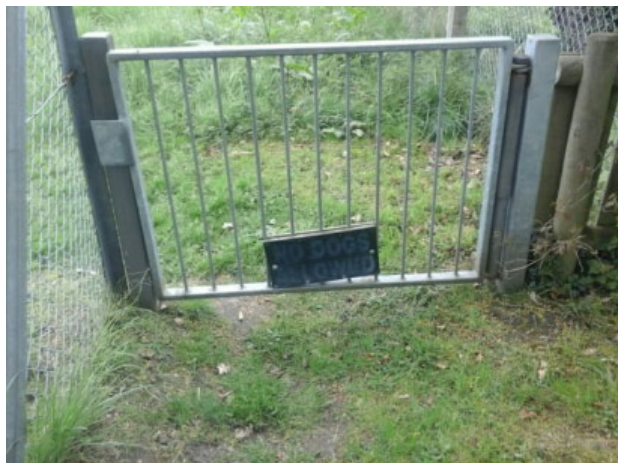
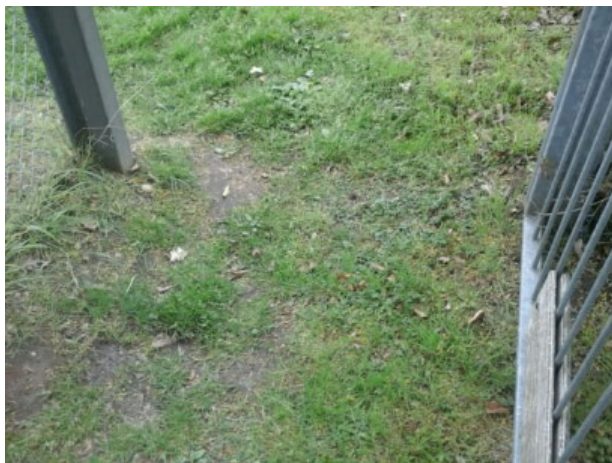
8 - Low Risk (Finding 2)

Finding: The area under the gate has eroded leaving uneven areas, or the concrete foundations exposed, resulting in trip hazards at the entrance/exit to the playground

Action: Reinstate to level with surrounding surfaces

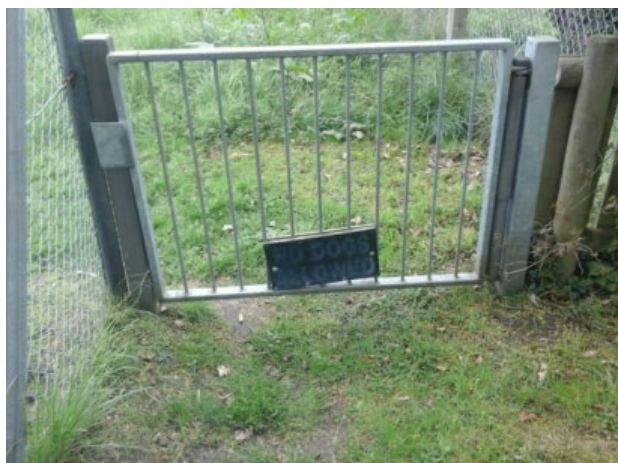
6 - Low Risk (Finding 3)

Finding: The gate is closing too quickly (less than 4 seconds)

Action: Take corrective action to ensure that the gate closes in 4-8 seconds

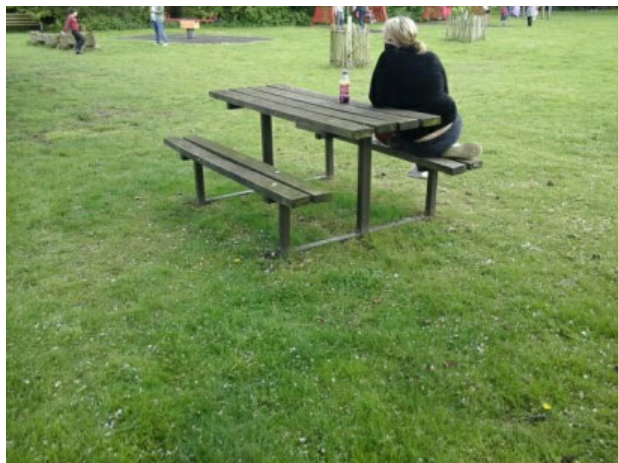
8 - Low Risk (Finding 1)

Finding: There is algae or moss on the surface of the table

Action: Clean and treat appropriately

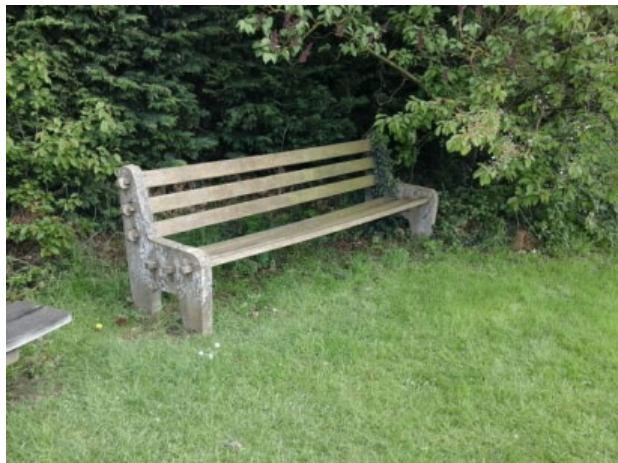
6 - Low Risk (Finding 1)

Finding: The adjacent foliage is overhanging

Action: Cut back and maintain

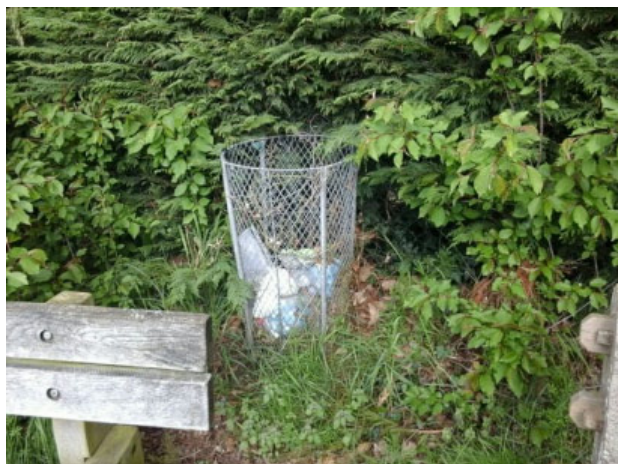
6 - Low Risk (Finding 2)

Finding: The adjacent foliage is overhanging

Action: Cut back and maintain

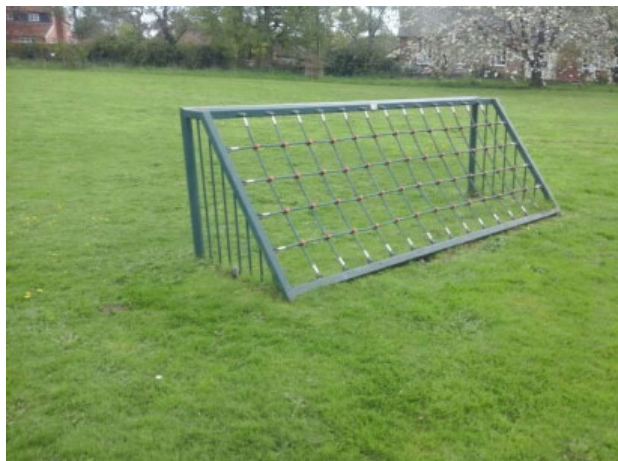
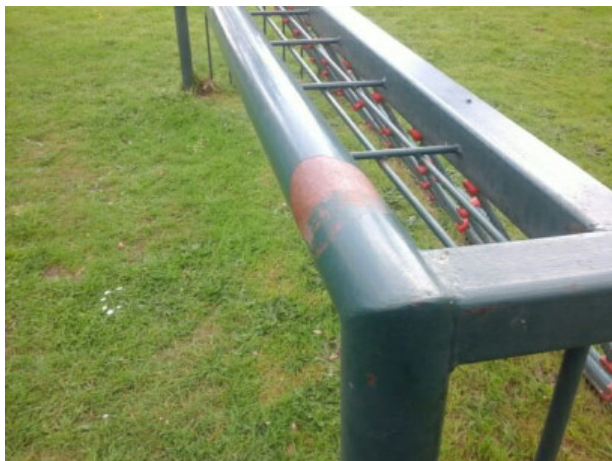
6 - Low Risk (Finding 1)

Finding: The paintwork on this item has been damaged or worn exposing the metal underneath which is rusting
Action: Treat any rusting components and repaint

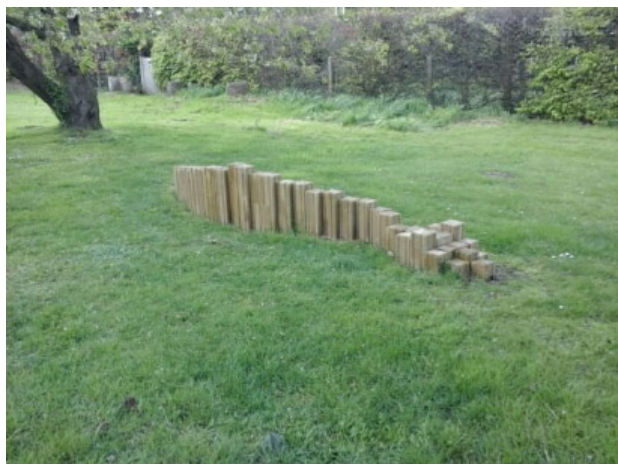
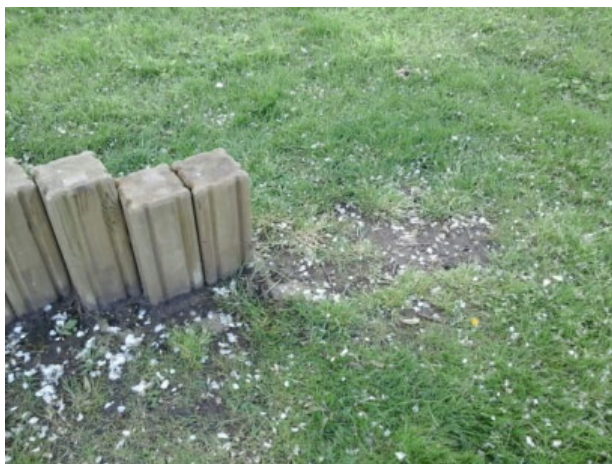
8 - Low Risk (Finding 1)

Finding: The surface has eroded and the foundations are exposed
Action: Reinstate surrounding surfaces to cover the foundations

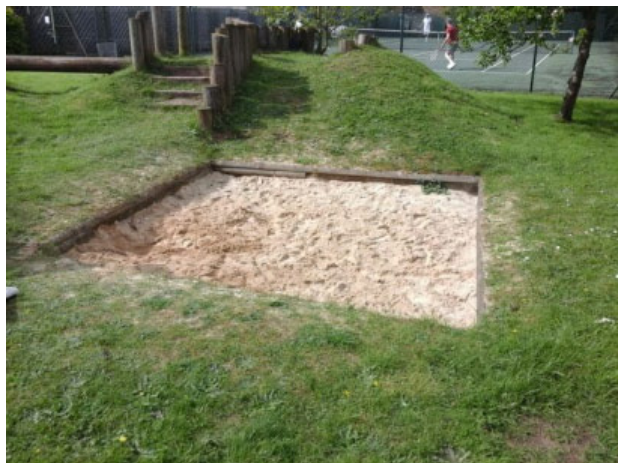
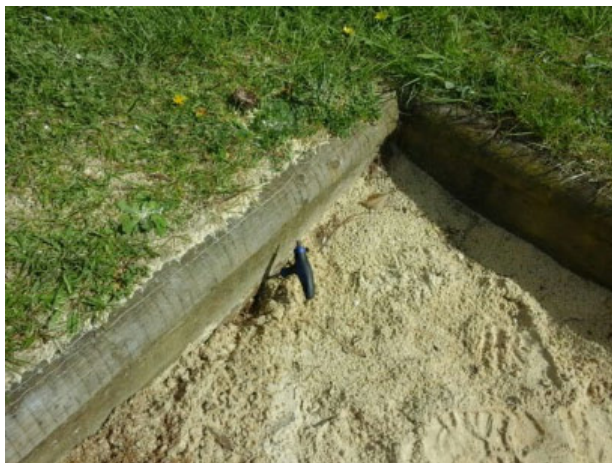
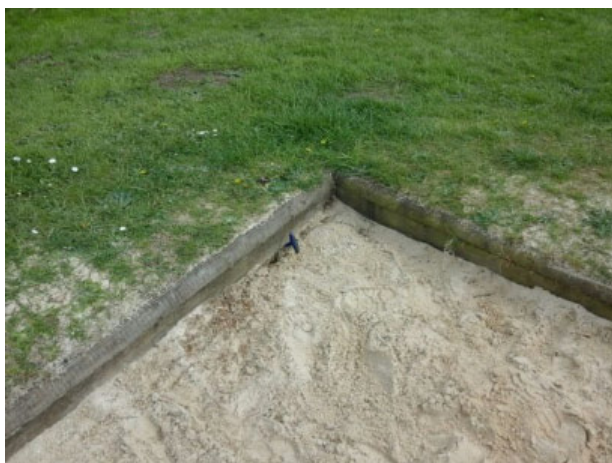
8 - Low Risk (Finding 1)

Finding: The timber surround has rotted

Action: Replace all affected timbers

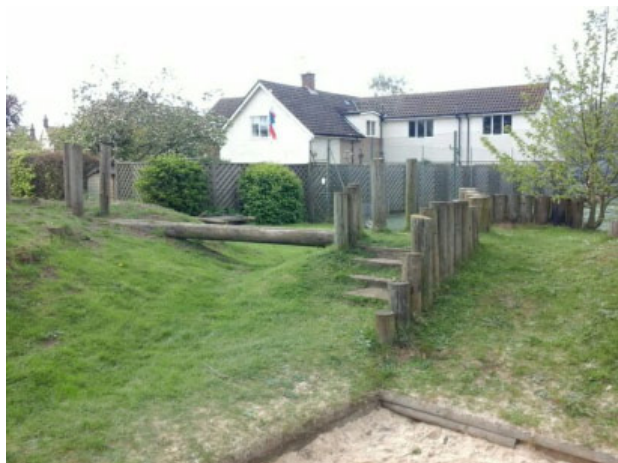
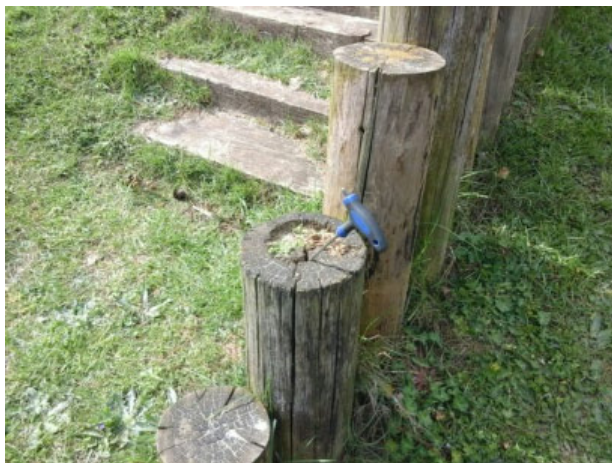
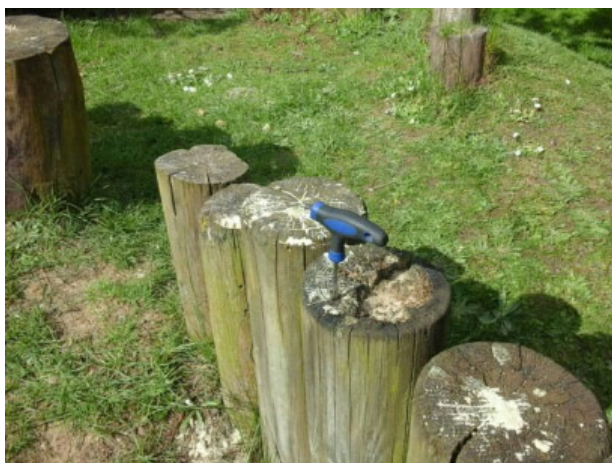
8 - Low Risk (Finding 1)

Finding: There are areas or parts of the timber logs that have rotted

Action: Replace all affected timbers

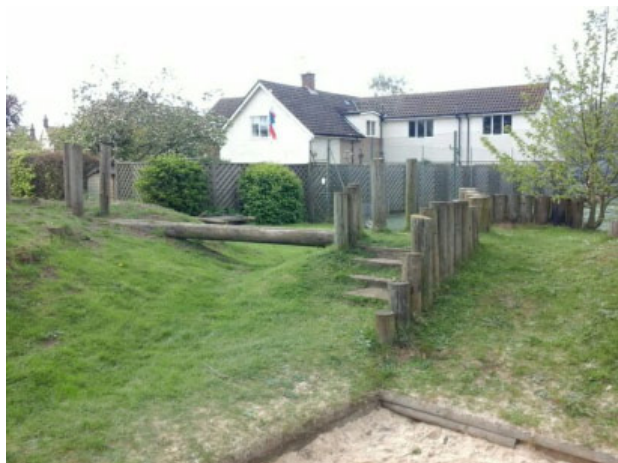
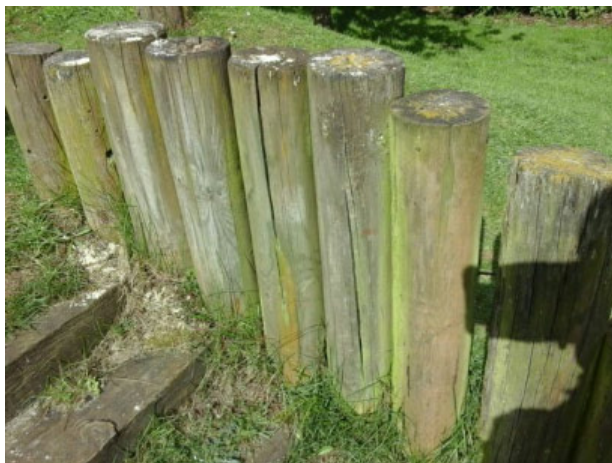
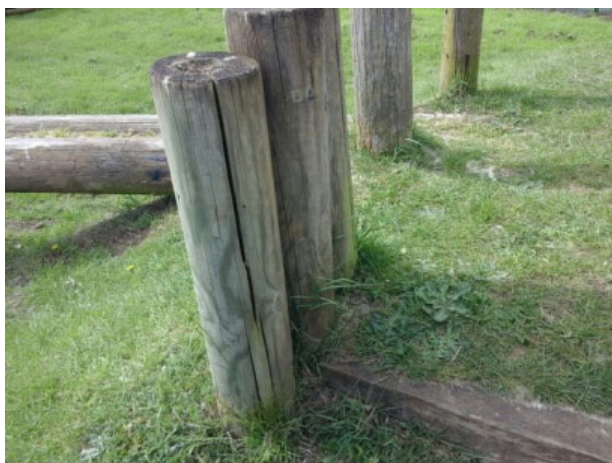
6 - Low Risk (Finding 2)

Finding: The timber has a number of splits (shakes) although these are not considered to be a problem at present

Action: Monitor to ensure the splits do not cross through fixing points of the structure and cause any instability

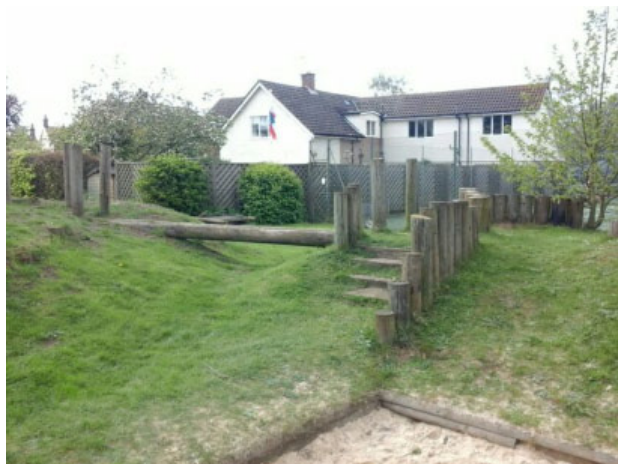
6 - Low Risk (Finding 4)

Finding: The tree canopy overhangs the equipment and is less than 2.0m away

Action: Lift tree canopy to ensure a minimum clearance of 2.0m from the equipment

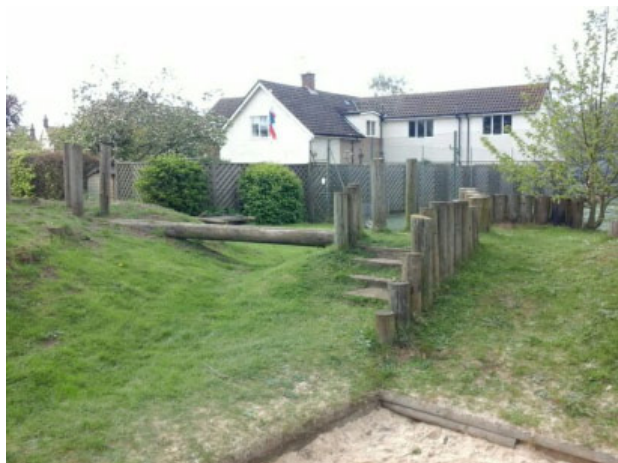
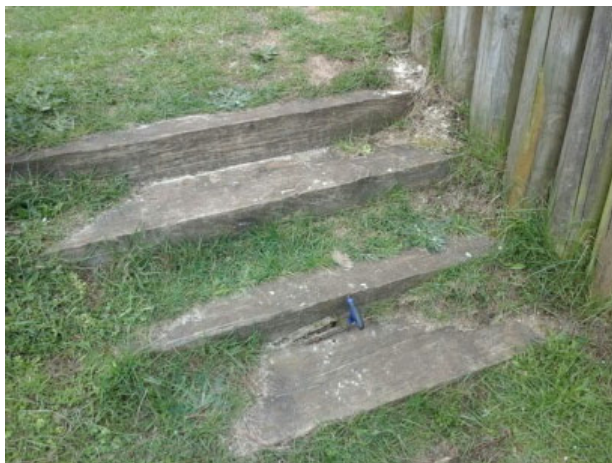
8 - Low Risk (Finding 5)

Finding: The timber steps have rotted

Action: Replace affected steps

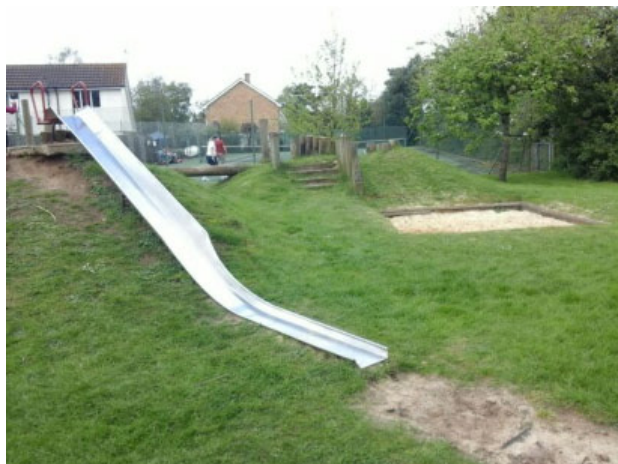
8 - Low Risk (Finding 1)

Finding: There is a large amount of sand on the surface

Action: Clean and maintain

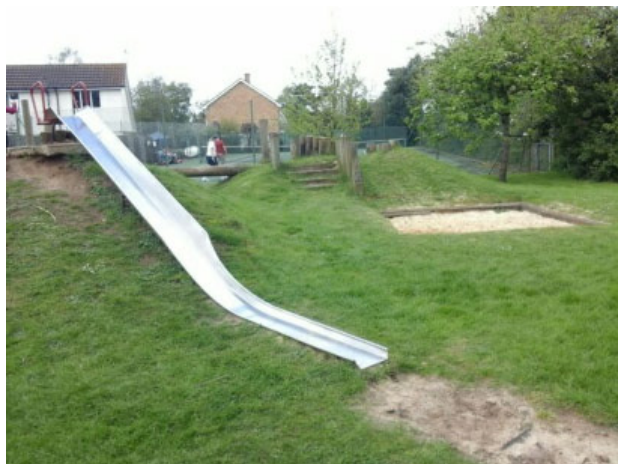
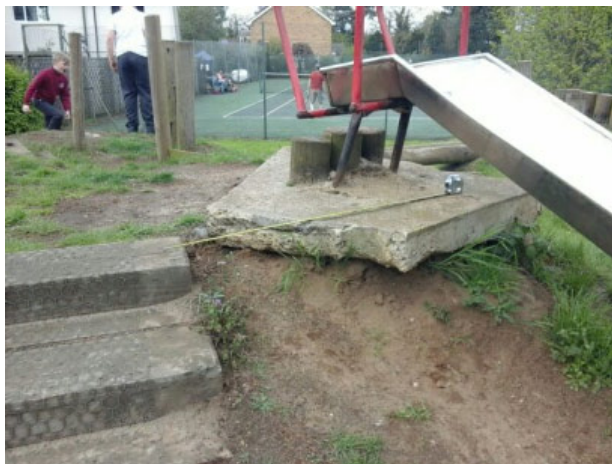
12 - Moderate Risk (Finding 2)

Finding: The exposed foundations and steps form a hard object within the falling space of the equipment in contravention of the requirements of BS EN 1176 Part 1

Action: Reinstate the surface to cover the foundations and monitor the use of the steps

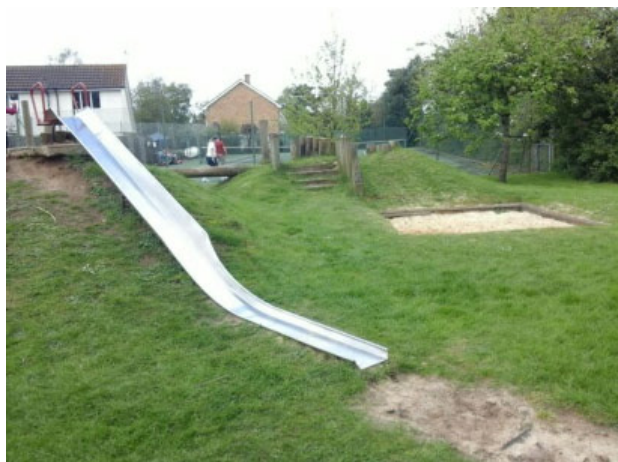
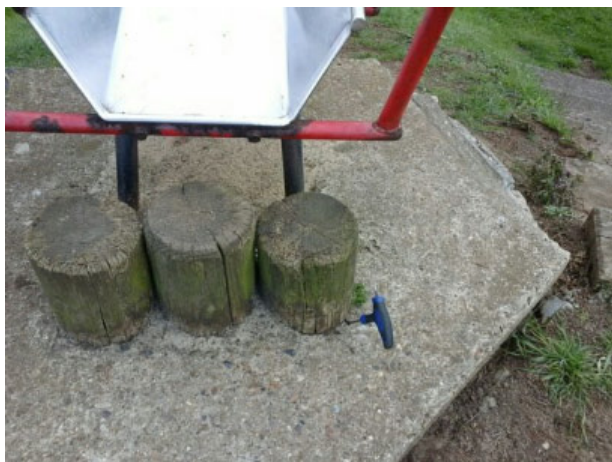
8 - Low Risk (Finding 3)

Finding: There are areas or parts of the timber on the structure that have rotted

Action: Replace all affected timbers

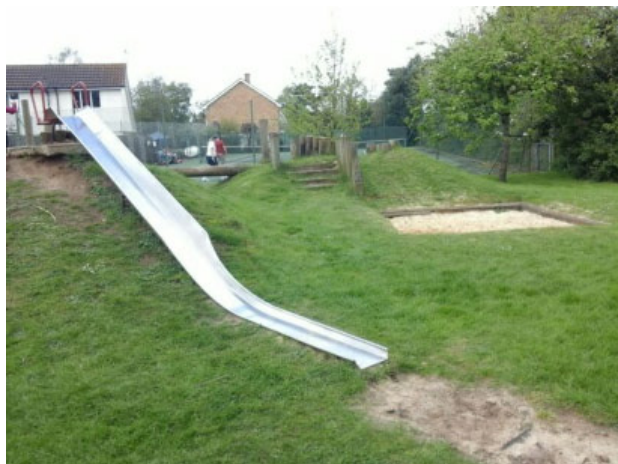
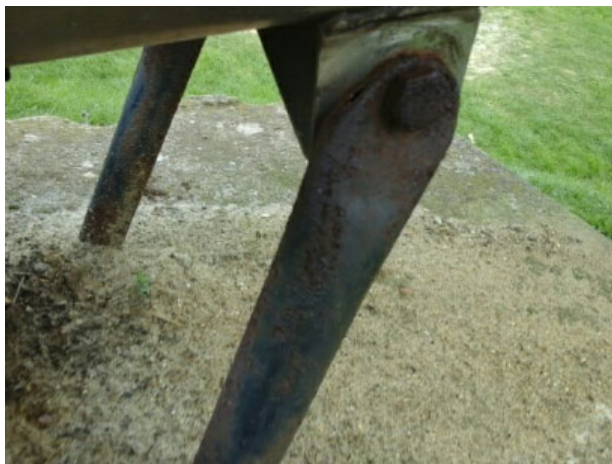
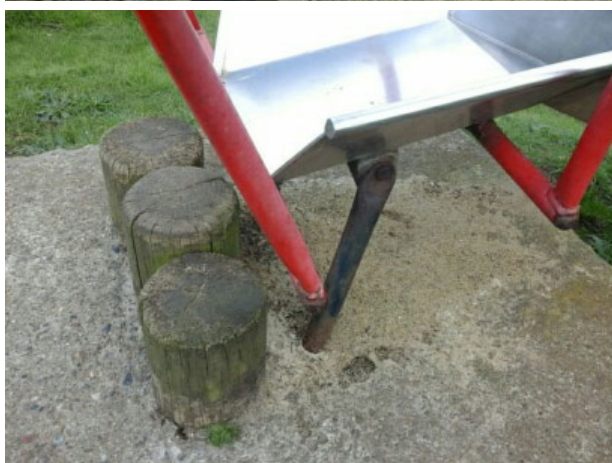
12 - Moderate Risk (Finding 4)

Finding: Parts of the steel on this item have corroded excessively and the metal has perforated in places

Action: Ensure all affected areas are treated and repaired

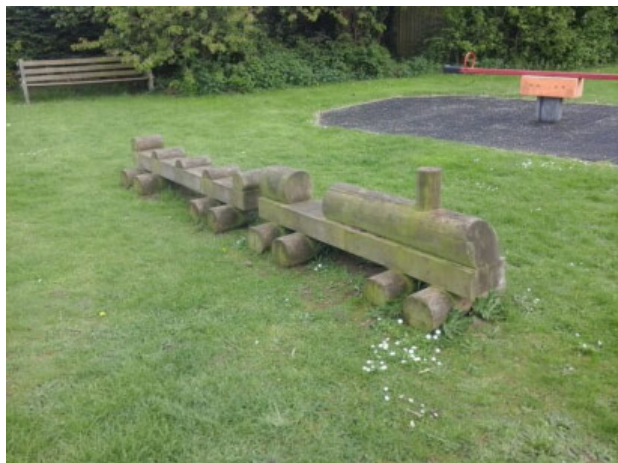
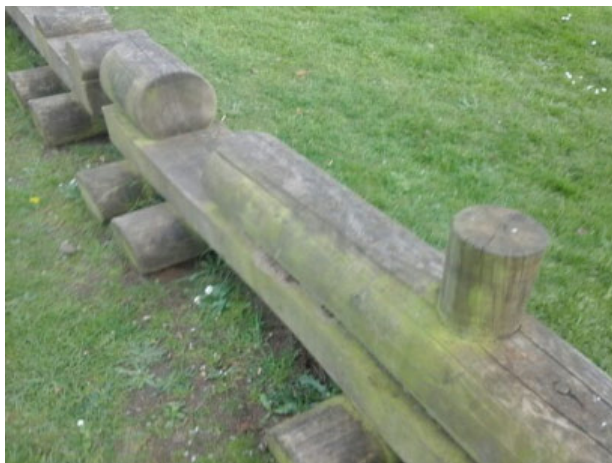
6 - Low Risk (Finding 1)

Finding: The timber has a number of air cracks apparent, the splits will have penetrated the preservative applied to the timber and allow water ingress to the unprotected areas

Action: Monitor for any deterioration (rot) and replace as required

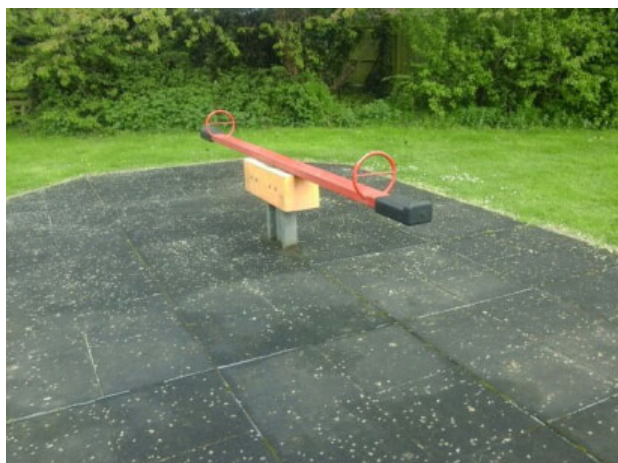
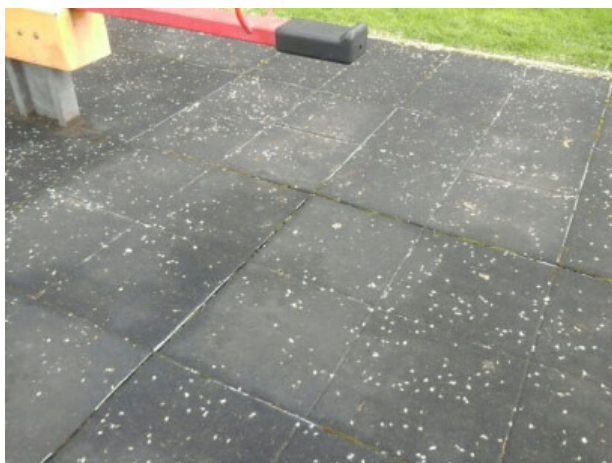
6 - Low Risk (Finding 1)

Finding: There are gaps opening in between the tiles

Action: Monitor for any further deterioration and repair as required

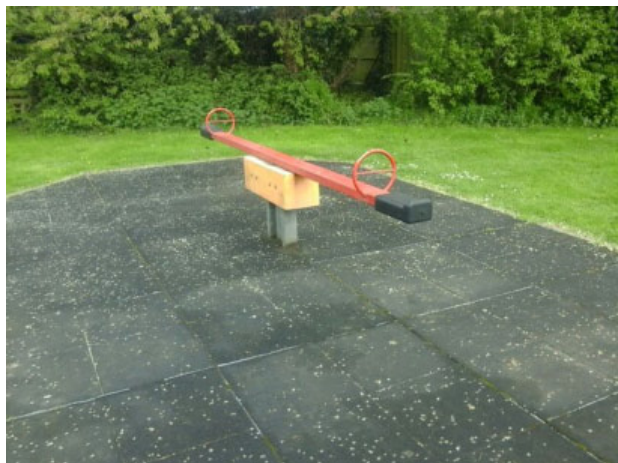
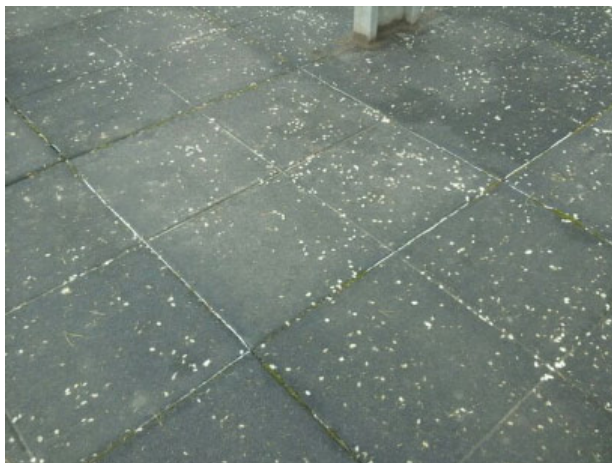
8 - Low Risk (Finding 2)

Finding: There is algae or moss growth on the surface resulting in slippery conditions
Action: Clean and treat appropriately

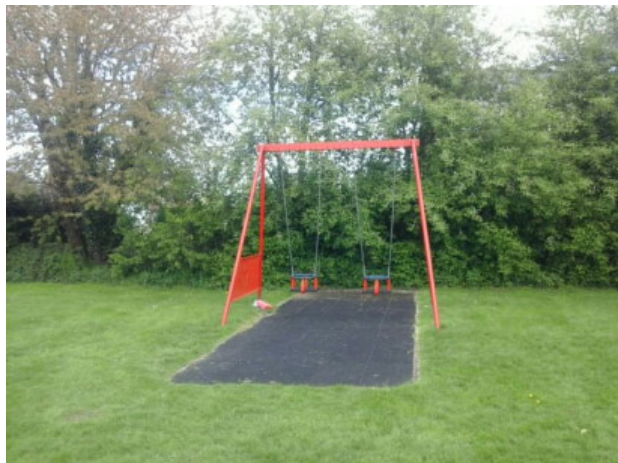
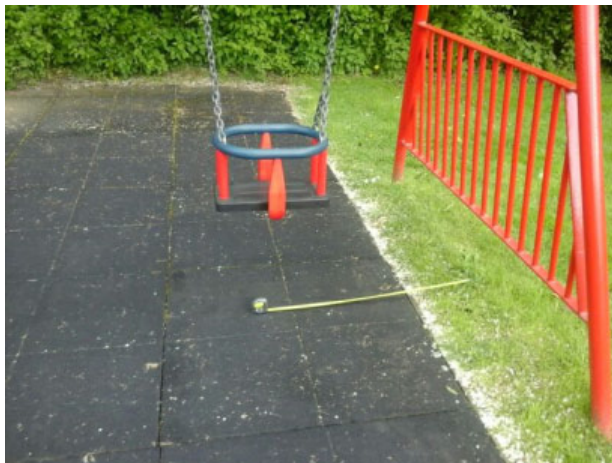
5 - Very Low Risk (Finding 1)

Finding: The surfacing width under each seat is less than 1.75 metres and fails the requirements of BS EN 1176 Part 2
Action: Monitor use

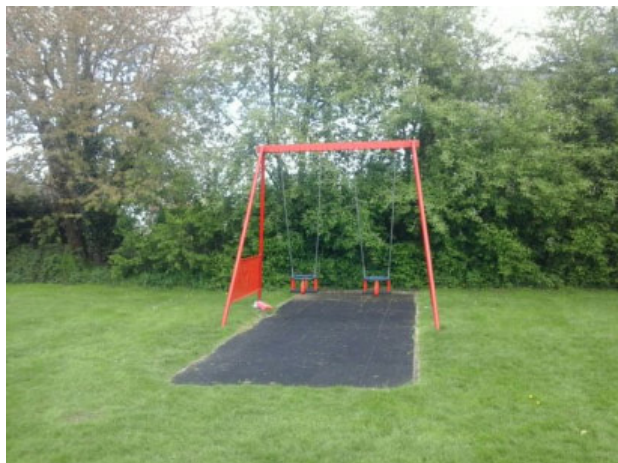
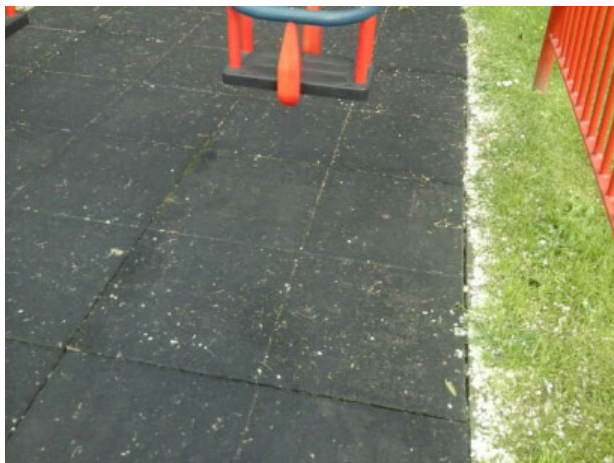
6 - Low Risk (Finding 2)

Finding: There are gaps opening in between the tiles

Action: Monitor for any further deterioration and repair as required

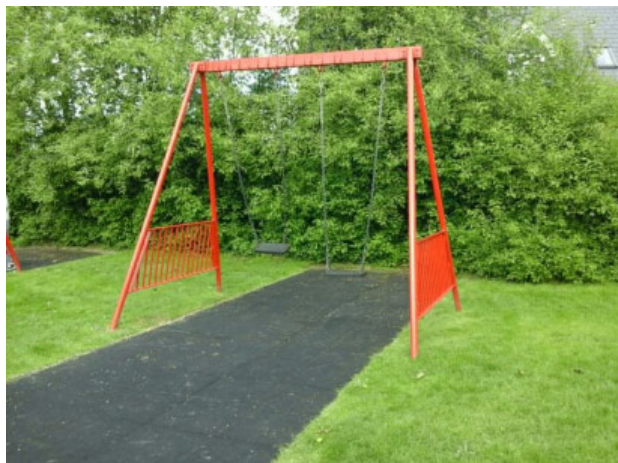
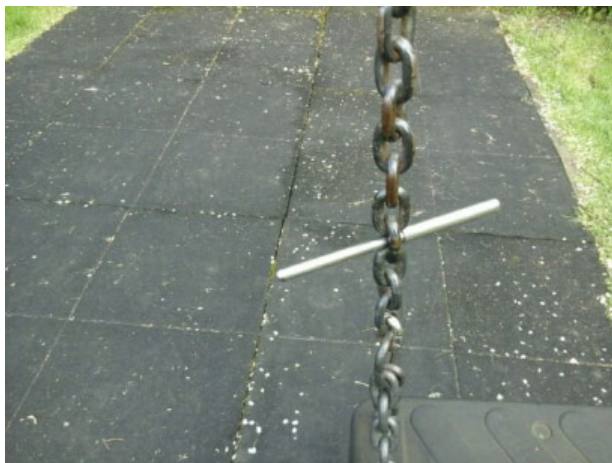
Finding: The chain openings are in excess of the 8.6mm as recommended by BS EN 1176

Action: Monitor use

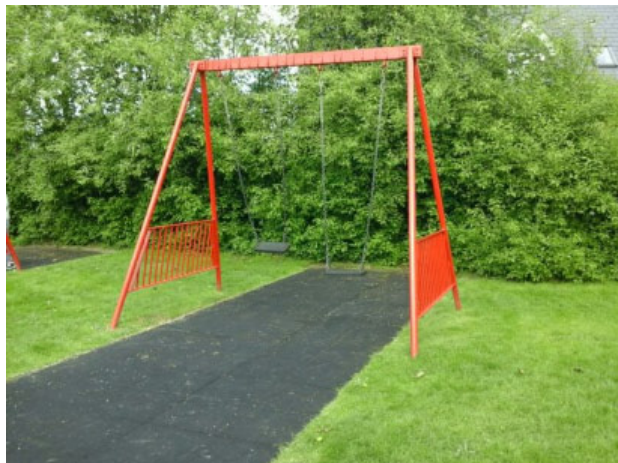
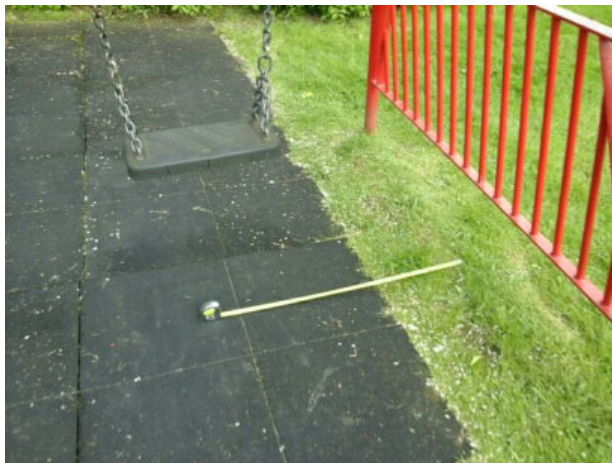
Finding: The surfacing width under each seat is less than 1.75 metres and fails the requirements of BS EN 1176 Part 2

Action: Monitor use

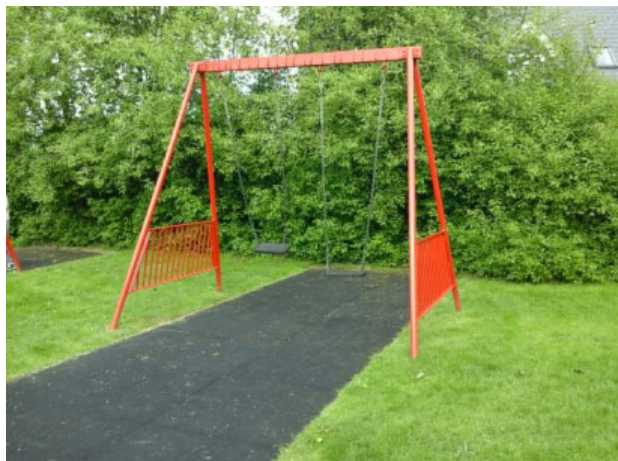
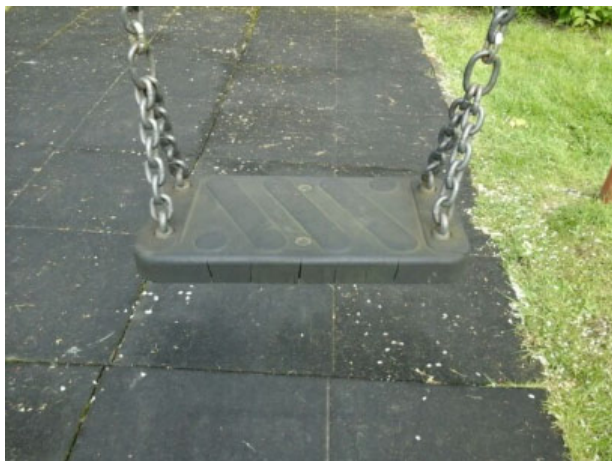
Finding: The seat has minor damage or wear

Action: Monitor for any further deterioration and replace as required

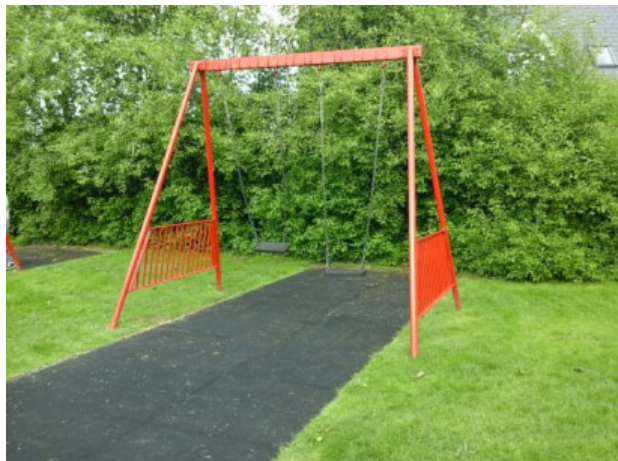
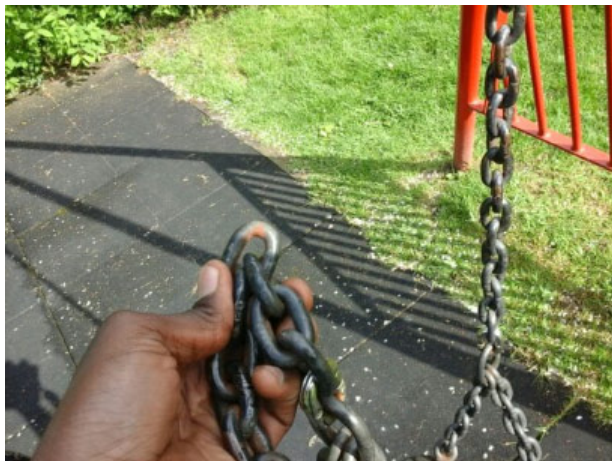
Finding: There is some notable evidence of chain wear

Action: Monitor for any further deterioration and replace when 40% worn

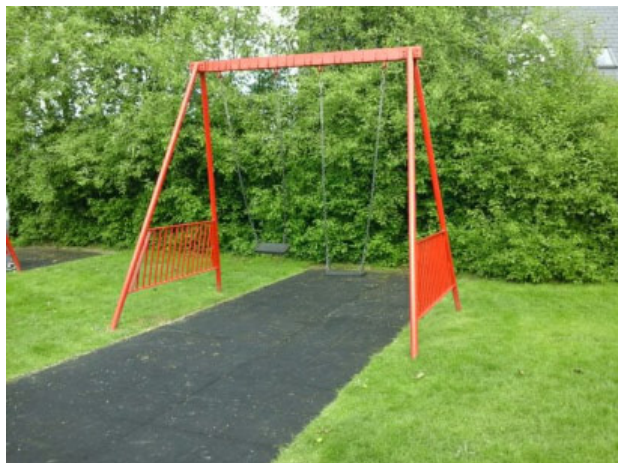
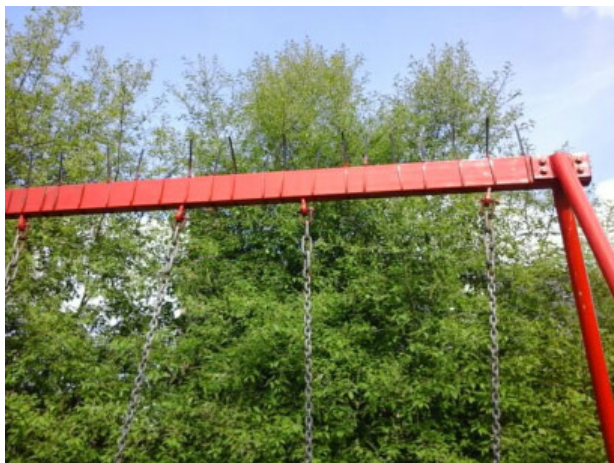
Finding: The bushes are showing signs of wear

Action: Monitor for any further deterioration and replace as required

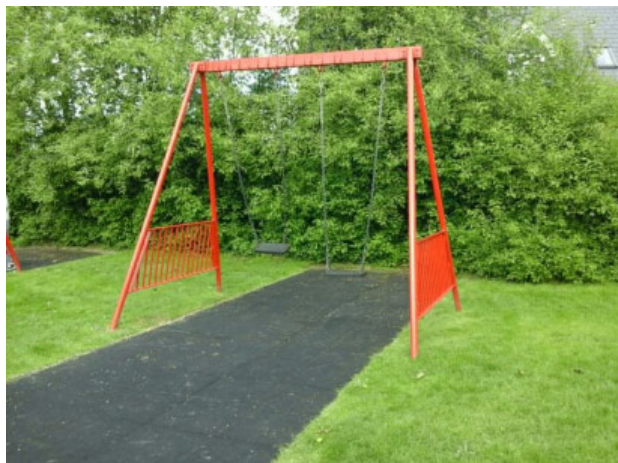
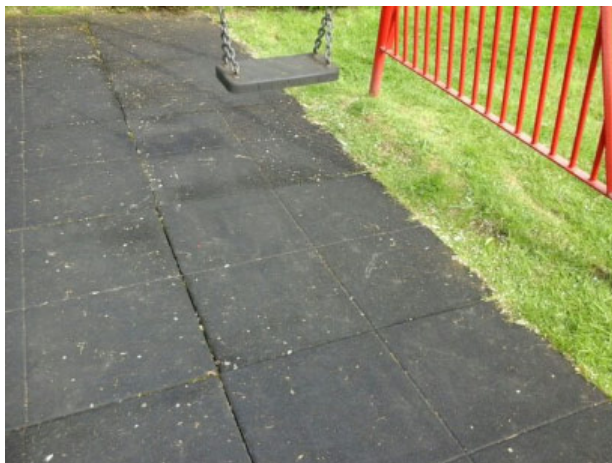
Finding: There are gaps opening in between the tiles

Action: Monitor for any further deterioration and repair as required

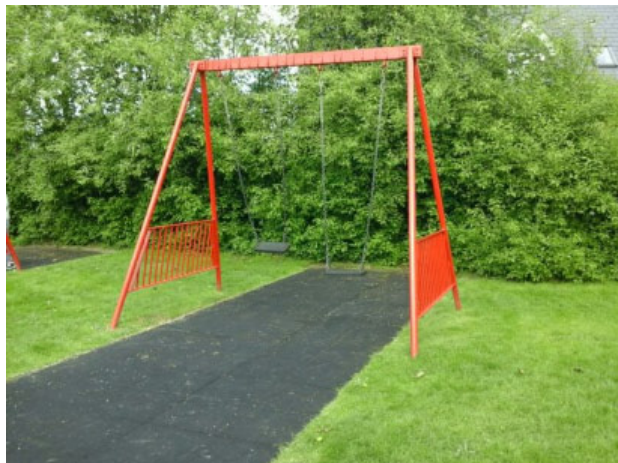
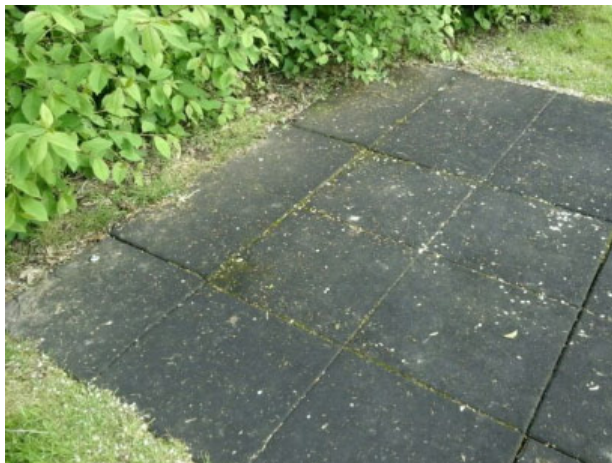
Finding: There is algae or moss growth on the surface resulting in slippery conditions

Action: Clean and treat appropriately

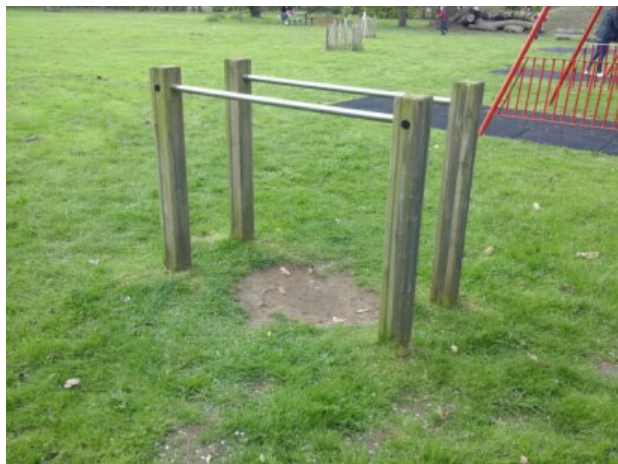
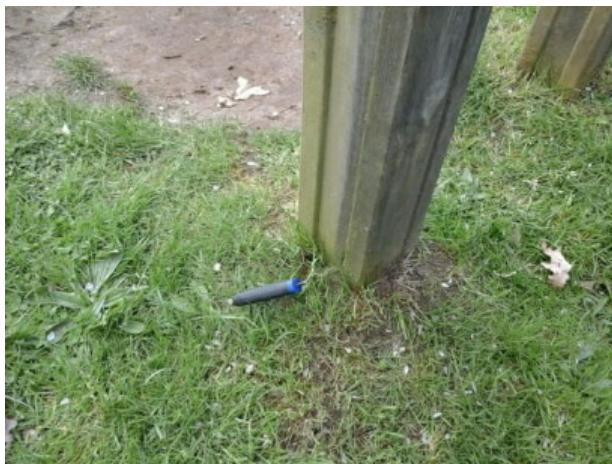
Finding: There is some evidence of rot in the timber

Action: Monitor for any further deterioration and replace as required
