Annual Inspection

Waldringfield Play Area

Inspection Ref: 877279

Inspected: 15 July 2019 at 09:24 Inspector: Alan Lingley RPII Annual Inspector

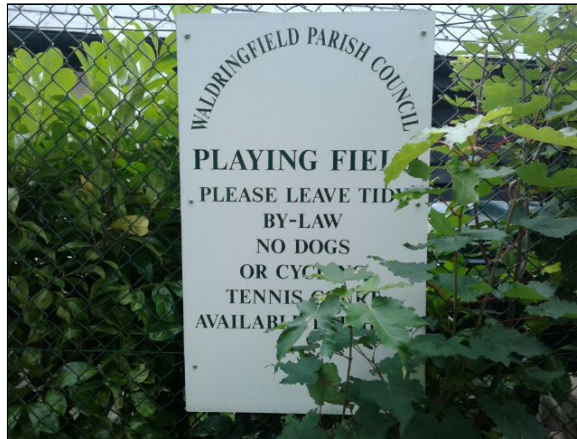
Item: Ancillary Items - Sign
Manufacturer: Owner/Operator
Comments

It is recommended that information signs with emergency contact details are installed at each entrance/exit point to the playground Provide in accordance with the recommendations set out in BS EN 1176

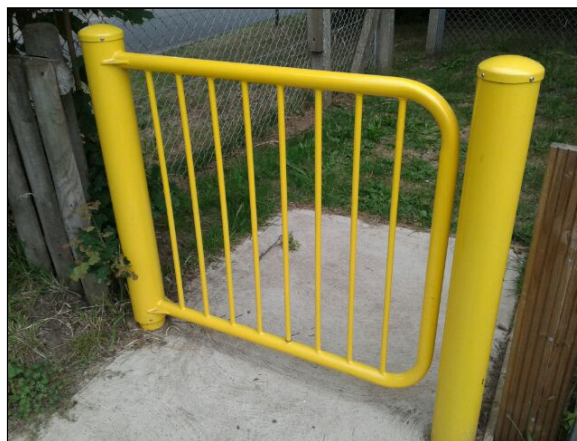
Item: Ancillary Items - Gate - Self Closing
Manufacturer: Not Identified
Comments

This item is satisfactory - no work required

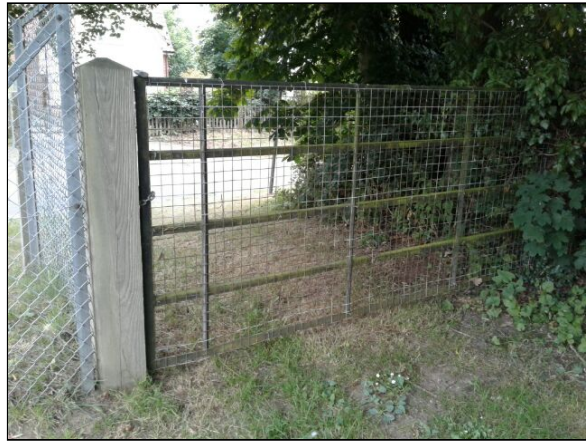
Item: Ancillary Items - Gate - Maintenance
Manufacturer: Not Identified
Comments

The timber on this item has severe rot Remove and replace all affected timber sections

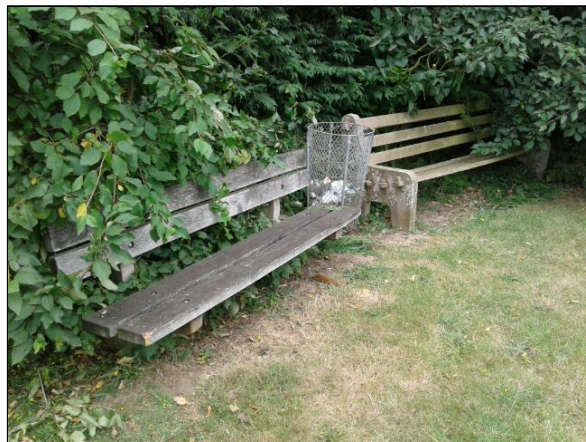
Item: Ancillary Items - Bench
Manufacturer: Owner/Operator
Comments

The adjacent foliage is overhanging Cut back and maintain

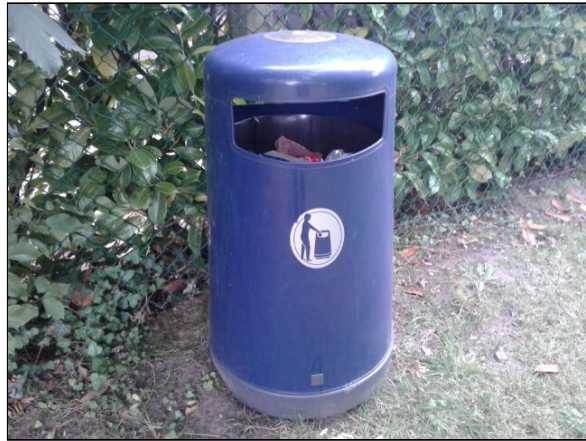
Item: Ancillary Items - Litter Bin
Manufacturer: Owner/Operator
Comments

The bin is not securely fixed to the surface and there is some possibility of the item tipping or rolling over Secure the bin to the ground

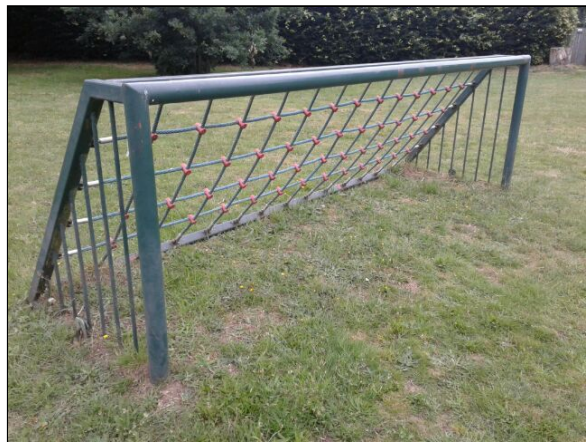
Item: Multi Use Games Area - 5 a side Goals
Manufacturer: Not Identified
Comments

The paintwork on this item has been damaged or worn exposing the metal underneath which is rusting Treat any rusting components and repaint

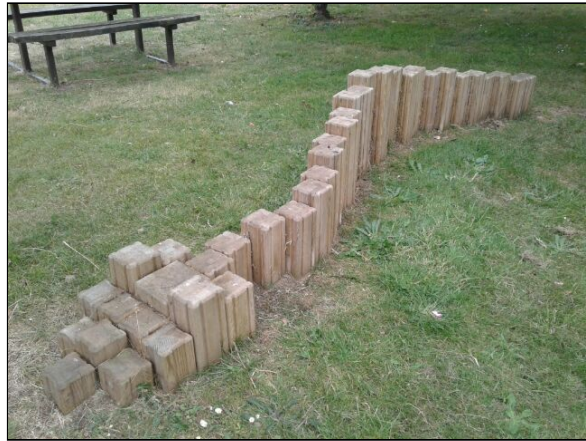
Item: Activity Equipment - Stepping
Manufacturer: Stones
Comments Not Identified

The tree canopy overhangs the equipment and is less than 2.0m away Lift tree canopy to ensure a minimum clearance of 2.0m from the equipment

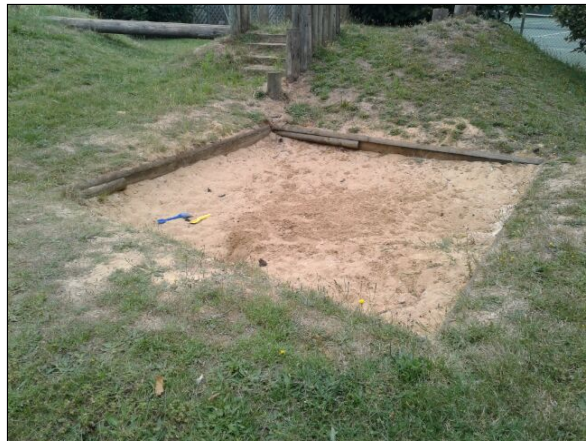
Item: Other - Sand Box
Manufacturer: Owner/Operator
Comments

The timber surround has rotted Replace all affected timbers

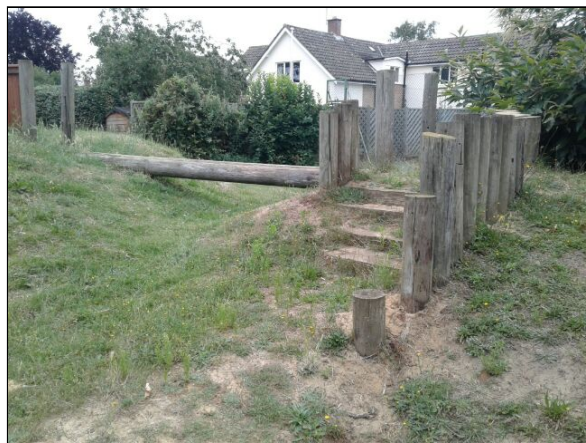
Item: Other - Natural Play Feature
Manufacturer: Not Identified
Comments

The timber on this item has severe rot Remove and replace all affected timber sections

The tree canopy overhangs the equipment and is less than 2.0m away Lift tree canopy to ensure a minimum clearance of 2.0m from the equipment

There are areas or parts of the timber on the structure that have rotted Replace all affected timbers

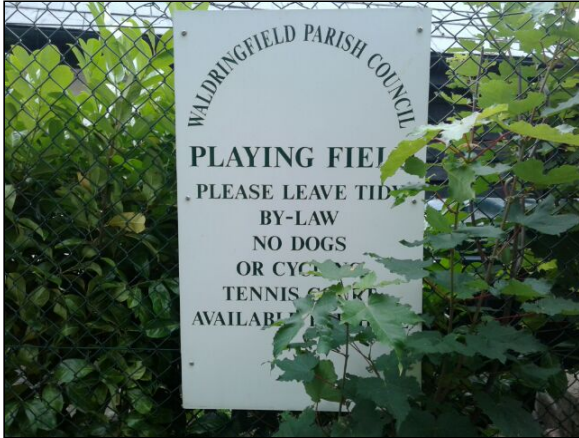
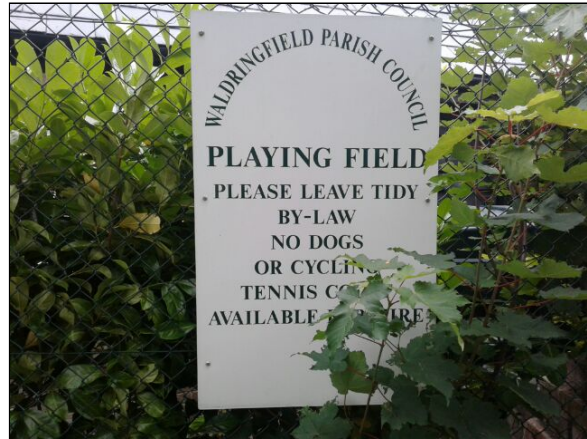
Item: Ancillary Items - Sign
Manufacturer: Owner/Operator

Finding: It is recommended that information signs with emergency contact details are installed at each entrance/exit point to the playground

Action: Provide in accordance with the recommendations set out in BS EN 1176

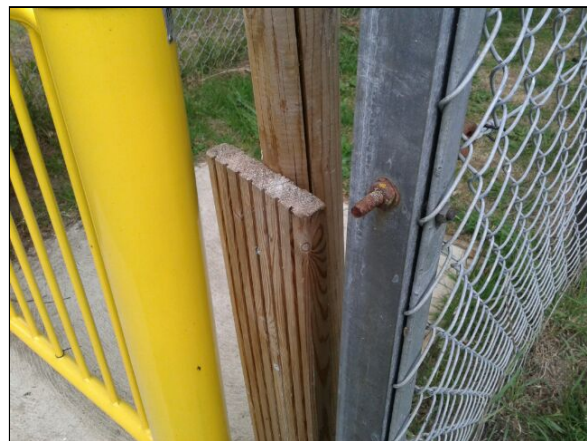
Item: Ancillary Items - Fence - Chainlink
Manufacturer: Owner/Operator

Finding: There are projecting bolt thread(s) present

Action: Remove excess thread length and deburr or provide cap

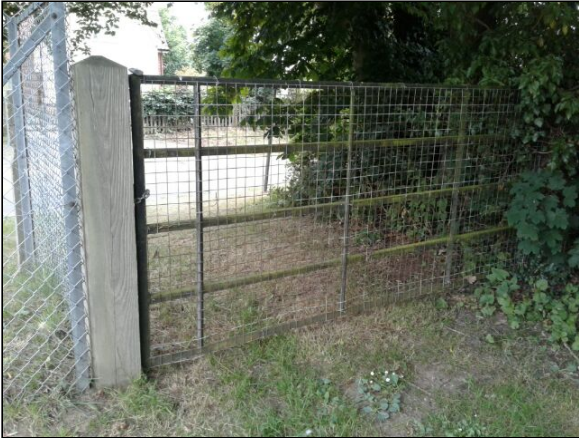
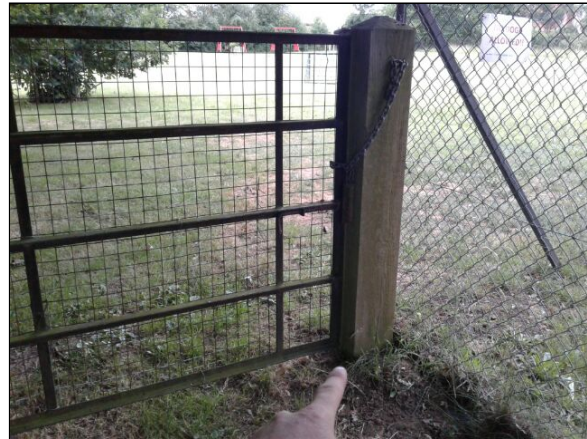
Item: Ancillary Items - Gate - Maintenance**Risk Level:** 12 - Moderate Risk**Manufacturer:** Not Identified**Surface:** Grass

**Finding:** The timber on this item has severe rot**Action:** Remove and replace all affected timber sections**Item:** Ancillary Items - Picnic Table**Risk Level:** 4 - Very Low Risk**Manufacturer:** Owner/Operator**Surface:** Grass

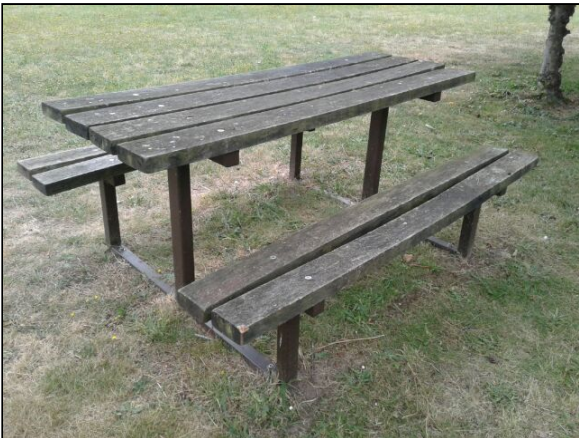
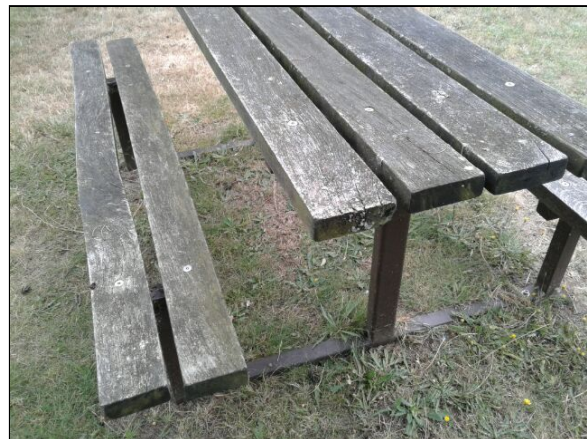
**Finding:** There is algae or moss on the surface of the equipment**Action:** Clean and treat appropriately

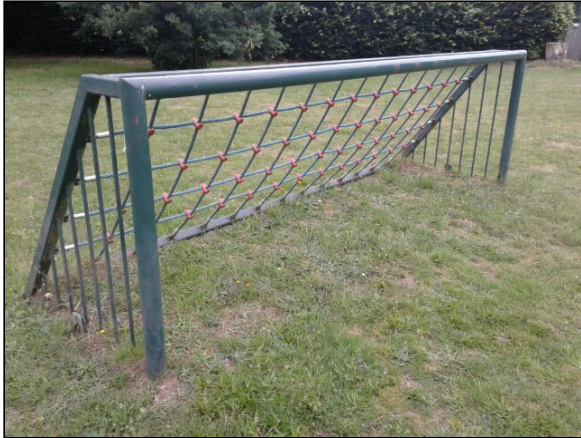
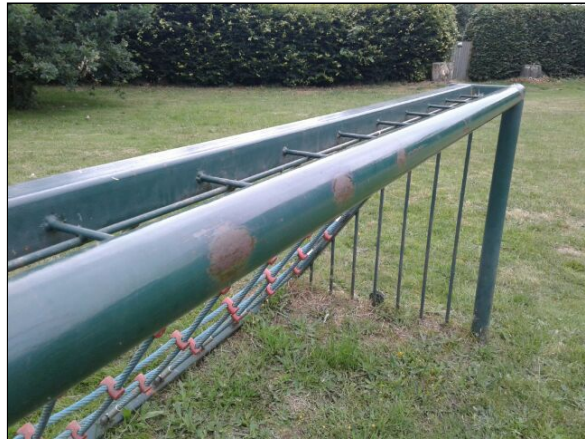
Item: Multi Use Games Area - 5 a side Goals
Manufacturer: Not Identified

Finding: The paintwork on this item has been damaged or worn exposing the metal underneath which is rusting
Action: Treat any rusting components and repaint

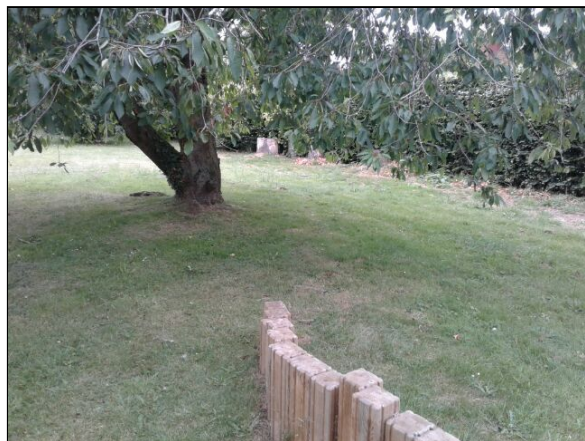
Item: Activity Equipment - Stepping Stones
Manufacturer: Not Identified

Finding: The tree canopy overhangs the equipment and is less than 2.0m away
Action: Lift tree canopy to ensure a minimum clearance of 2.0m from the equipment

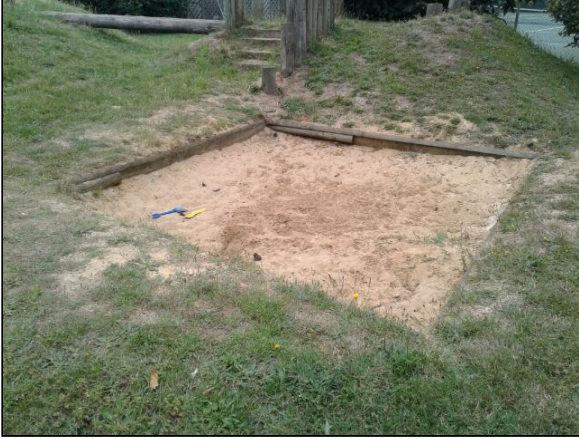
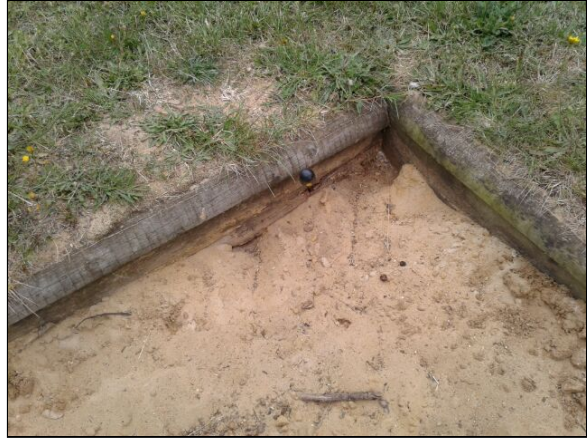
Item: Other - Sand Box
Manufacturer: Owner/Operator

Finding: The timber surround has rotted
Action: Replace all affected timbers

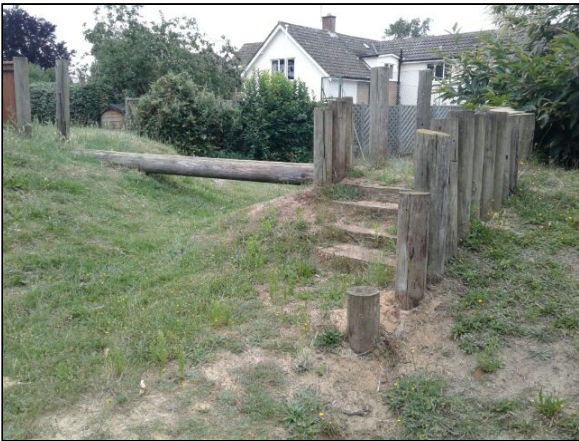
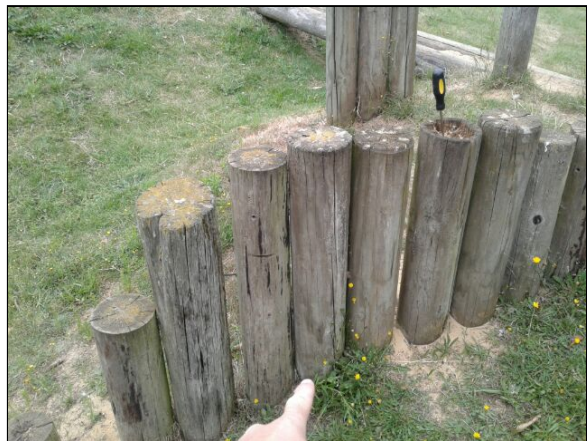
Item: Other - Natural Play Feature
Manufacturer: Not Identified

Finding: The timber on this item has severe rot
Action: Remove and replace all affected timber sections

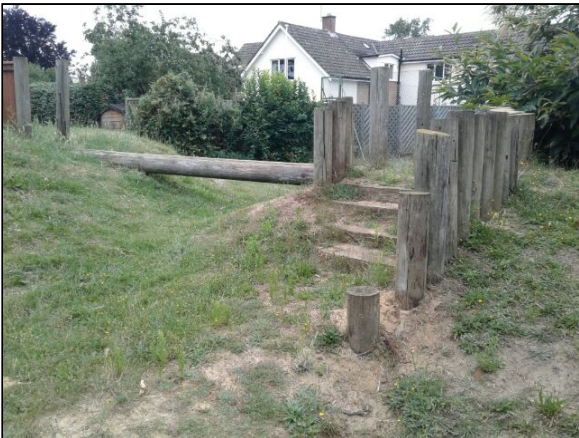
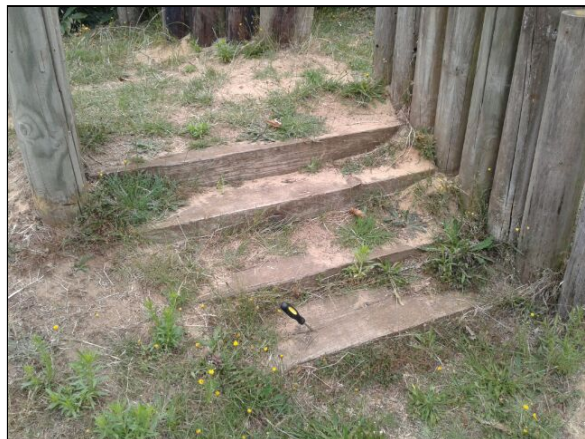
Item: Other - Natural Play Feature
Manufacturer: Not Identified

Finding: The timber on this item has severe rot
Action: Remove and replace all affected timber sections

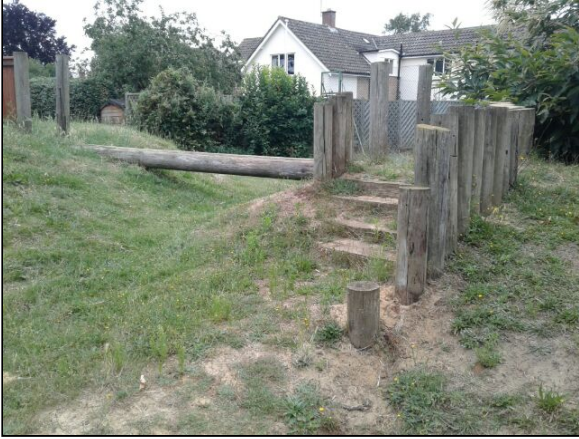
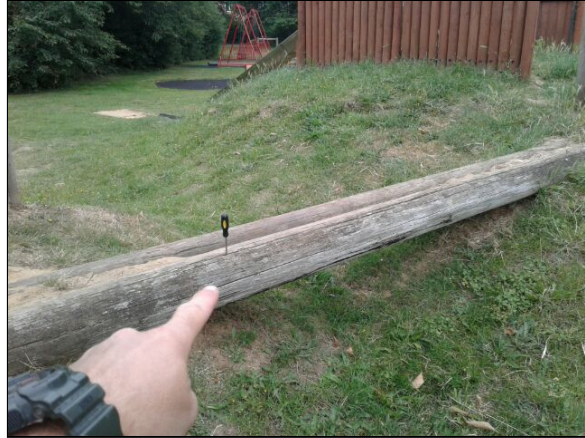
Item: Other - Natural Play Feature
Manufacturer: Not Identified

Finding: There are areas or parts of the timber on the structure that have rotted
Action: Replace all affected timbers

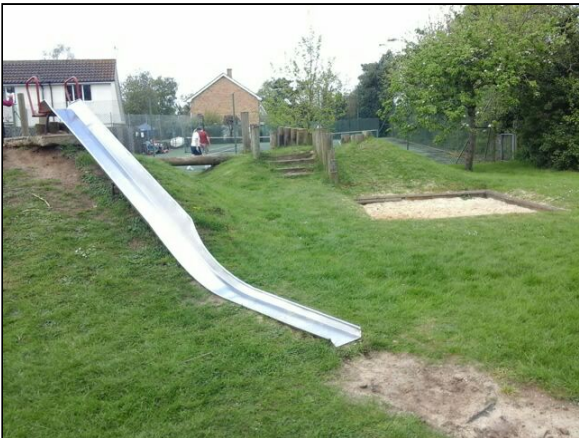
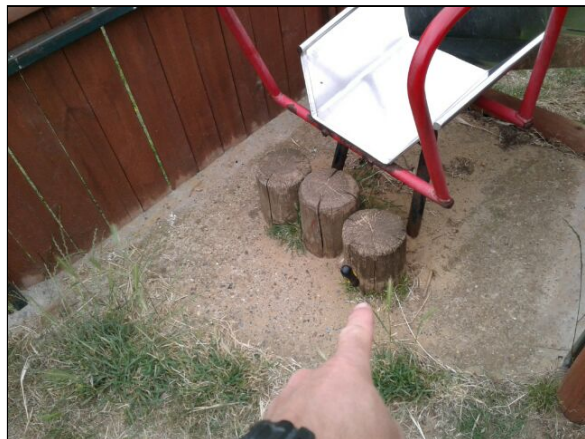
Item: Other - Embankment Slide
Manufacturer: Not Identified

Finding: There are areas or parts of the timber on the structure that have rotted
Action: Replace all affected timbers

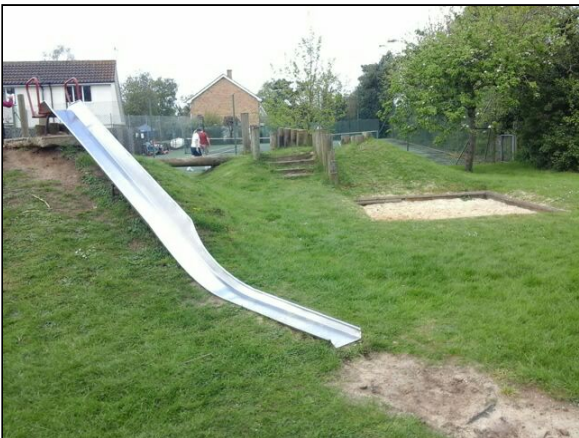
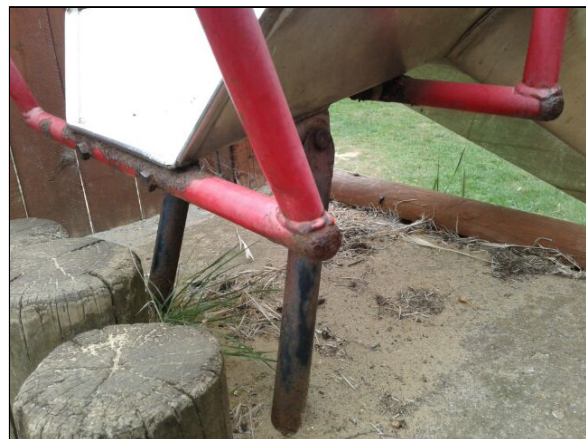
Item: Other - Embankment Slide
Manufacturer: Not Identified

Finding: There is surface corrosion present on the item
Action: Consider treating and repainting the item

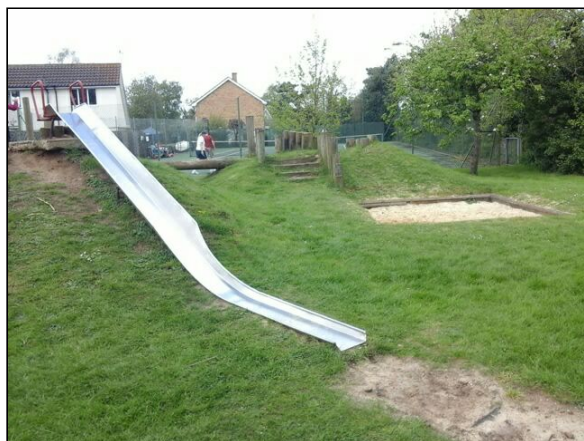
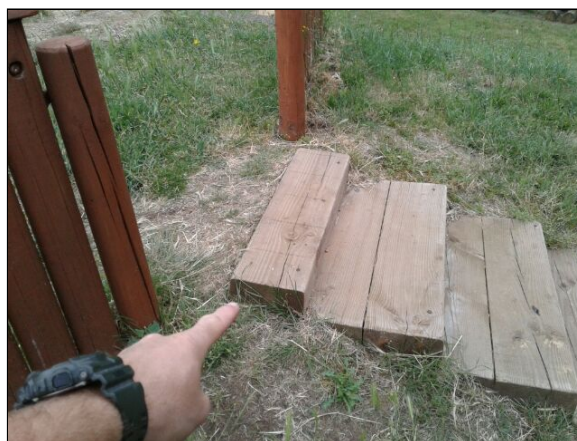
Item: Other - Embankment Slide
Manufacturer: Not Identified

Finding: The top step is loose
Action: Secure

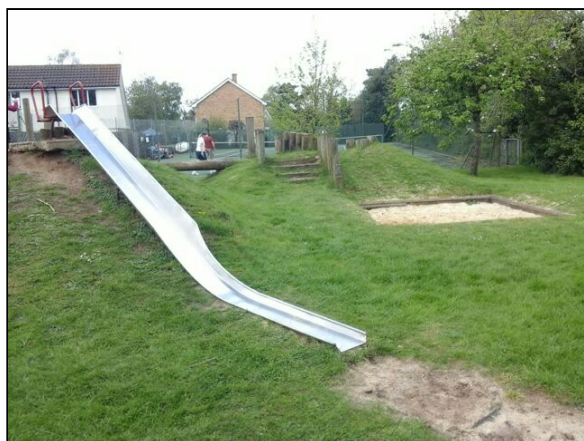
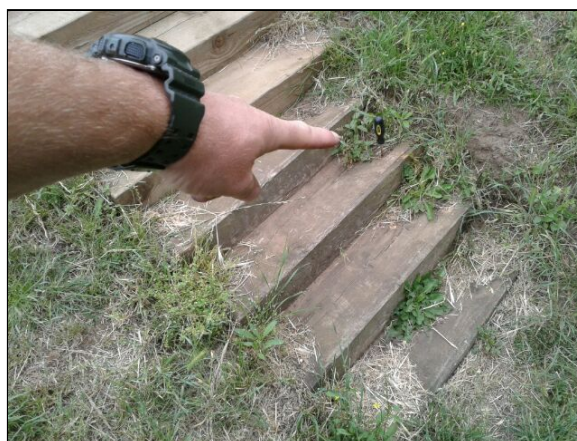
Item: Other - Embankment Slide
Manufacturer: Not Identified

Finding: The timber on this item has severe rot
Action: Remove and replace all affected timber sections

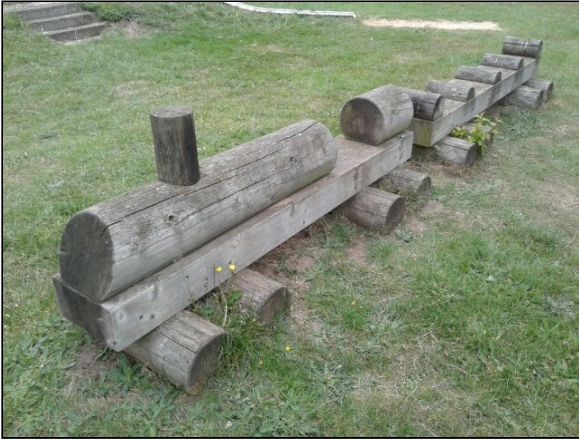
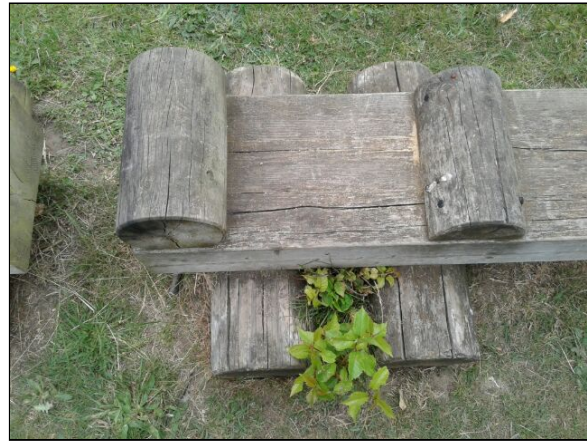
Item: Activity Equipment - Train
Manufacturer: Not Identified

Finding: The timber has a number of splits/shakes or air cracks and this may affect the stability or allow water ingress which will accelerate the rotting process
Action: Monitor to ensure the splits do not cross through fixing points of the structure and/or cause any instability

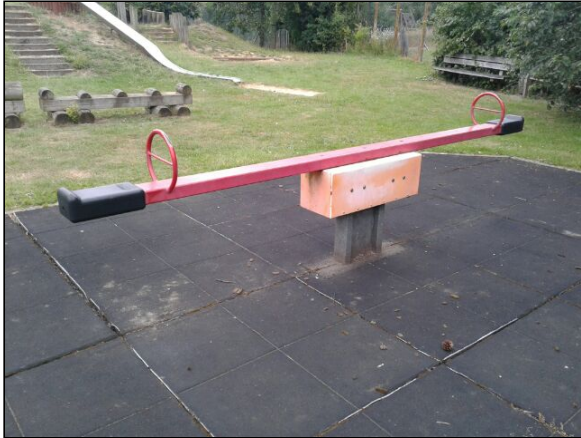
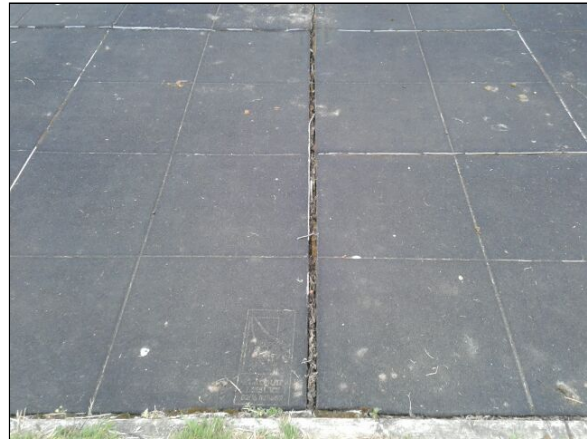
Item: Rocking Equipment - See Saw
Manufacturer: GL Jones

Finding: There are significant gaps (over 30mm) between the surface and the edging or between the joints in the surface; these are large enough for a small foot to enter
Action: Repair surfacing

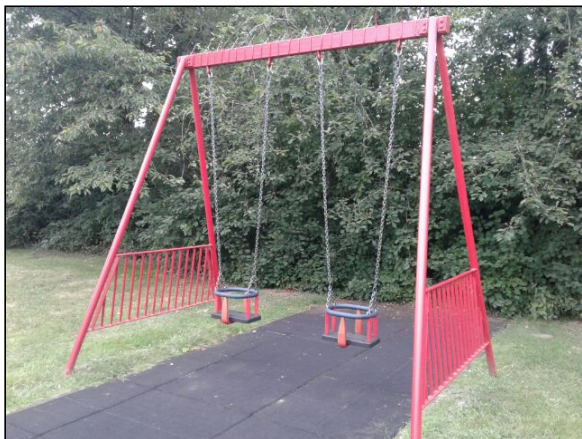
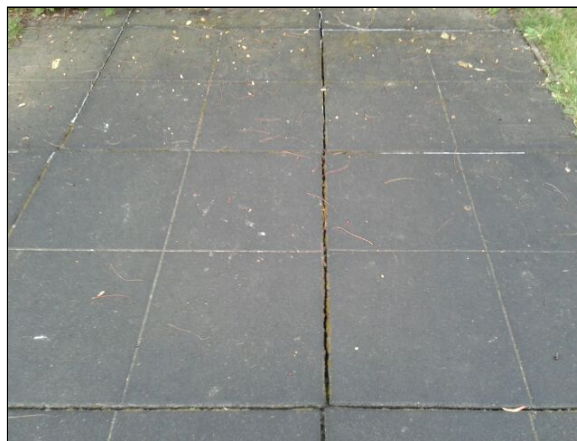
Item: Swings - 1 Bay 2 Seat (Cradle)
Manufacturer: Playquip

Finding: There are gaps opening in between the tiles
Action: Monitor for any further deterioration and repair as required

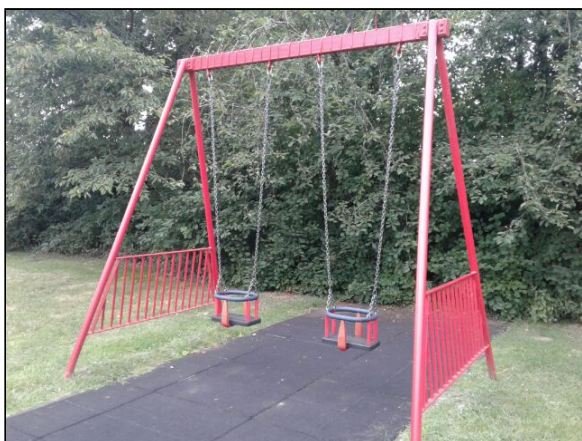
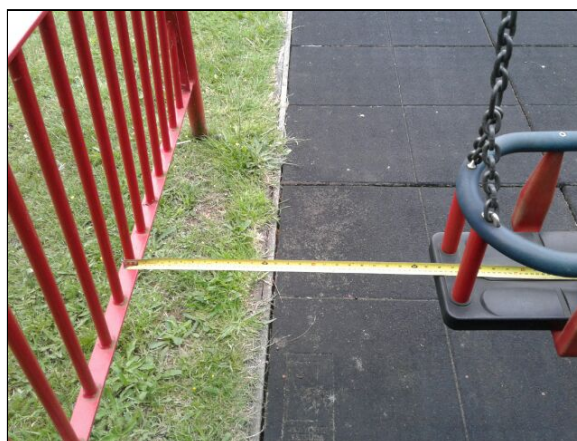
Item: Swings - 1 Bay 2 Seat (Cradle)
Manufacturer: Playquip

Finding: The surfacing width under each seat is less than 1.75 metres and fails the requirements of BS EN 1176 Part 2
Action: Monitor - No remedial work recommended

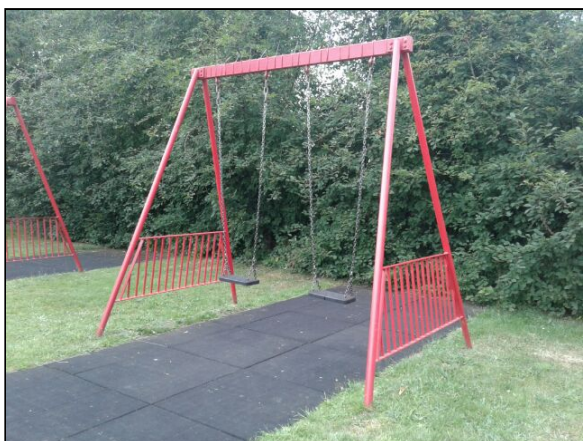
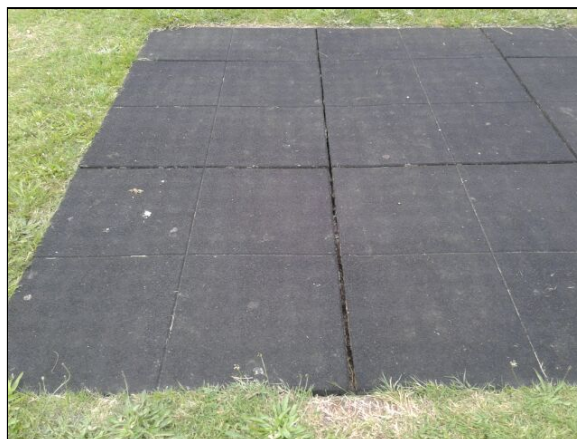
Item: Swings - 1 Bay 2 Seat (Flat)
Manufacturer: Playquip

Finding: There are gaps opening in between the tiles
Action: Monitor for any further deterioration and repair as required

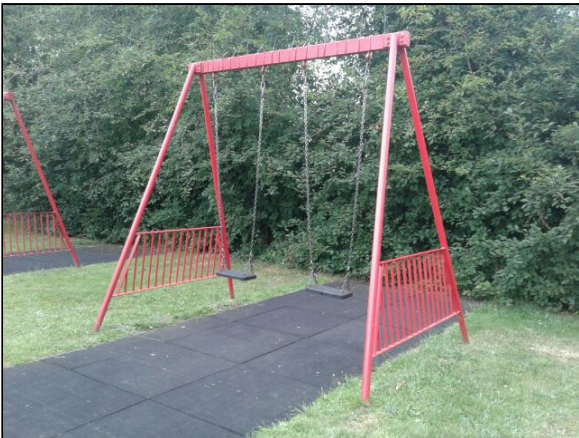
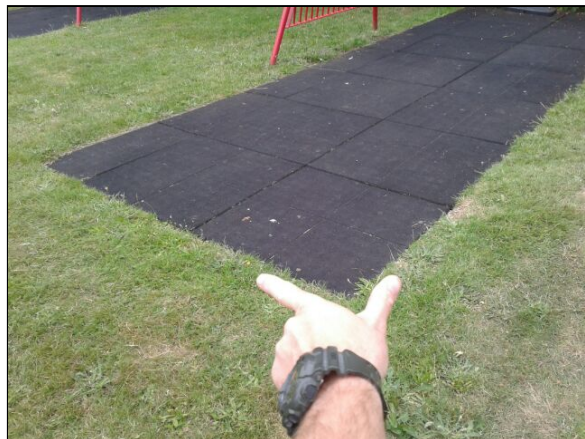
Item: Swings - 1 Bay 2 Seat (Flat)
Manufacturer: Playquip

Finding: The timber edgings have rotted
Action: Replace

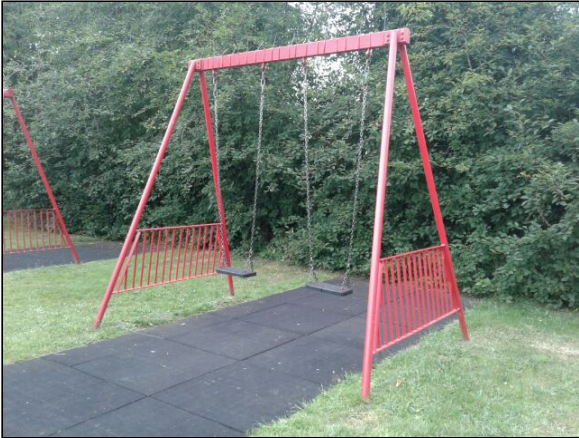
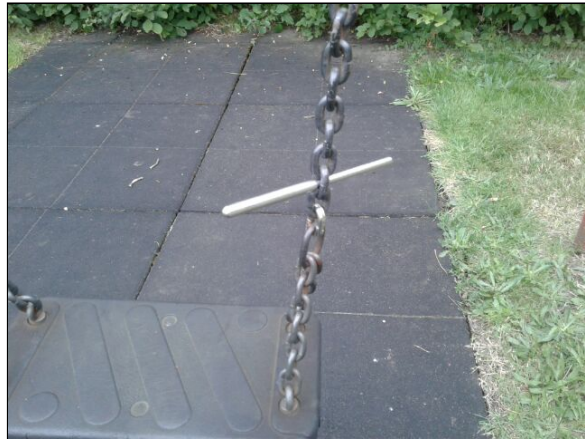
Item: Swings - 1 Bay 2 Seat (Flat)
Manufacturer: Playquip

Finding: The chain openings are in excess of the 8.6mm as recommended by BS EN 1176
Action: Monitor - No remedial work recommended

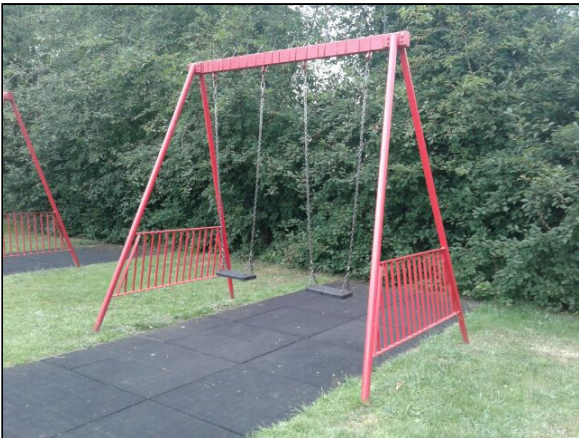
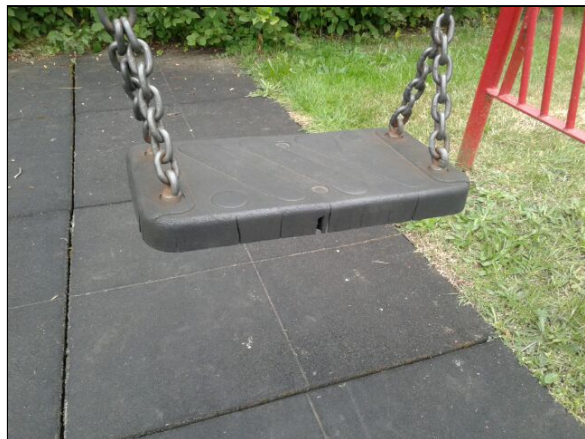
Item: Swings - 1 Bay 2 Seat (Flat)
Manufacturer: Playquip

Finding: The seat has minor damage or wear
Action: Monitor for any further deterioration and replace as required

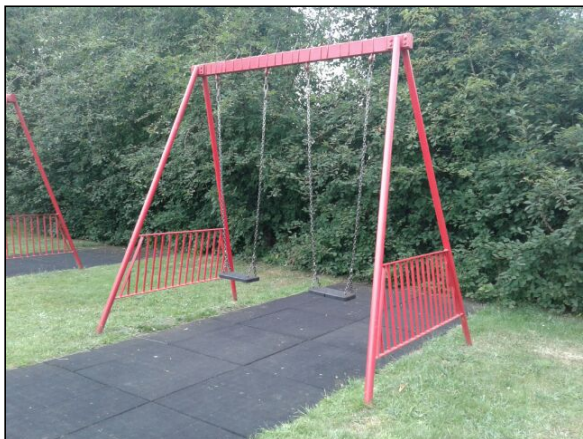
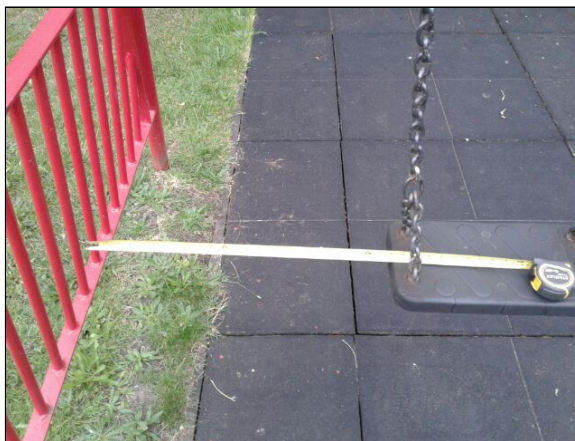
Item: Swings - 1 Bay 2 Seat (Flat)
Manufacturer: Playquip

Finding: The surfacing width under each seat is less than 1.75 metres and fails the requirements of BS EN 1176 Part 2

Action: Monitor - No remedial work recommended

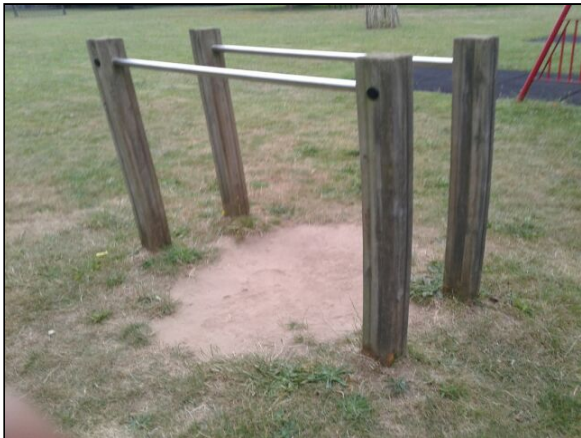
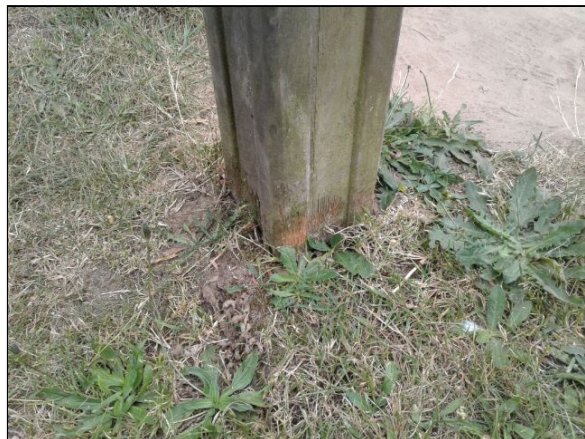
Item: Activity Equipment - Parallel Bars
Manufacturer: Not Identified

Finding: There is some strimmer / machinery damage apparent on the posts, this can penetrate the preservative applied to the timber and accelerate the rotting process
Action: Monitor for any deterioration (rot) and replace as required

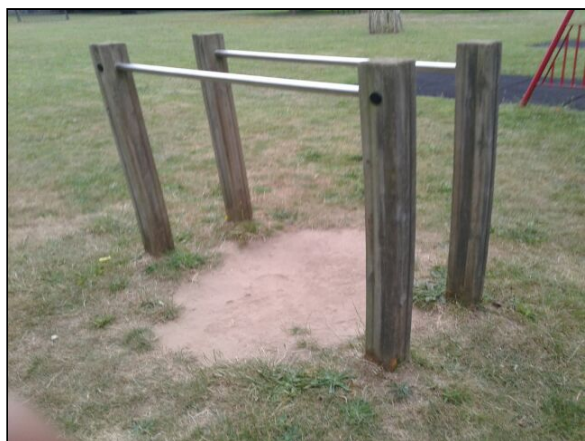
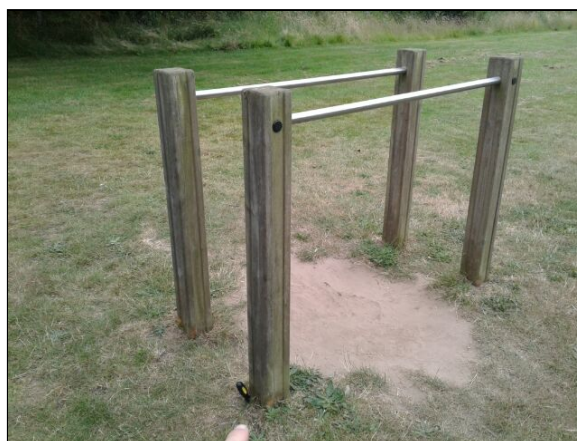
Item: Activity Equipment - Parallel Bars
Manufacturer: Not Identified

Finding: The timber on this item has severe rot
Action: Remove and replace all affected timber sections

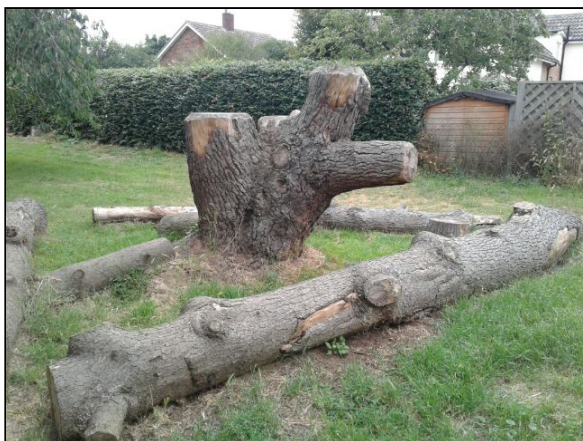
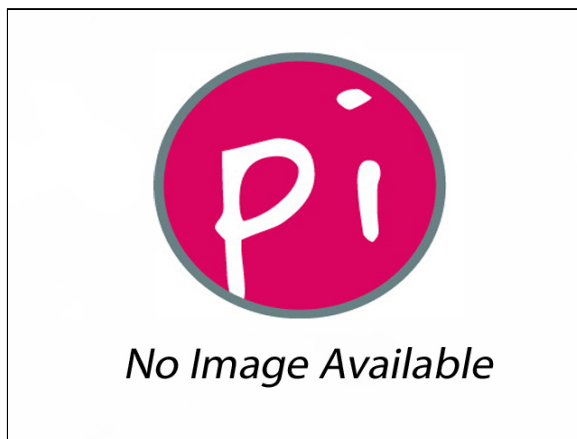
Item: Other - Natural Play Feature
Manufacturer: Natural Feature

Finding: This item of equipment relies on a single post, or a line of posts, for stability and extra care needs to be taken with equipment of this nature to avoid the potential for catastrophic failure
Action: Ensure that regular detailed inspections are undertaken to assess for rot, corrosion and general stability

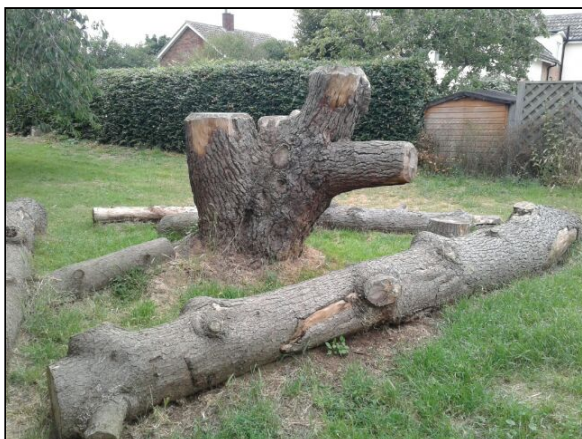
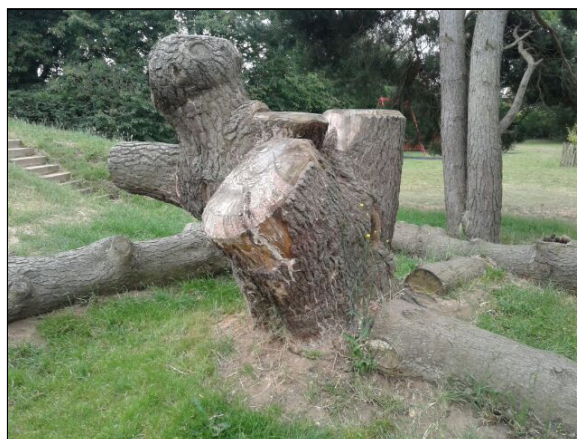
Item: Other - Natural Play Feature
Manufacturer: Natural Feature

Finding: Due to the dimensions of the timber it was not possible to ascertain the condition of the timber at its core without further testing. We recommend a Resi-PD survey to establish the condition of the timber at its core.
Action: Contact the Play Inspection Company office for further information
