the **play inspection** company  
*the safest hands around playgrounds*

**Annual Inspection**

East Suffolk Norse

Cliff Road Waldringfield

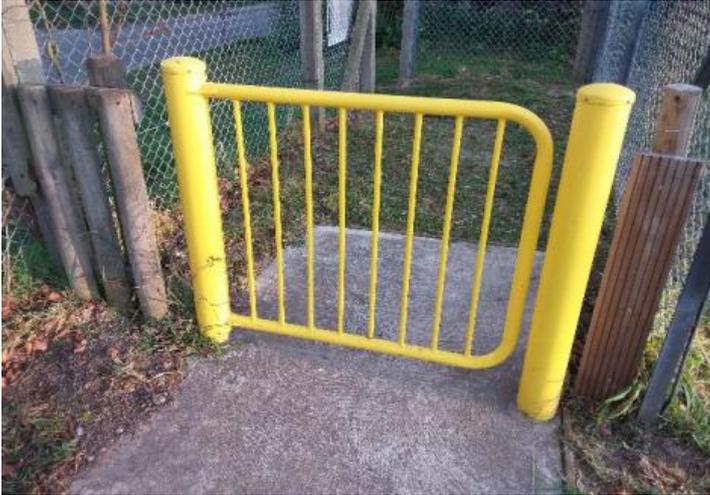
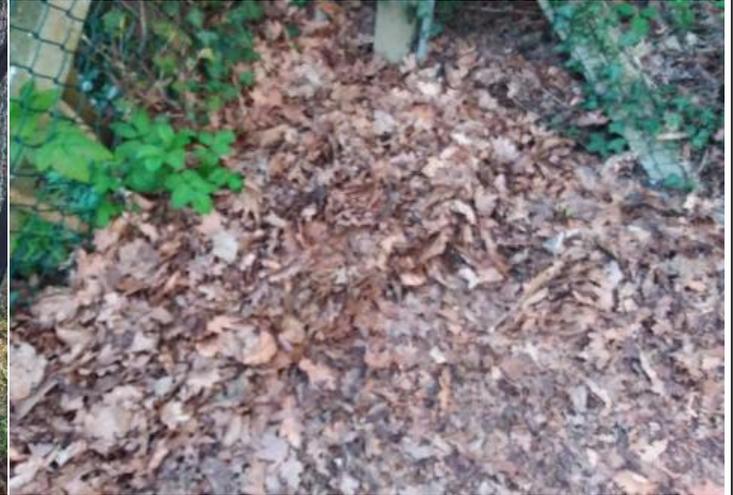
**Item:** Ancillary Items - Gate - Self Closing  
**Manufacturer:** Not Identified

**Finding:** Tree debris behind one gate prevents the gate from opening fully

**Action:** Remove the tree debris

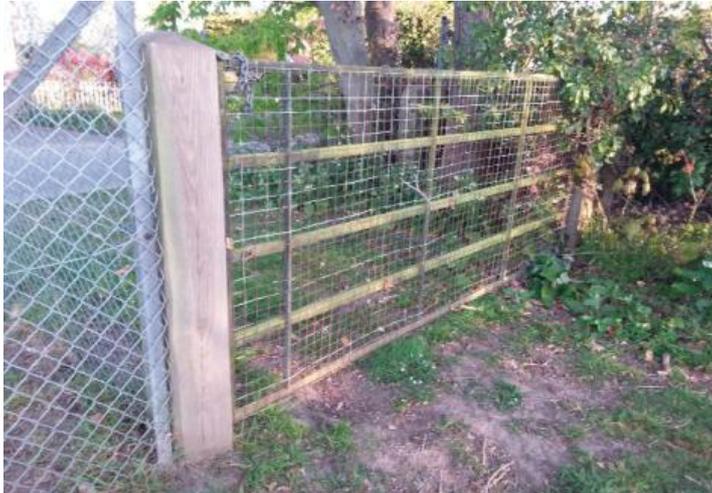
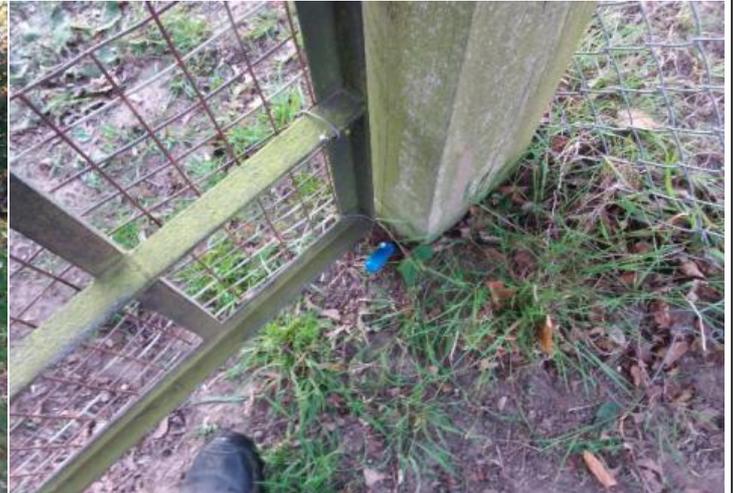
**Item:** Ancillary Items - Gate - Maintenance  
**Manufacturer:** Not Identified

There are areas or parts of the timber slamming post that have rotted - Replace all affected timbers

**Finding:** There are areas or parts of the timber slamming post that have rotted

**Action:** Replace all affected timbers

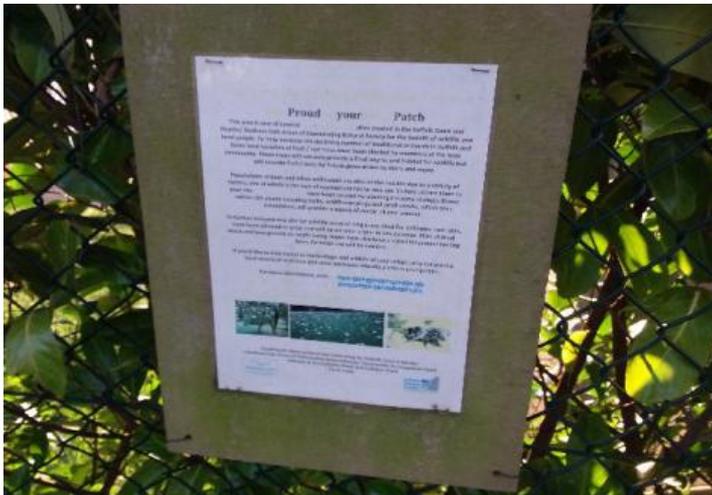
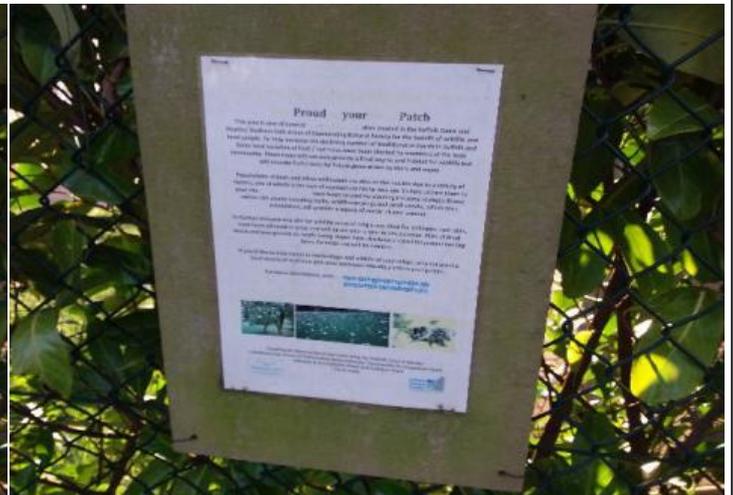
**Item:** Ancillary Items - Sign  
**Manufacturer:** Owner/Operator

BS EN 1176 recommends that signage, with information including the site address, contact information for maintenance issues and emergency contact details are provided on the playground - Provide in accordance with the recommendations set out in BS EN 1176 Part 7

**Finding:** BS EN 1176 recommends that signage, with information including the site address, contact information for maintenance issues and emergency contact details are provided on the playground

**Action:** Provide in accordance with the recommendations set out in BS EN 1176 Part 7

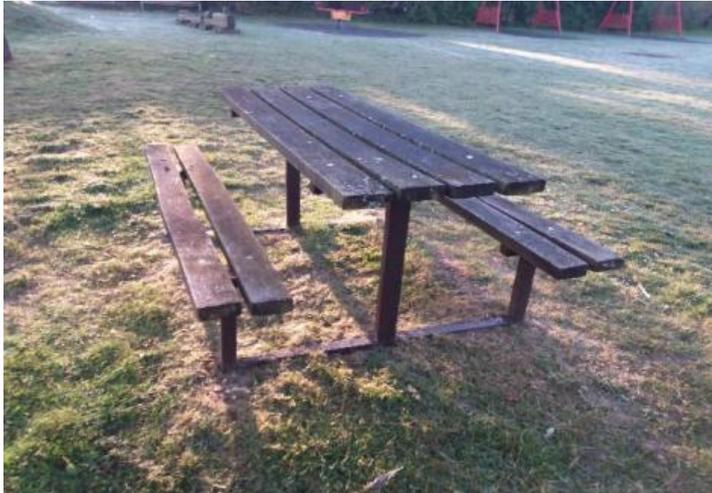
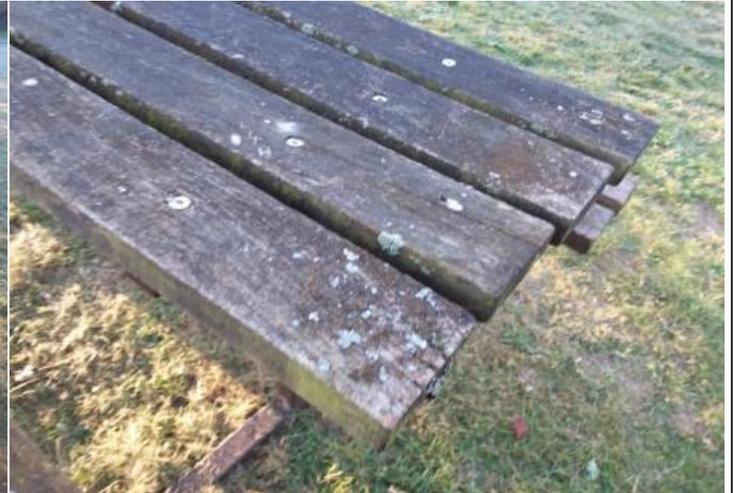
**Item:** Ancillary Items - Picnic Table  
**Manufacturer:** Owner/Operator

**Finding:** There is algae or moss on the surface of the table **Action:** Clean and treat appropriately

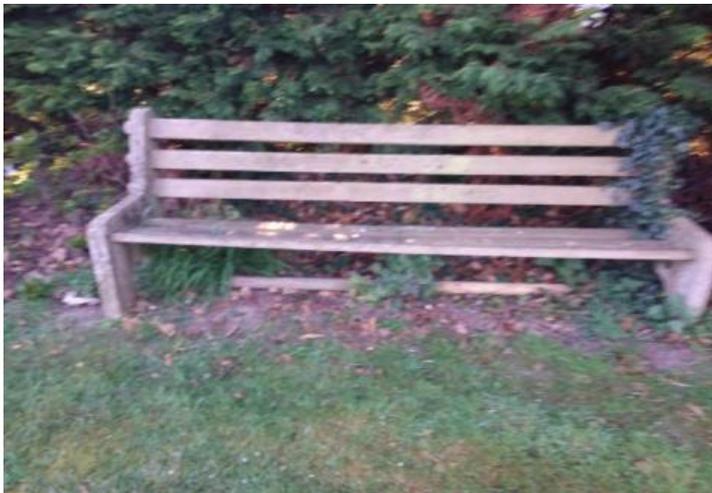
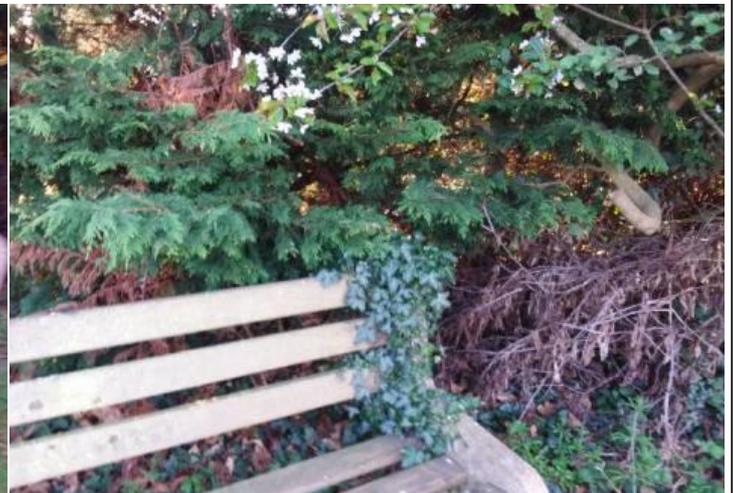
**Item:** Ancillary Items - Bench  
**Manufacturer:** Owner/Operator

**Finding:** The adjacent foliage is overhanging the bench **Action:** Cut back and maintain

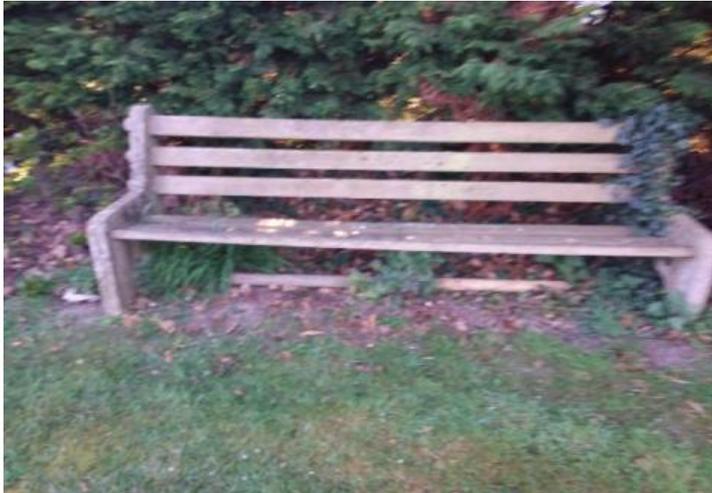
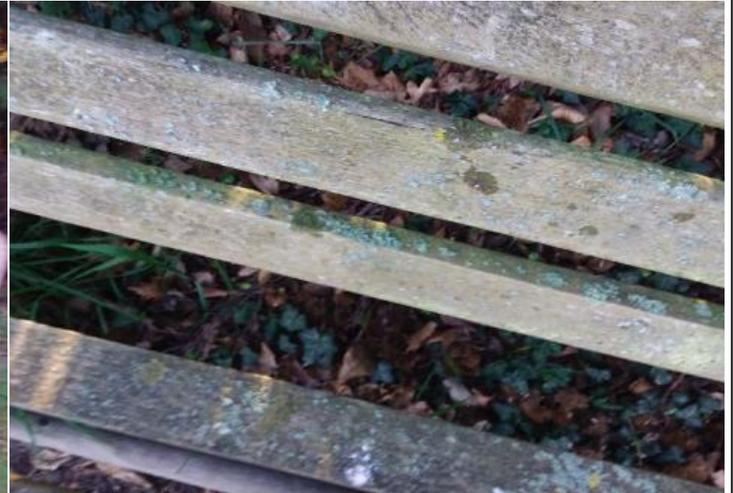
**Item:** Ancillary Items - Bench  
**Manufacturer:** Owner/Operator

**Finding:** There is algae or moss on the surface of the bench **Action:** Clean and treat appropriately

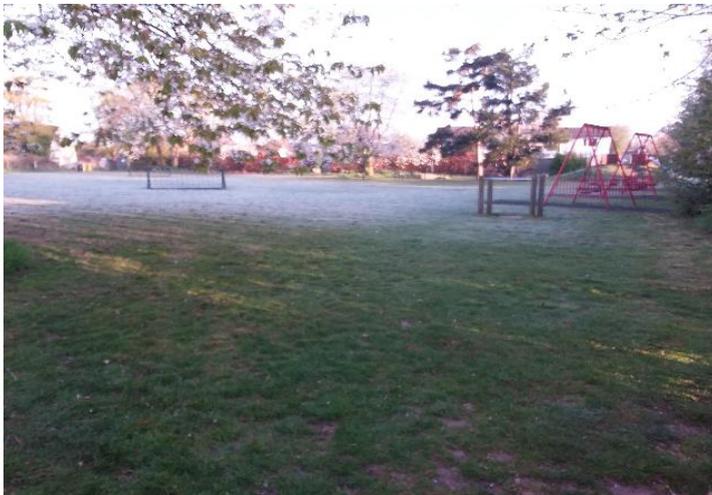
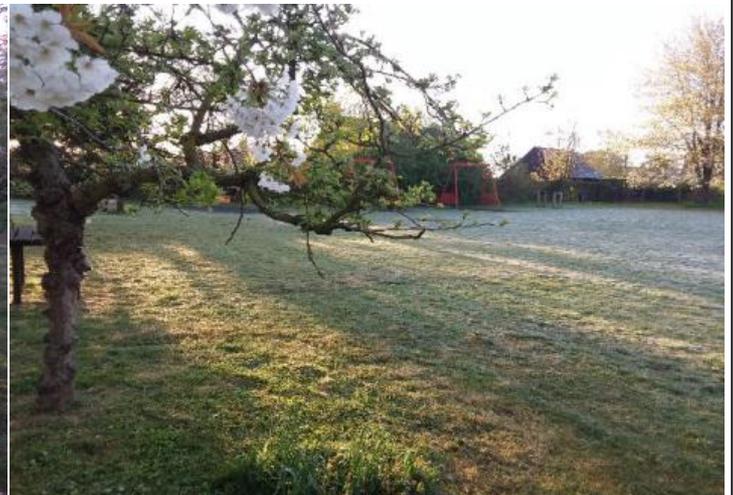
**Item:** Ancillary Items - Site General  
**Manufacturer:** Owner/Operator

**Finding:** Tree canopies overhang the access routes to the equipment and are less than 2.0m high **Action:** Lift tree canopy to ensure a minimum clearance of 2.0m from ground level

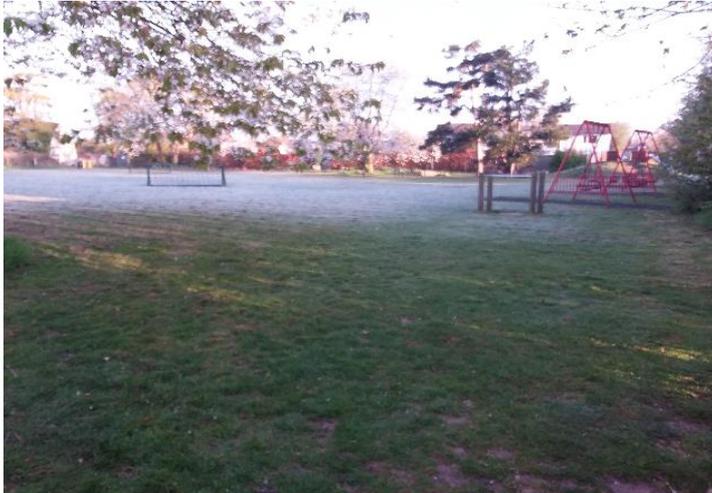
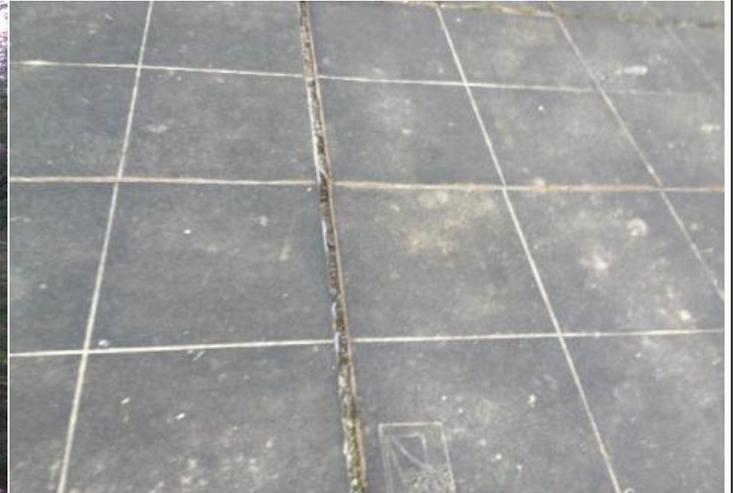
**Item:** Ancillary Items - Site General  
**Manufacturer:** Owner/Operator

There are gaps opening in between the tiles - Repair as required

**Finding:** There are gaps opening in between the tiles

**Action:** Repair as required

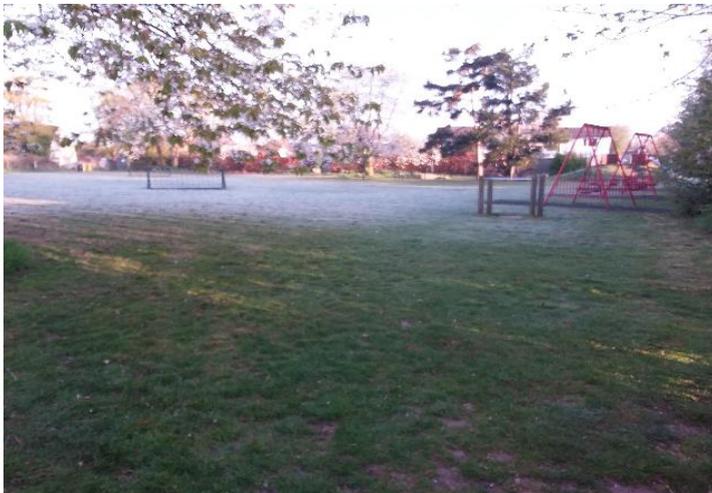
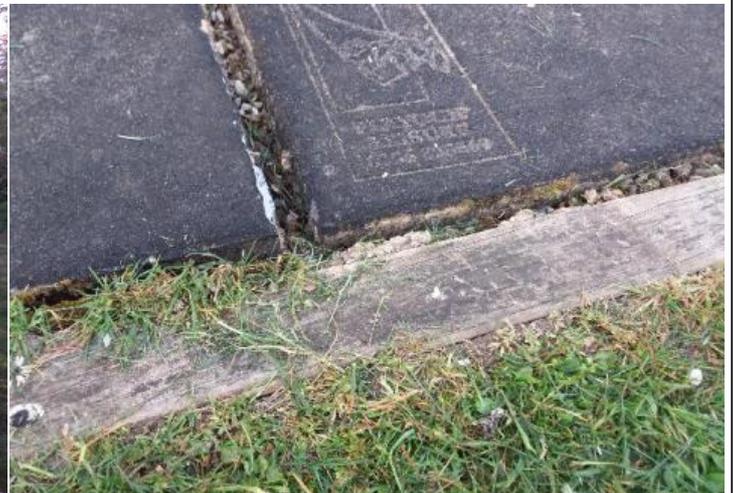
**Item:** Ancillary Items - Site General  
**Manufacturer:** Owner/Operator

**Finding:** The tiles can easily be lifted or are lifting along the edges of the area

**Action:** Lift and re-glue tiles to secure

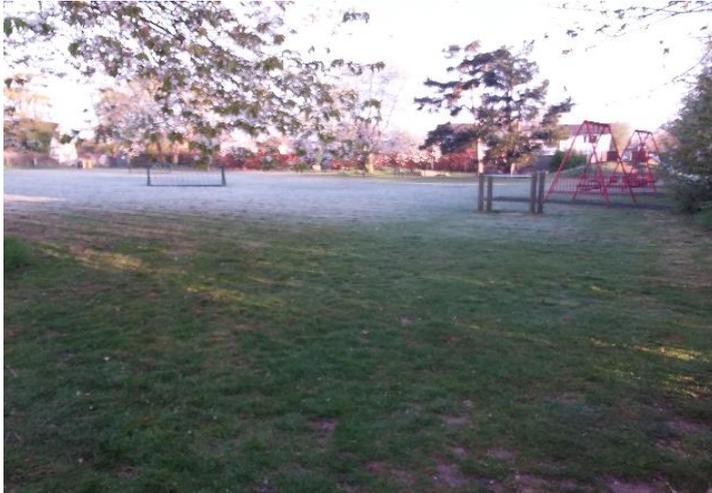
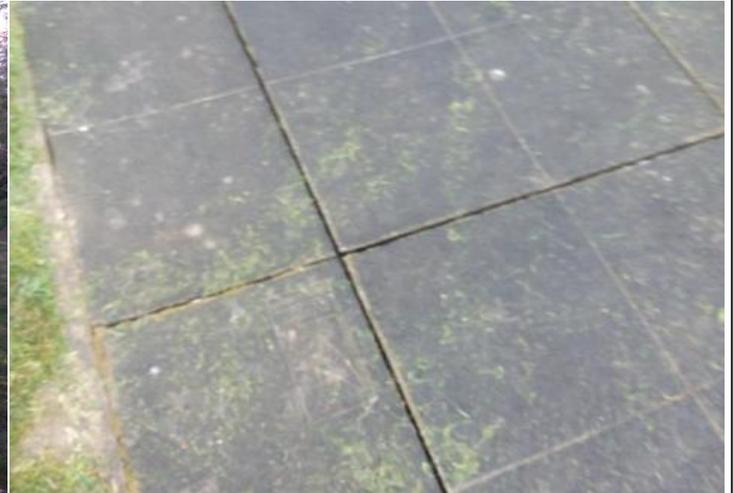
**Item:** Ancillary Items - Site General  
**Manufacturer:** Owner/Operator

There is algae or moss growth on the safety surface resulting in slippery conditions - Clean and treat appropriately

**Finding:** There is algae or moss growth on the safety surface resulting in slippery conditions

**Action:** Clean and treat appropriately

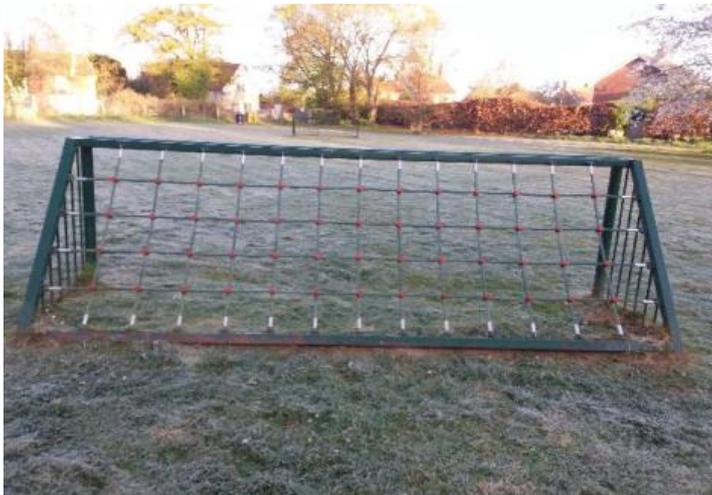
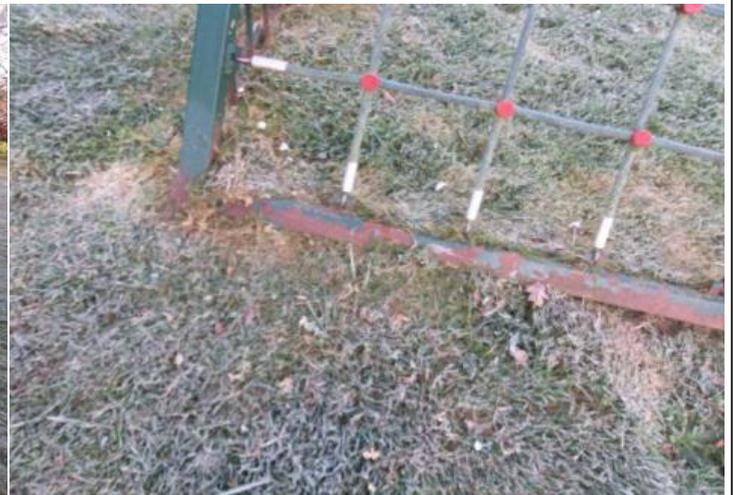
**Item:** Multi Use Games Area - 5 a side Goals  
**Manufacturer:** Not Identified

The paintwork on this item has been damaged or worn exposing the metal underneath which is rusting - Treat any rusting components and repaint

**Finding:** The paintwork on this item has been damaged or worn exposing the metal underneath which is rusting

**Action:** Treat any rusting components and repaint

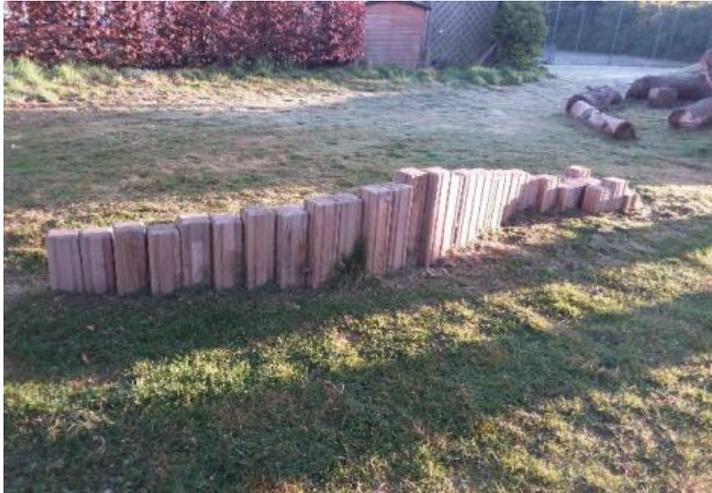
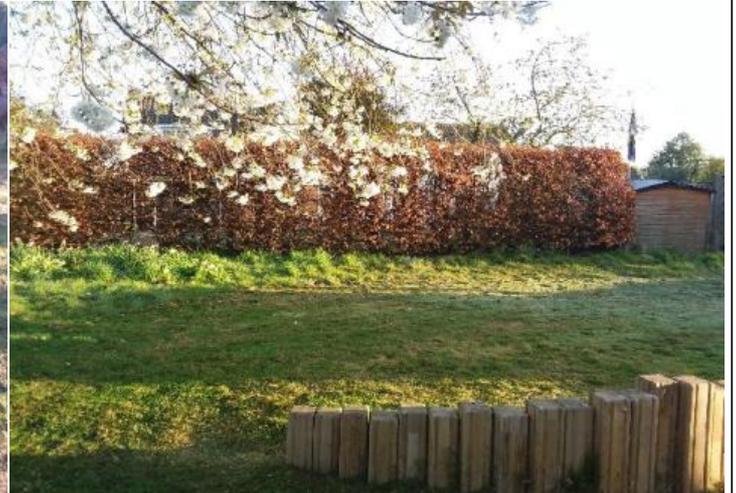
**Item:** Activity Equipment - Stepping Stones  
**Manufacturer:** Not Identified

**Finding:** The tree canopy overhangs the equipment and is less than 2.0m away

**Action:** Lift tree canopy to ensure a minimum clearance of 2.0m from the equipment

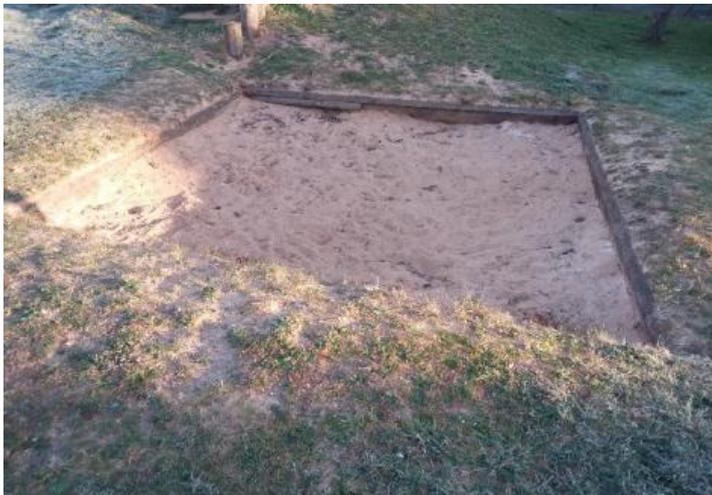
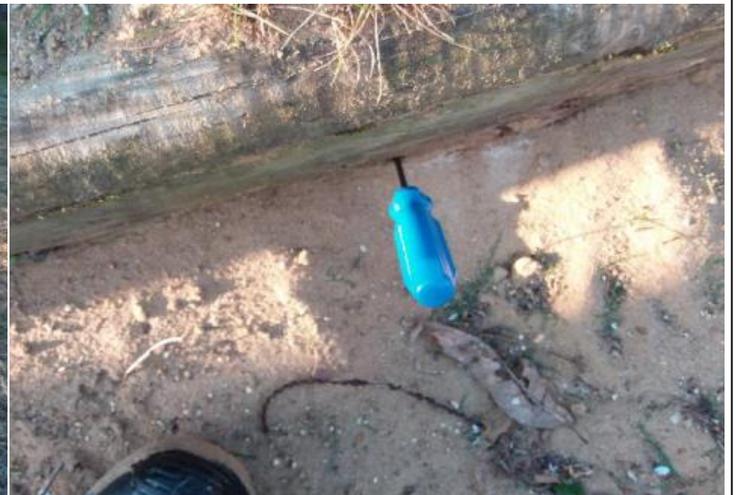
**Item:** Other - Sand Box  
**Manufacturer:** Owner/Operator

There are areas or parts of the timber edging boards that have rotted - Replace all affected timbers

**Finding:** There are areas or parts of the timber edging boards that have rotted

**Action:** Replace all affected timbers

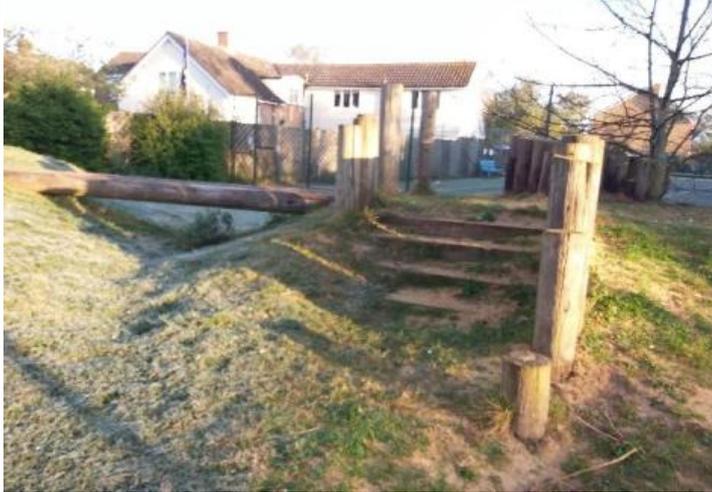
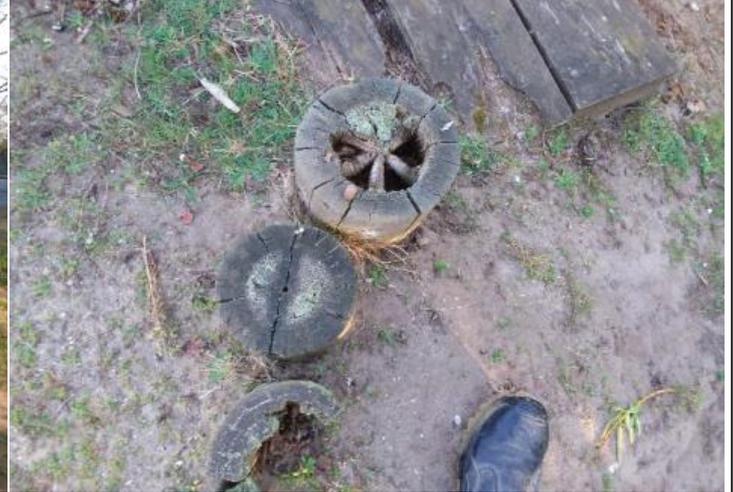
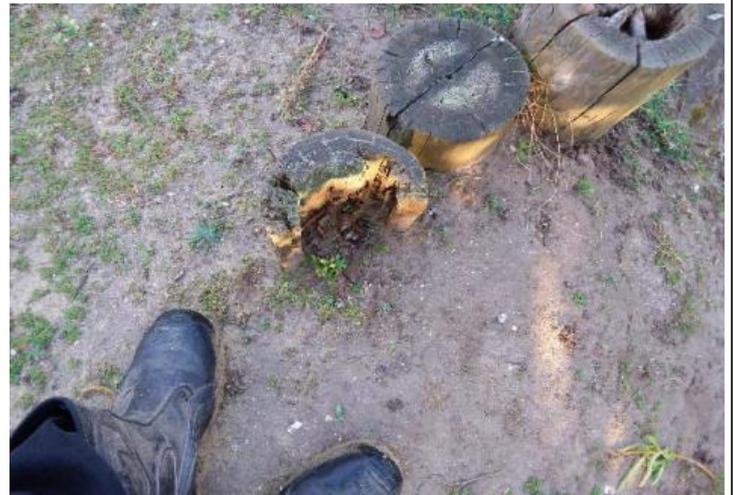
**Item:** Activity Equipment - Bridge  
**Manufacturer:** Not Identified

The timber throughout this item has severe rot - Remove and replace all affected timber sections

**Finding:** The timber throughout this item has severe rot

**Action:** Remove and replace all affected timber sections

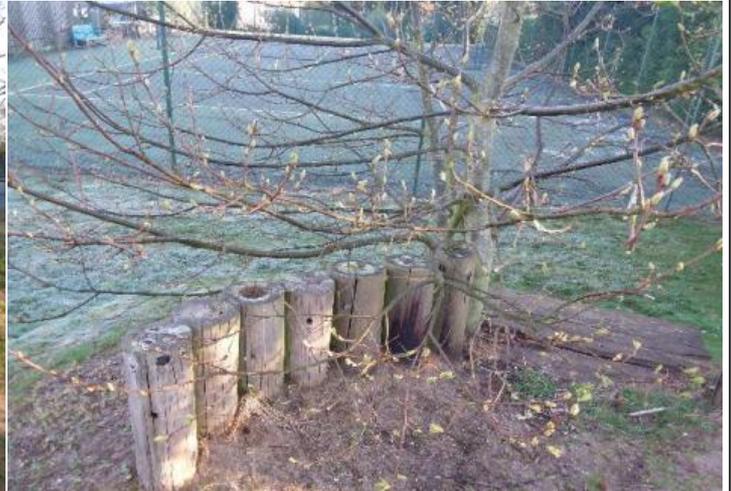
**Item:** Activity Equipment - Bridge  
**Manufacturer:** Not Identified

**Finding:** The tree canopy overhangs the equipment and is less than 2.0m away

**Action:** Lift tree canopy to ensure a minimum clearance of 2.0m from the equipment

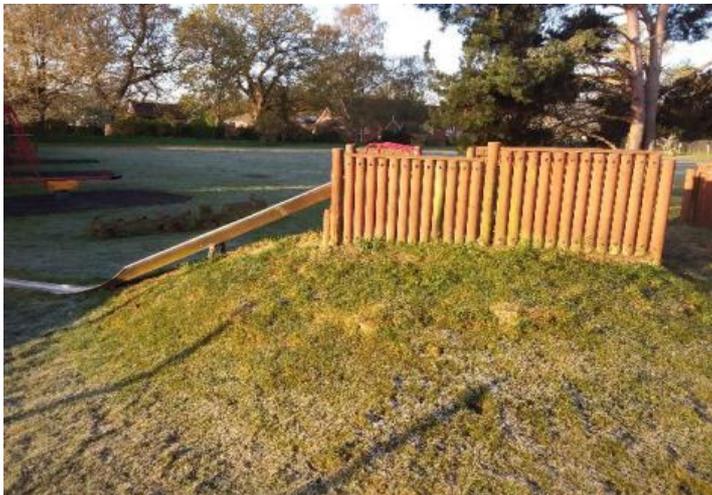
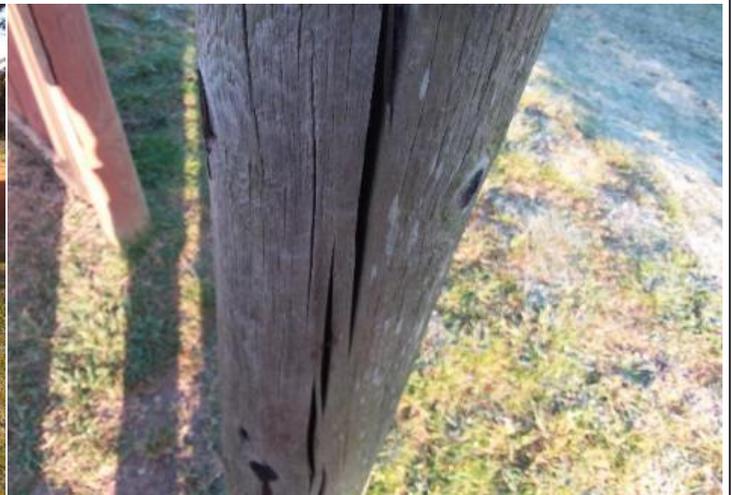
**Item:** Other - Embankment Slide  
**Manufacturer:** Not Identified

The timber has a number of splits/shakes or air cracks and this may affect the stability or allow water ingress which will accelerate the rotting process - Monitor to ensure the splits do not cross through fixing points of the structure and/or cause any instability

**Finding:** The timber has a number of splits/shakes or air cracks and this may affect the stability or allow water ingress which will accelerate the rotting process

**Action:** Monitor to ensure the splits do not cross through fixing points of the structure and/or cause any instability

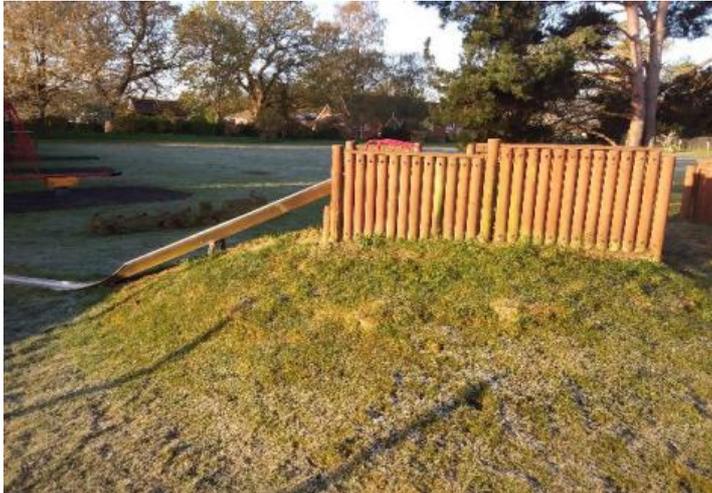
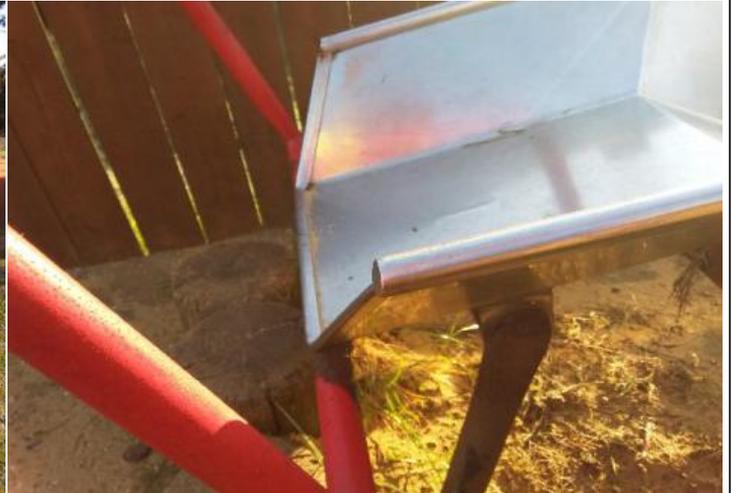
**Item:** Other - Embankment Slide  
**Manufacturer:** Not Identified

The slide start section incline is not in the direction of travel; it should slope towards the direction of the sliding surface to meet the requirements of BS EN 1176 Part 3 - Monitor - No remedial work recommended

**Finding:** The slide start section incline is not in the direction of travel; it should slope towards the direction of the sliding surface to meet the requirements of BS EN 1176 Part 3

**Action:** Monitor - No remedial work recommended

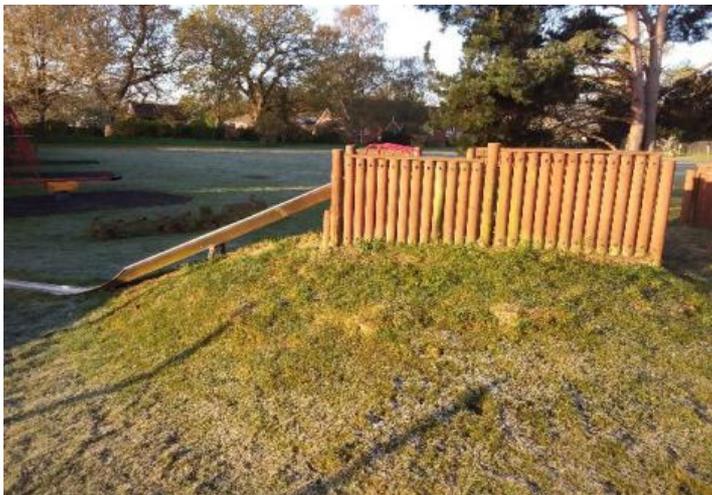
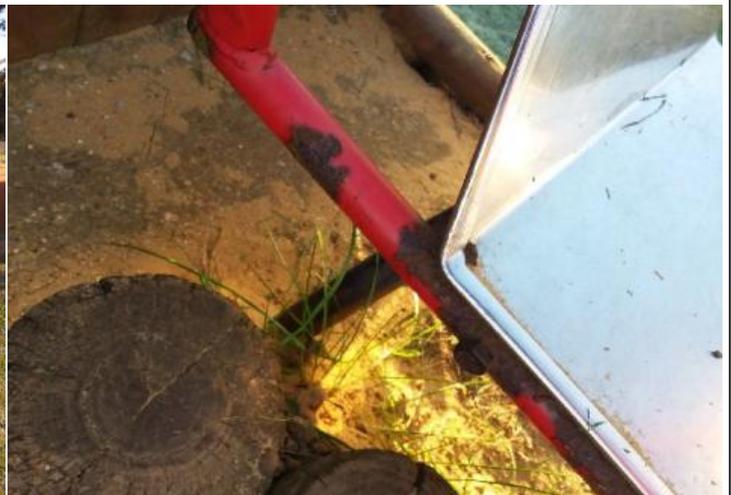
**Item:** Other - Embankment Slide  
**Manufacturer:** Not Identified

The paintwork on this item has been damaged or worn exposing the metal underneath which is rusting - Treat any rusting components and repaint

**Finding:** The paintwork on this item has been damaged or worn exposing the metal underneath which is rusting

**Action:** Treat any rusting components and repaint

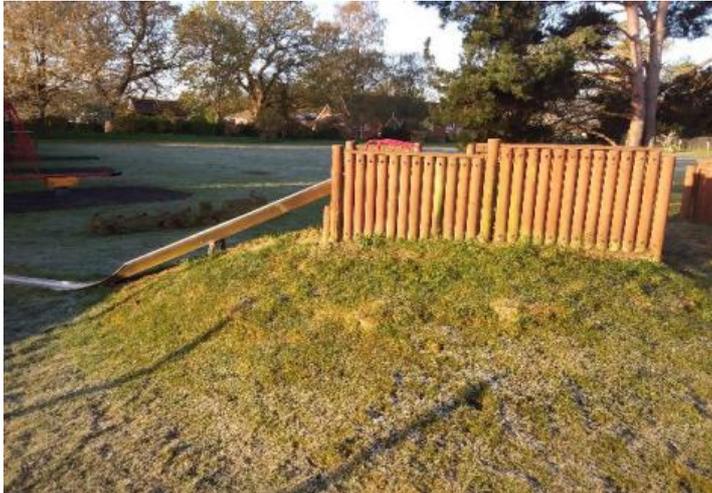
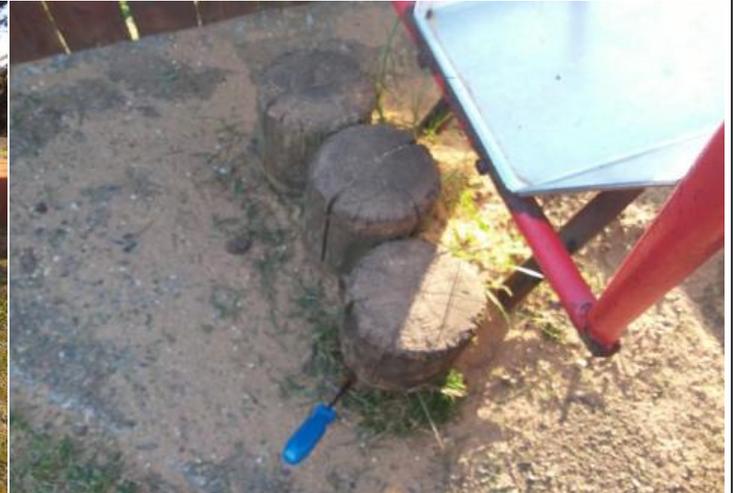
**Item:** Other - Embankment Slide  
**Manufacturer:** Not Identified

There are areas or parts of the timber stepping stones that have rotted - Replace all affected timbers

**Finding:** There are areas or parts of the timber stepping stones that have rotted

**Action:** Replace all affected timbers

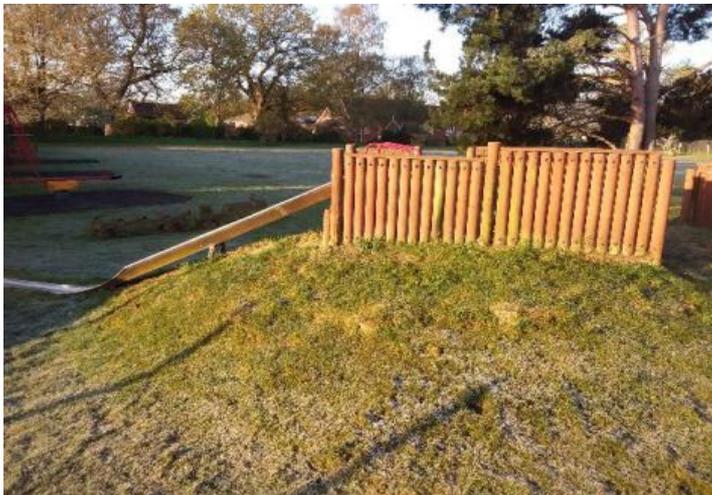
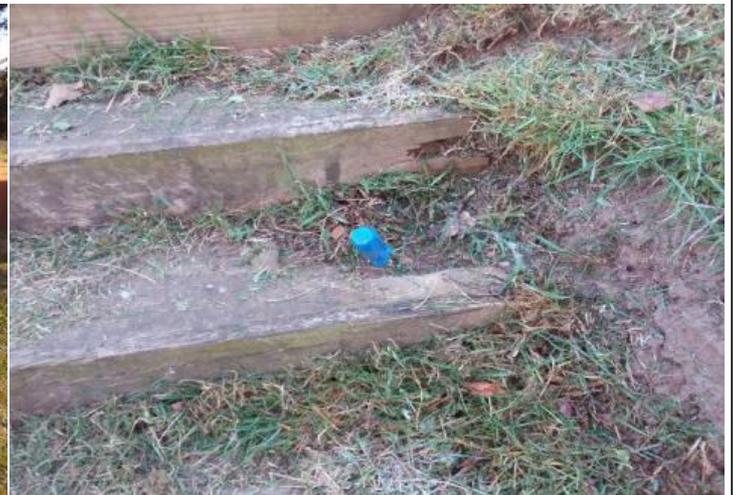
**Item:** Other - Embankment Slide  
**Manufacturer:** Not Identified

There are areas or parts of the timber steps that have rotted - Replace all affected timbers

**Finding:** There are areas or parts of the timber steps that have rotted

**Action:** Replace all affected timbers

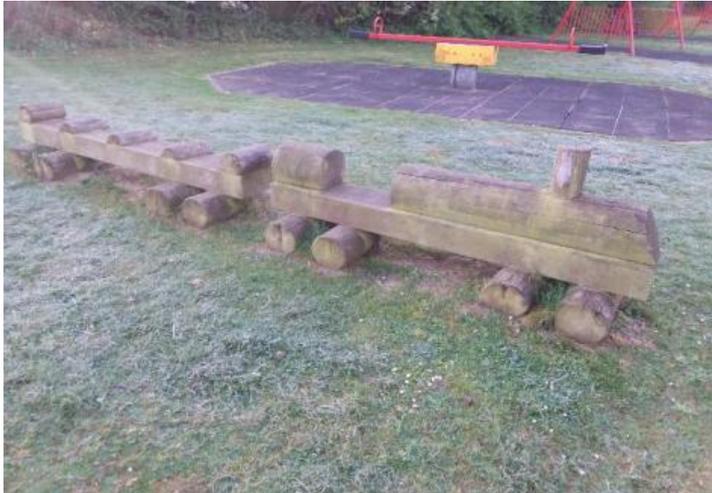
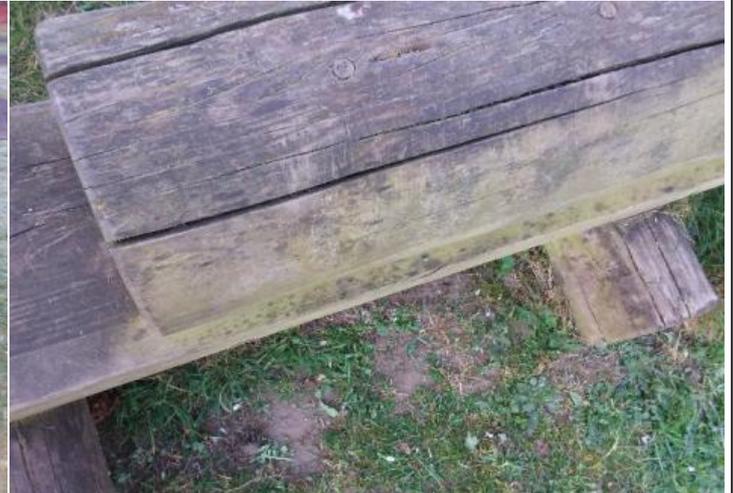
**Item:** Activity Equipment - Train  
**Manufacturer:** Not Identified

The timber has a number of splits/shakes or air cracks and this may affect the stability or allow water ingress which will accelerate the rotting process - Monitor to ensure the splits do not cross through fixing points of the structure and/or cause any instability

**Finding:** The timber has a number of splits/shakes or air cracks and this may affect the stability or allow water ingress which will accelerate the rotting process  
**Action:** Monitor to ensure the splits do not cross through fixing points of the structure and/or cause any instability

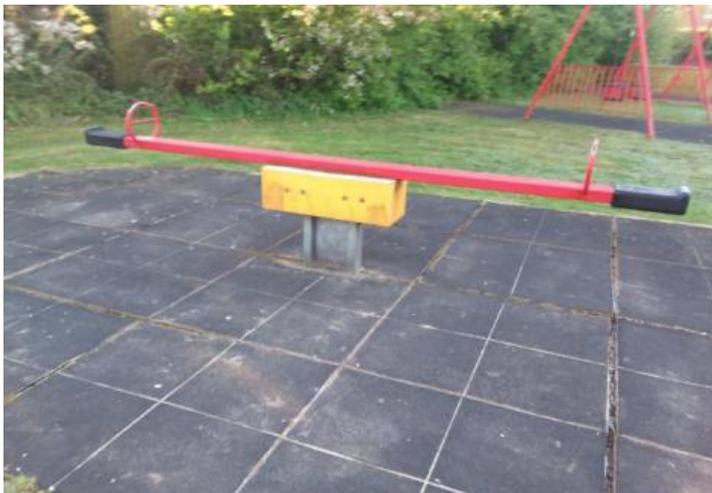
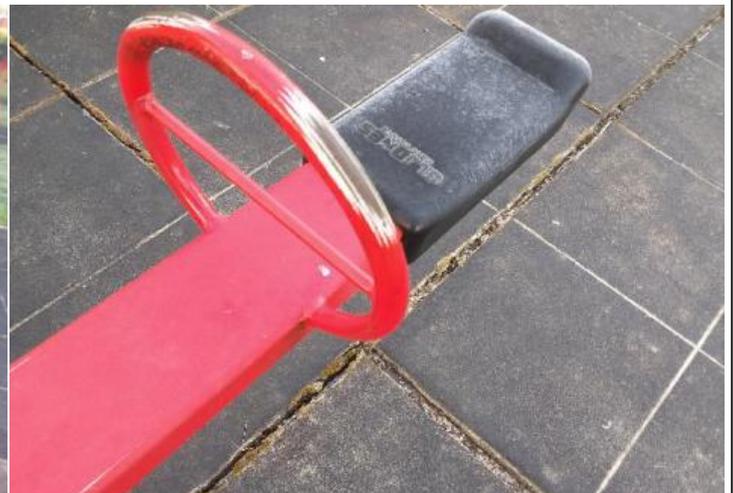
**Item:** Rocking Equipment - See Saw  
**Manufacturer:** GL Jones

The paintwork on this item has been damaged or worn exposing the metal underneath which is rusting - Treat any rusting components and repaint

**Finding:** The paintwork on this item has been damaged or worn exposing the metal underneath which is rusting  
**Action:** Treat any rusting components and repaint

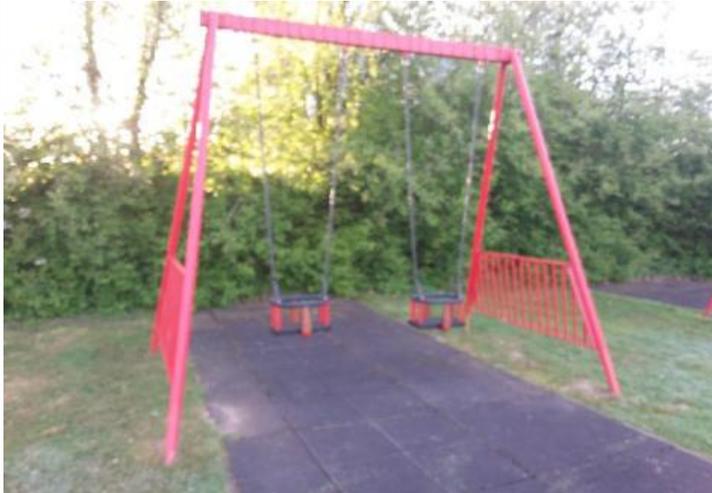
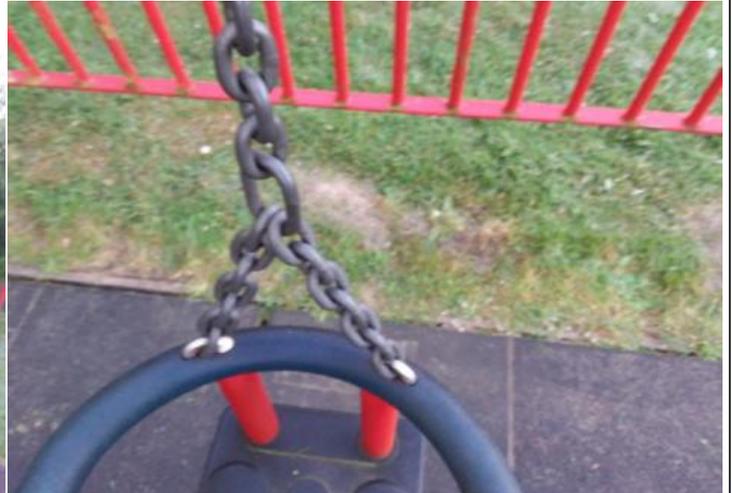
**Item:** Swings - 1 Bay 2 Seat (Cradle)  
**Manufacturer:** Playquip

The surfacing width under each seat is less than 1.75 metres and fails the requirements of BS EN 1176 Part 2 - Monitor - No remedial work recommended

**Finding:** The surfacing width under each seat is less than 1.75 metres and fails the requirements of BS EN 1176 Part 2

**Action:** Monitor - No remedial work recommended

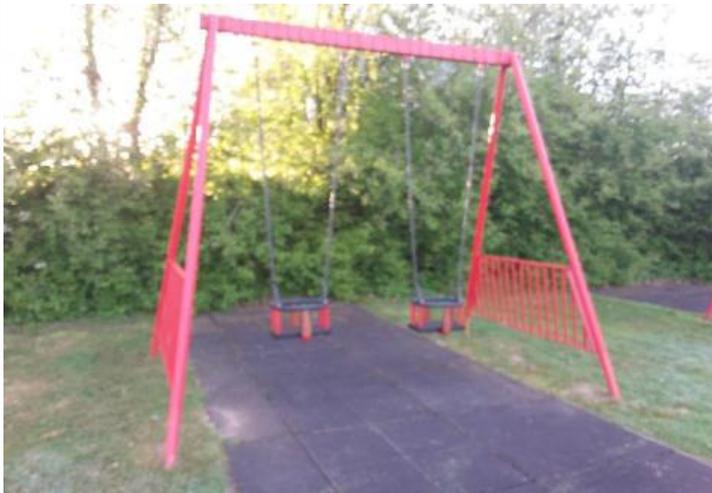
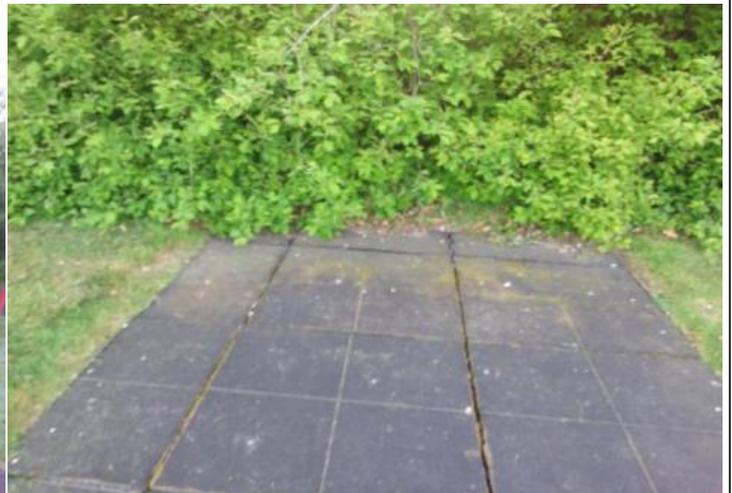
**Item:** Swings - 1 Bay 2 Seat (Cradle)  
**Manufacturer:** Playquip

**Finding:** The adjacent foliage is overhanging the safety surfacing

**Action:** Cut back and maintain

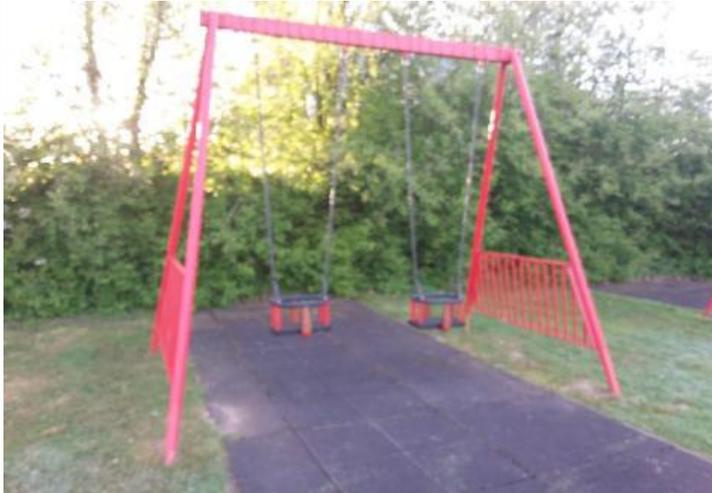
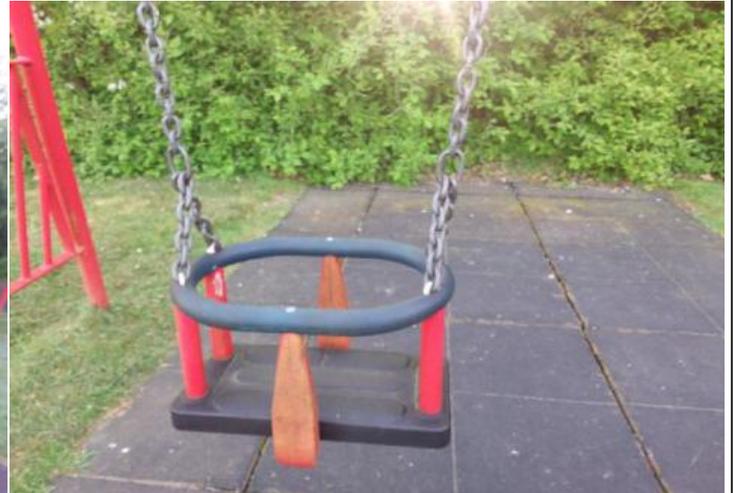
**Item:** Swings - 1 Bay 2 Seat (Cradle)  
**Manufacturer:** Playquip

BS EN 1176 requires an additional 1.5m of unobstructed space at each end of the swing surfacing area. This is a relatively low risk finding and no remedial action is recommended at this point. - Monitor - No remedial work recommended

**Finding:** BS EN 1176 requires an additional 1.5m of unobstructed space at each end of the swing surfacing area. This is a relatively low risk finding and no remedial action is recommended at this point.

**Action:** Monitor - No remedial work recommended

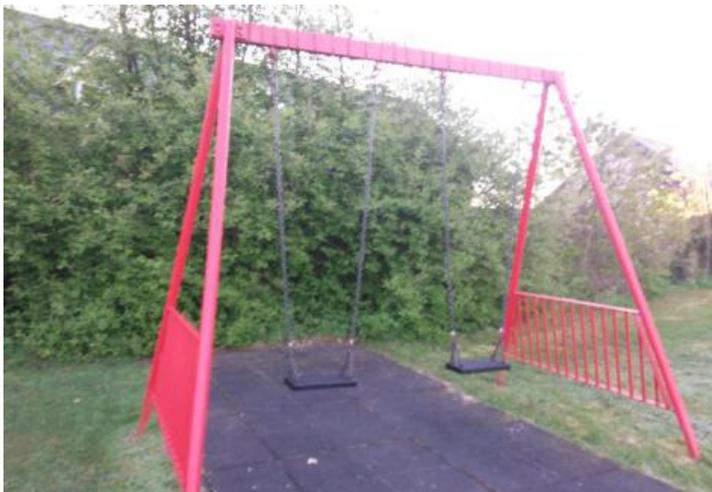
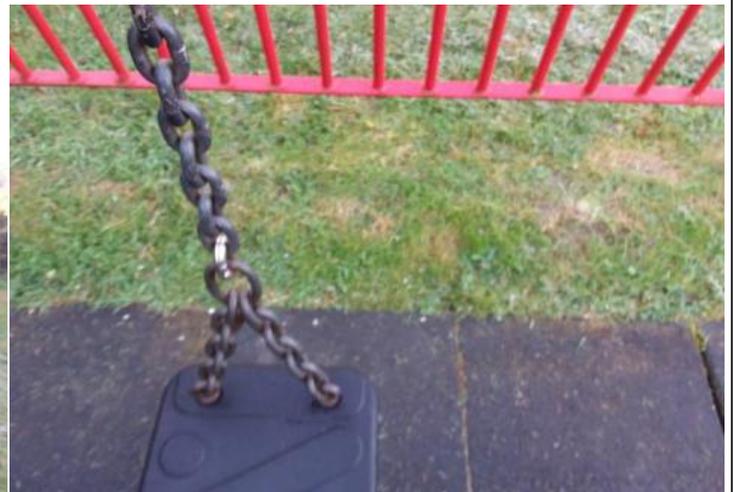
**Item:** Swings - 1 Bay 2 Seat (Flat)  
**Manufacturer:** Playquip

The surfacing width under each seat is less than 1.75 metres and fails the requirements of BS EN 1176 Part 2 - Monitor - No remedial work recommended

**Finding:** The surfacing width under each seat is less than 1.75 metres and fails the requirements of BS EN 1176 Part 2

**Action:** Monitor - No remedial work recommended

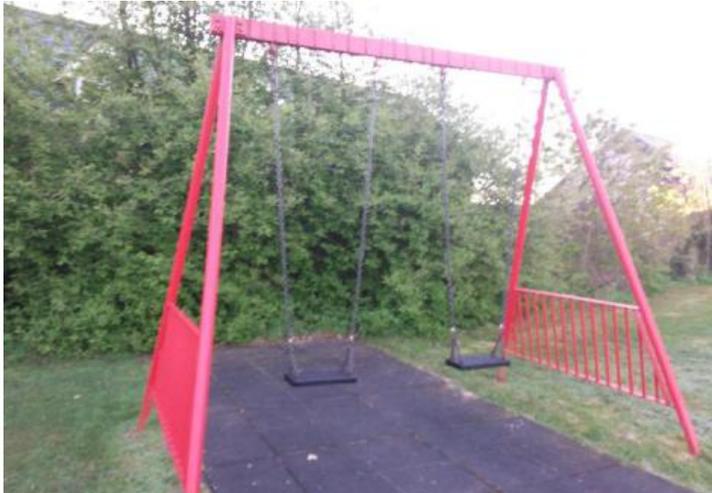
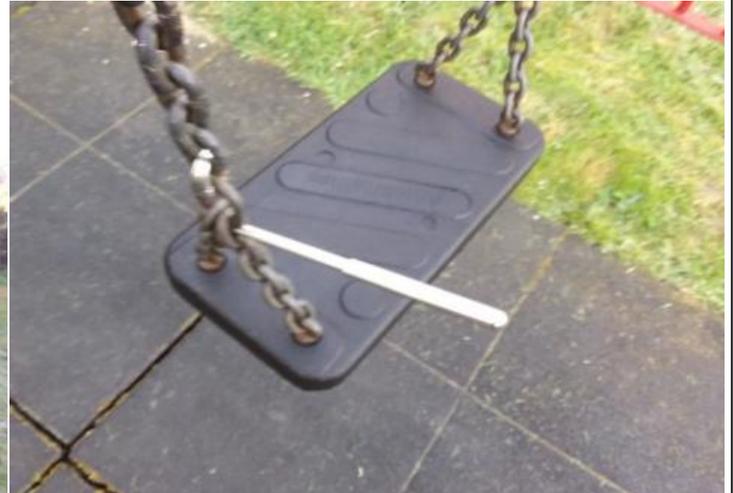
The chain openings are in excess of the 8.6mm as recommended by BS EN 1176 - Monitor - No remedial work recommended

**Finding:** The chain openings are in excess of the 8.6mm as recommended by BS EN 1176  
**Action:** Monitor - No remedial work recommended

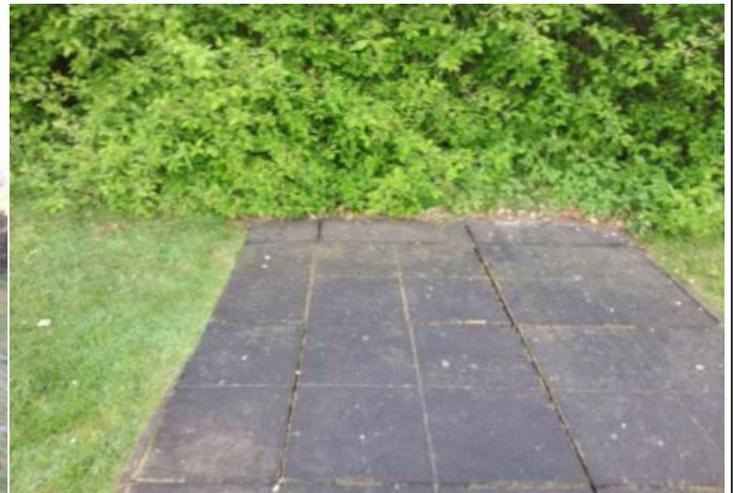
**Finding:** The adjacent foliage is overhanging the safety surfacing  
**Action:** Cut back and maintain

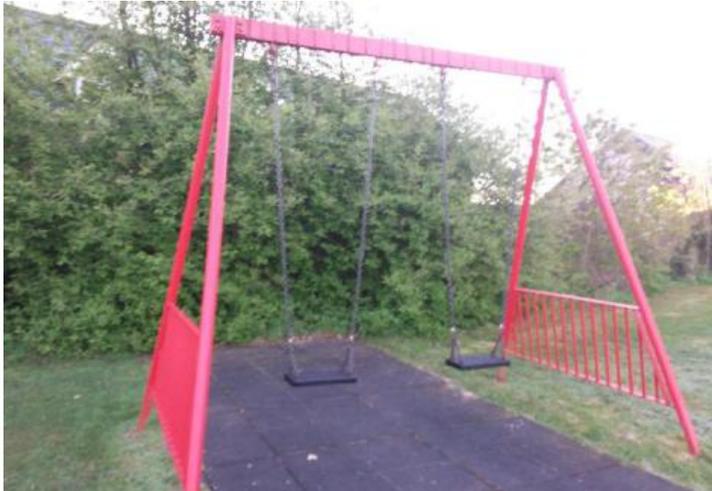
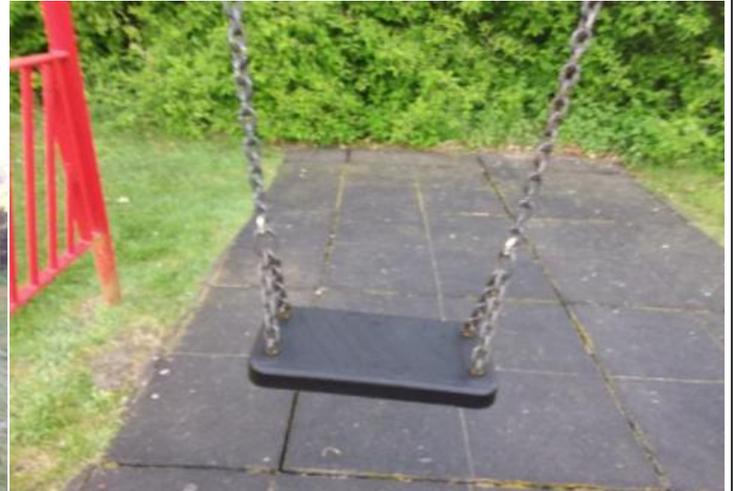
BS EN 1176 requires an additional 1.5m of unobstructed space at each end of the swing surfacing area. This is a relatively low risk finding and no remedial action is recommended at this point. - Monitor - No remedial work recommended

**Finding:** BS EN 1176 requires an additional 1.5m of unobstructed space at each end of the swing surfacing area. This is a relatively low risk finding and no remedial action is recommended at this point.

**Action:** Monitor - No remedial work recommended
