the **play inspection** company  
*the safest hands around playgrounds*

**Annual Inspection**

East Suffolk Norse

Cliff Road Waldringfield

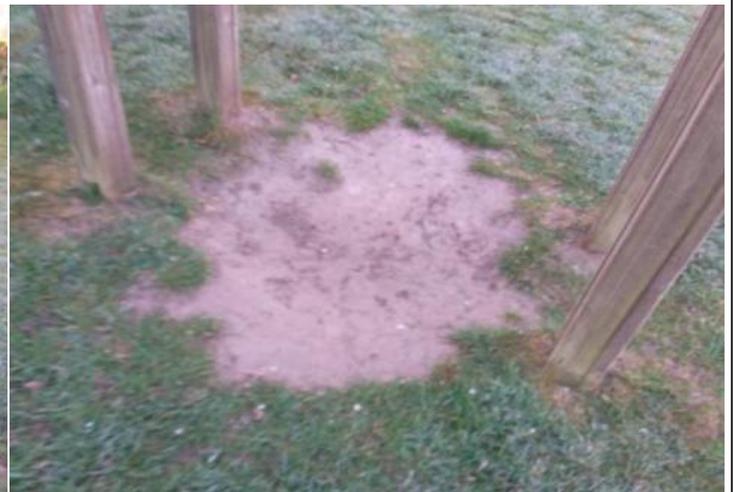
**Finding:** The area around the item has eroded and may become slippery

**Action:** Reinststate eroded area

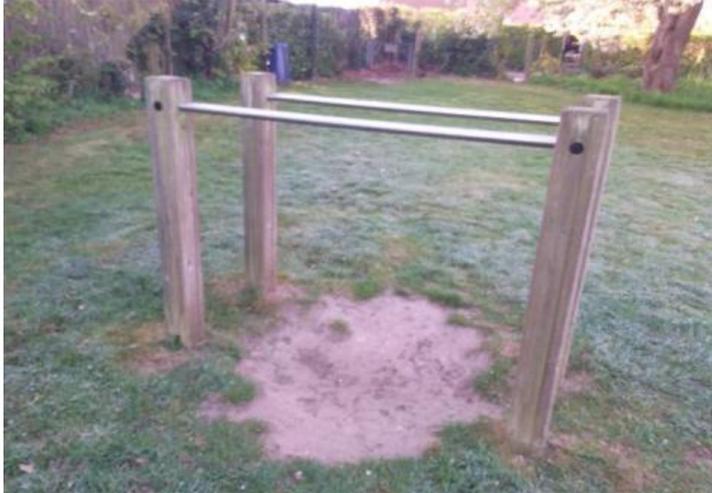
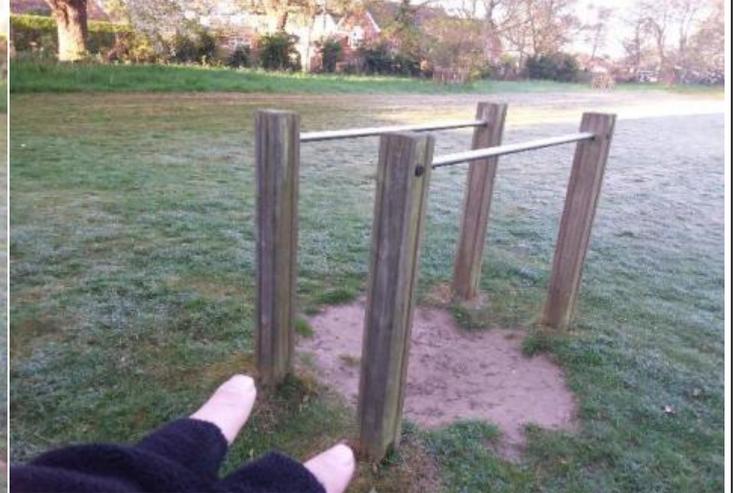
Two posts have rotted - Replace all affected timbers

**Finding:** Two posts have rotted

**Action:** Replace all affected timbers

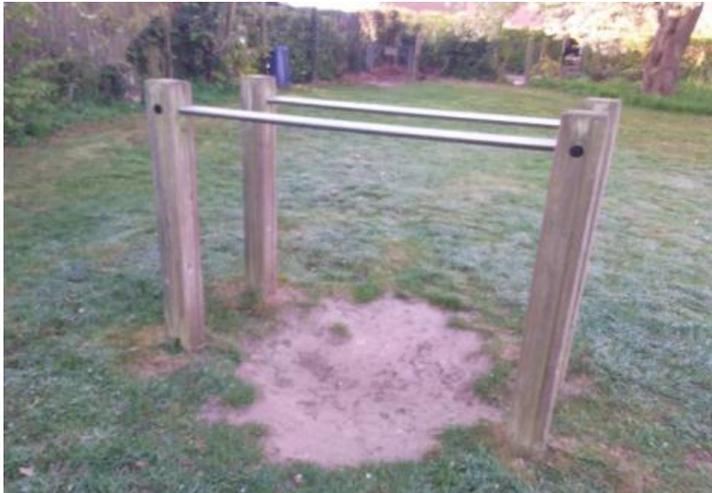
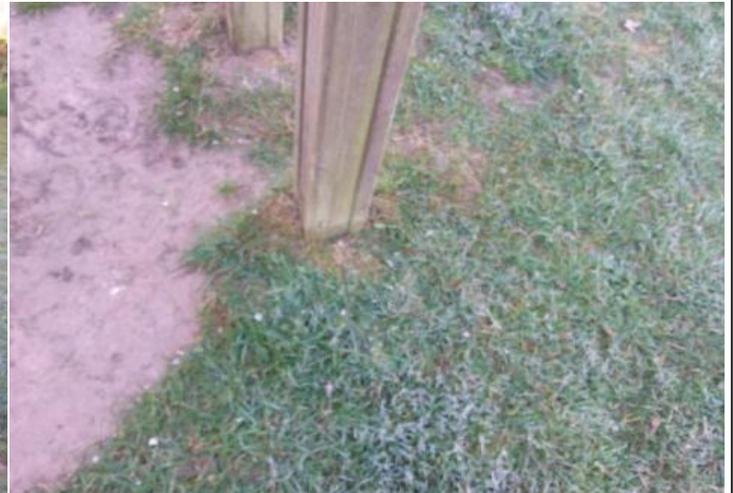
There is some strimmer / machinery damage apparent on the posts, this can penetrate the preservative applied to the timber and accelerate the rotting process - Monitor for any deterioration (rot) and replace as required

**Finding:** There is some strimmer / machinery damage apparent on the posts, this can penetrate the preservative applied to the timber and accelerate the rotting process

**Action:** Monitor for any deterioration (rot) and replace as required

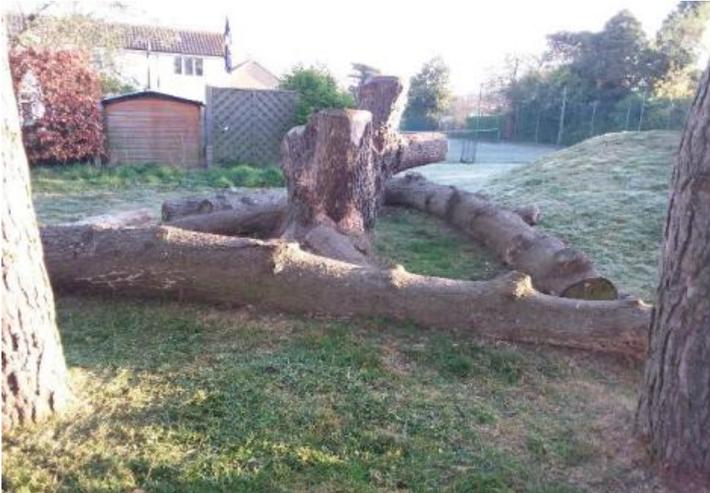
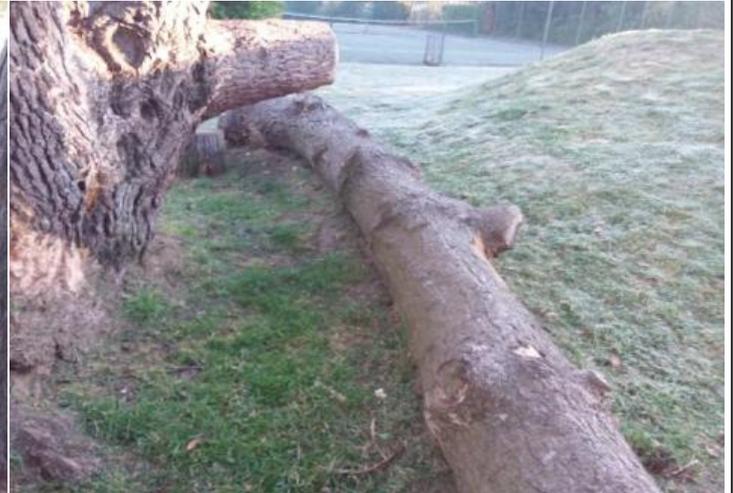
There are falls in excess of 600mm between adjacent components on the structure, in contravention of the recommendations set out in BS EN 1176 Part 1; 4.2.8.4 - Monitor - No remedial work recommended

**Finding:** There are falls in excess of 600mm between adjacent components on the structure, in contravention of the recommendations set out in BS EN 1176 Part 1; 4.2.8.4

**Action:** Monitor - No remedial work recommended

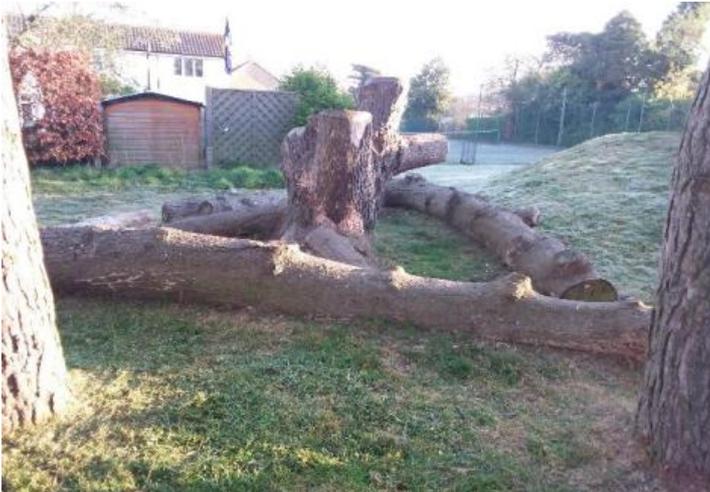
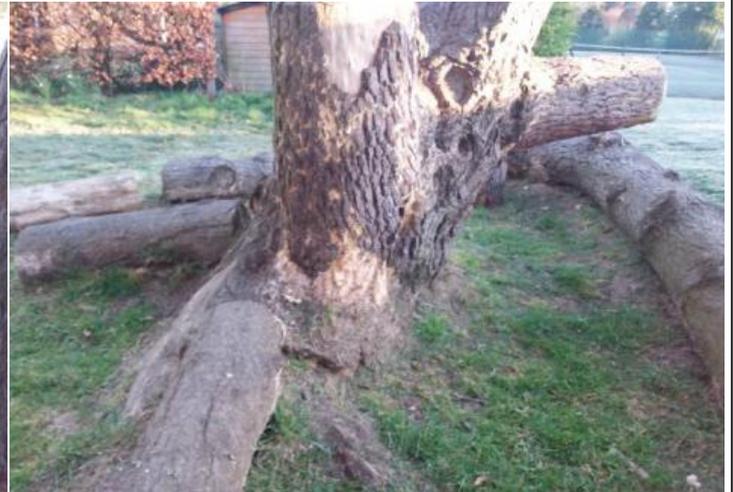
Due to the dimensions of the timber it was not possible to ascertain the condition of the timber at its core without further testing. We recommend a Resi-PD survey to establish the condition of the timber at its core. - Contact the Play Inspection Company office for further information

**Finding:** Due to the dimensions of the timber it was not possible to ascertain the condition of the timber at its core without further testing. We recommend a Resi-PD survey to establish the condition of the timber at its core.

**Action:** Contact the Play Inspection Company office for further information

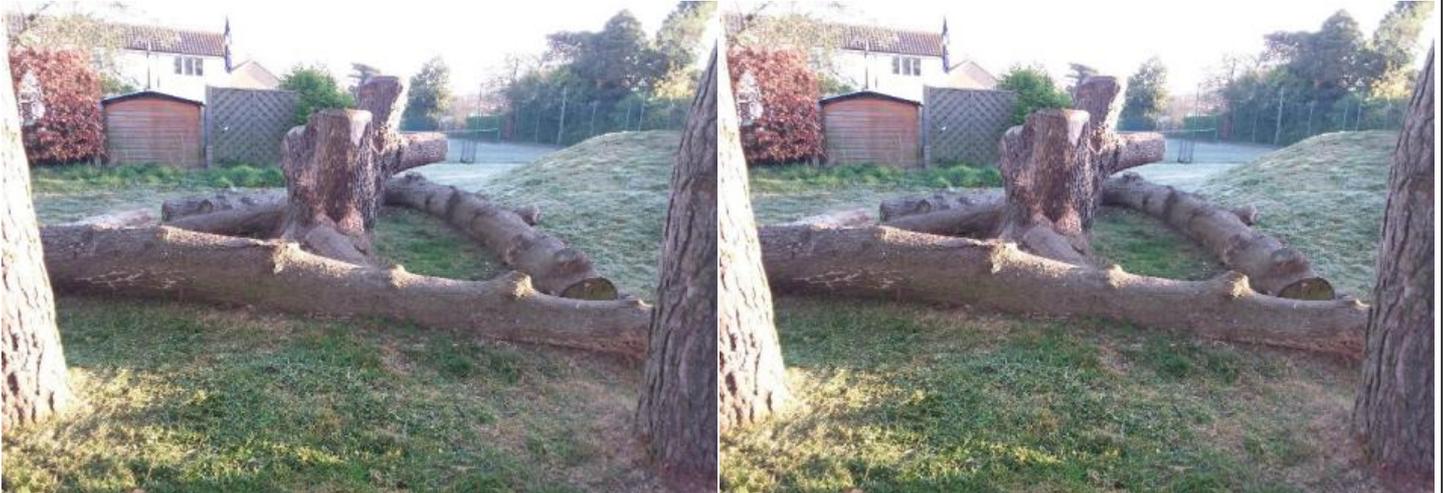
**Finding:** The item of equipment has a fall height exceeding 1.50 metres and grass has been provided as a safety surface

**Action:** Provide a suitable impact attenuating surface
