# **Safety Inspection Report**

**Annual Inspection**

# **Waldringfield Playing Field**

13 September 2024

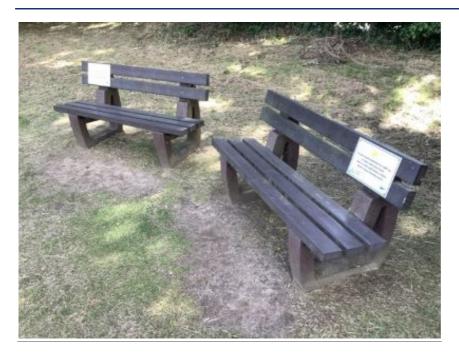
# **Seating - Benches**

Loose in ground.

Tighten foundation bolts. Benches adjacent to carousel.

The gaps between the slats exceed 30 mm and are known to cause entrapments.

Encroaching vegetation or trees.

Clean off algae and cut back bushes.

Timber is decayed.

Timber bench supports.

Read the notes for further action.

Remove.

Replace affected parts.

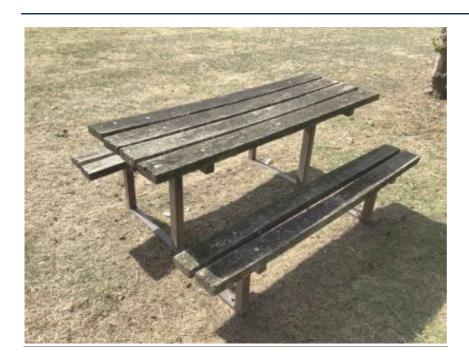
# **Seating - Picnic Table**

The equipment is dirty or algae covered.

Timber is not in good condition.

Timber slats are splintered. Repair and Replace when necessary.

Clean off.

Repair., Replace.

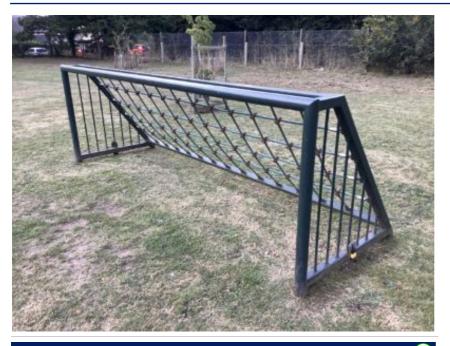
# Goal Post - Football - 5-A-Side

Ground erosion present.

Throughout pitch.

Balls may leave the area and strike a user of the play equipment.

Repair the worn areas.

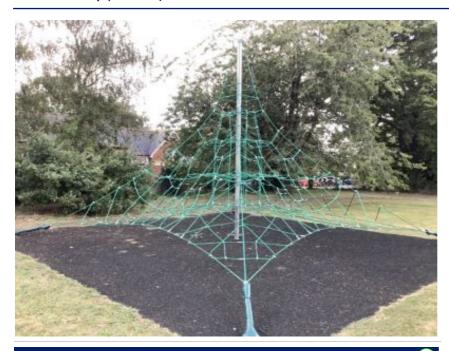
# **Space Net**

Bolt(s) loose.

Multiple rope connectors have loose and projecting fixings.

Tighten.

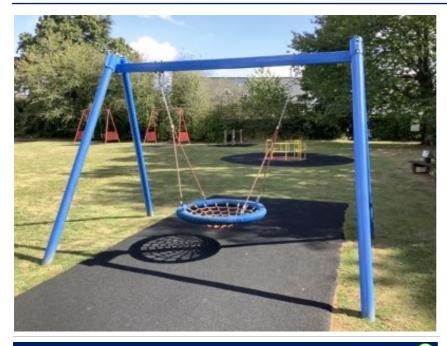
# **Swing - Basket**

There is wear to the surfacing due to foot drag.

Raise seats up to approximately 500 mm to the bottom of the seat. This will help with the dragging of feet on the ground/surfacing.

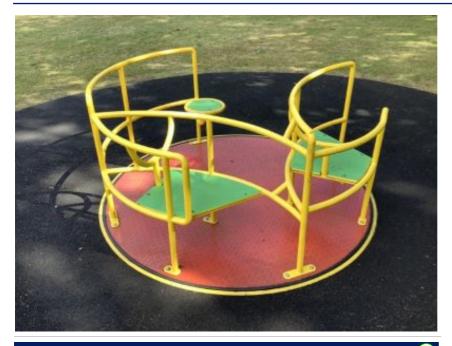
# **Carousel - Flush**

Bearings require service.

Rattling when in use.

Service the bearings.

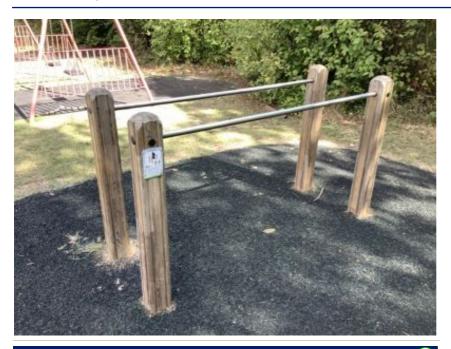
# **Agility - Parallel Bars**

Bolt(s) loose.

Slightly loose bar.

Tighten.

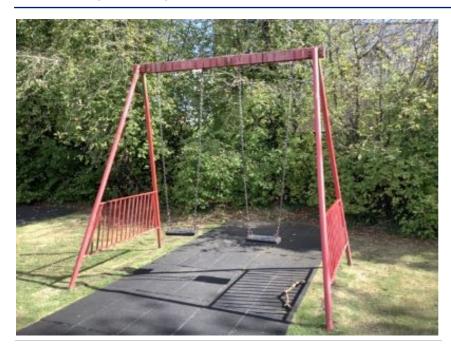
# Swing - Junior - 1 Bay 2 Seat

The item is not compliant with the requirements of the relevant standards. The surfacing meets with the requirements of the relevant standards.

Loose swing seat eye-bolts.

Shackle locking pin projecting creating potential scraping injuries. Remove excess. Seat eye bolts are loose and rotating. Tighten.

Moderate repairs are needed.

Sections of timber edge boarding are missing and decayed. Replace affected areas.

Gaps between the tiles present hazards.

Remove moss from gaps and repair. Surface/the equipment are algae and moss covered, providing a slippery surface when wet.

Chains present that do not conform to the applicable standard.

Tighten connecting nuts., Read the notes for further action.

Replace the missing parts.

Eliminate the gaps., Read the notes for further action.

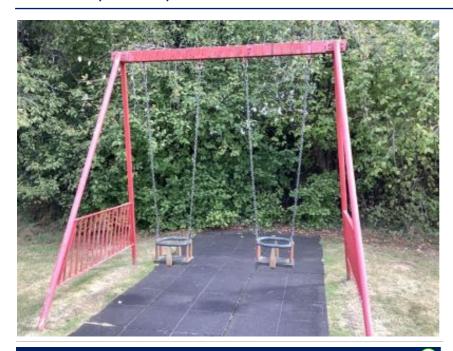
# Swing - Toddler - 1 Bay 2 Seat

There is wear to the top of the cradle(s) leaving exposed metal.

Early signs of wear. Replace when the metal frame is exposed.

Moderate repairs are needed.

Sections of timber edge boarding are missing and decayed. Replace affected areas.

Gaps between the tiles present hazards.

Remove moss and repair. Surface/the equipment are algae and moss covered, providing a slippery surface when wet.

Replace the missing parts.

Eliminate the gaps., Read the notes for further action.

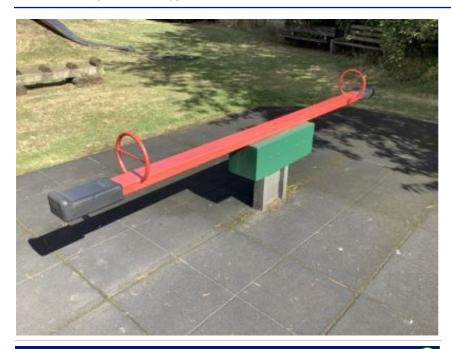
# **Rocker - Seesaw - Gullwing**

Gaps between the tiles present hazards.

Large gaps are present between tiles. Remove moss and repair. Surface/the equipment are algae and moss covered providing a slippery surface when wet.

Eliminate the gaps., Read the notes for further action.

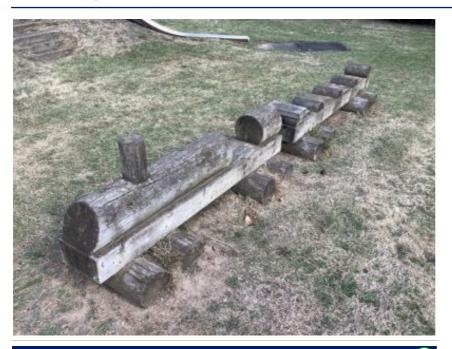
# **Play Train - Log**

Algae growth giving slippery conditions.

Item is not secure.

Logs becoming loose to frames.

Timber is decayed.

Replace all decayed log and frame sections. Replace.

Monitor all timbers throughout the year due to timbers starting to soften.

Powerwashing is recommended. Care should be taken to ensure that the material can sustain high pressure washing.

Secure.

Check on a routine basis., Replace affected parts.

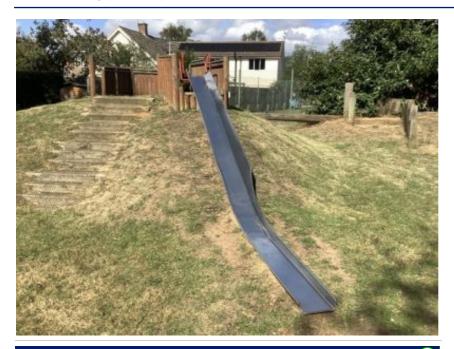
# **Slide - Embankment - With Tower**

Chicken wire on access steps are damaged and lifting creating scraping injuries. Remove and consider alternative anti-slip methods such as paints.

Gaps between the tiles present hazards.

Timber is decayed.

Multiple access step sleepers are decayed on tops and hollow. Replace affected timbers

Barrier posts and verticals around slide are decayed through at ground level and loose. Replace.

Check on a routine basis., Replace affected parts.

Replace missing barrier slats.

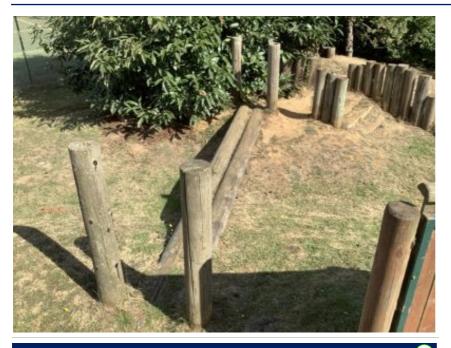
# **Agility - Bridge**

Timber is decayed.

Several post tops are decayed through on tops and at ground level. Consider replacing. Replace missing logs.

Access steps leading to bridge section are decayed. Replace.

Beams on bridge are decaying on tops. Monitor and replace when necessary.

Check on a routine basis., Replace affected parts., We recommend resistance penetration testing to determine the internal condition of the timber. We can undertake this testing at additional cost. Please contact us for details.

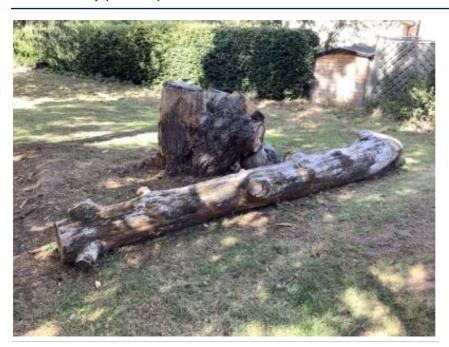
## **Natural Play - Tree**

Our inspector recommends removing the bark from the logs due to the bark creating sharp edges and projections.

Timber is decayed.

Tree logs and stumps are decaying and splintered. Replace/remove entirely. Logs are decayed through at ground level and loose. Secure/replace.

Check on a routine basis., Replace affected parts.

Eliminate the hazard.

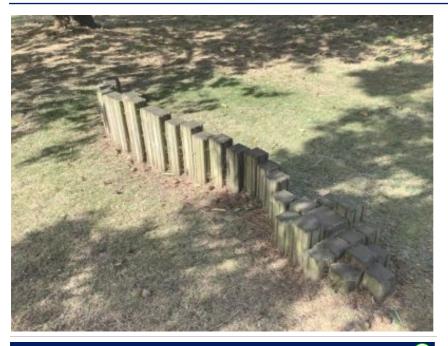
## **Agility - Stepping Posts**

Strimmer damage is present on posts, allowing water to enter and timbers to soften. It can also remove the protective envelope around the timber. Prevent further damage and check timbers for decay throughout the year.

Prevent further damage.
