TPO application DC/21/1460/TPO

High River View, Cliff Road, Waldringfield

This refers to trees T7 oak and T8 sweet chestnut, granted tpo status under the order no.191,2005

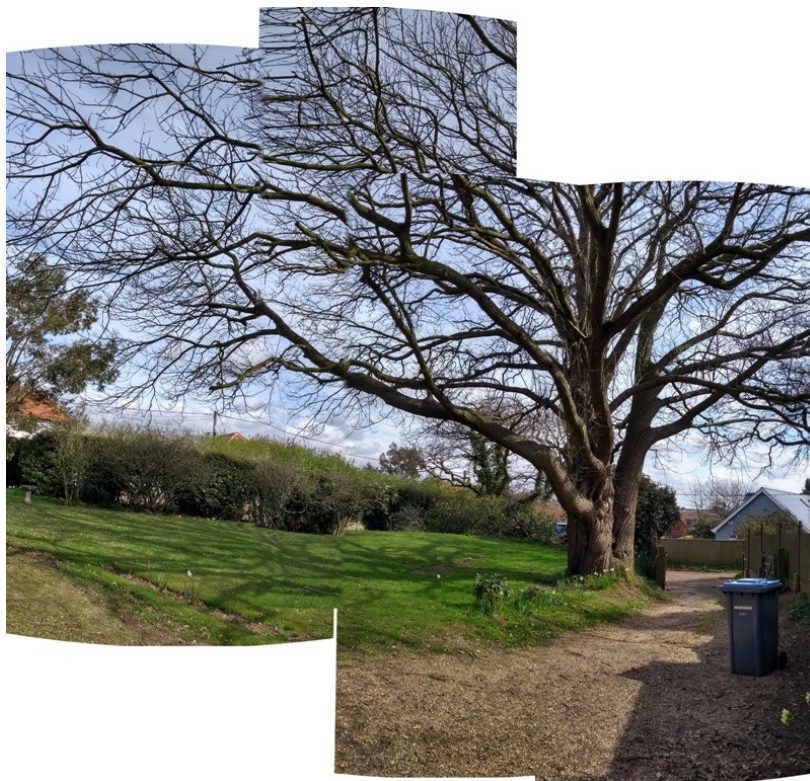
Sweet Chestnut Tree T8 (Veteran tree)

This is a very grand tree with a massive bole. It also has no low branches from the trunk although some of the lower ones are quite long and sweep down giving the tree an interesting shape.

There are a lot of vertical water shoots which are a sign of stress – they might be 2-3 years old. The owner tells me that these are to be removed although this is not mentioned in the application.

In conversation with the owner she did not appear to want the lower branches removed except where they are dead. Removal of dead wood would tidy the tree

up and possible shortening of the very longest branches one of which stretches towards the house.

Again reduction by 30% seems unnecessary once the dead wood and any rubbing or crossing branches are removed the tree is a good shape.

To summarise I would only support removal of dead wood and water shoots on T8 and up to 10% removal of weak or crossing branches. On T7 the oak I would say remove dead wood and crossing branches with restraint and definitely not a reduction of branch length all over.
