Annual Inspection

Suffolk Coastal & Waveney Norse

Waldringfield Play Area

Inspection Ref: 365051

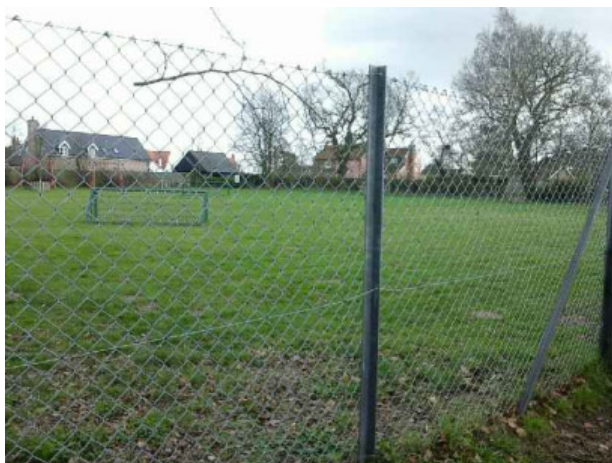
Item: Ancillary Items - Fence - Chainlink
Manufacturer: Owner/Operator
Surface Type: Grass
Equipment Compliance: N/A
Surface Area Compliance: N/A
Ref/Part Number:
Total Findings: 1

This item is satisfactory - no work required

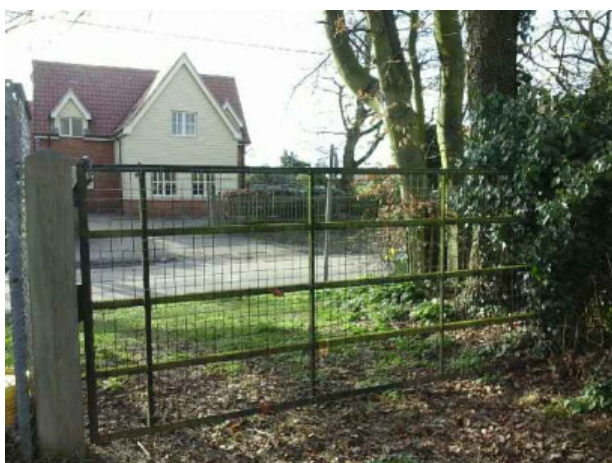
Item: Ancillary Items - Gate - Maintenance
Manufacturer: Not Identified
Surface Type: Grass
Equipment Compliance: N/A
Surface Area Compliance: N/A
Ref/Part Number:
Total Findings: 1

This item is satisfactory - no work required

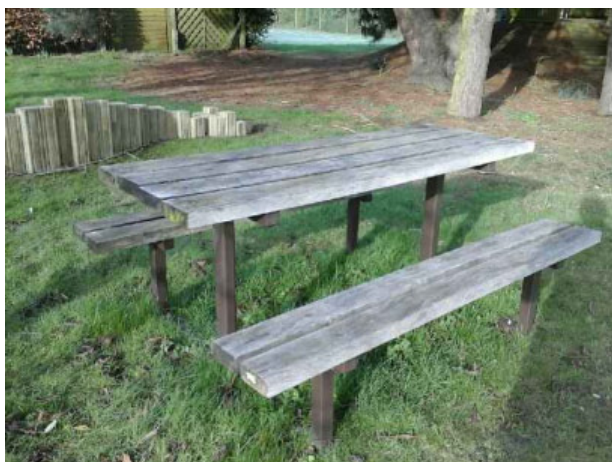
Item: Ancillary Items - Picnic Table
Manufacturer: Owner/Operator
Surface Type: Grass
Equipment Compliance: N/A
Surface Area Compliance: N/A
Ref/Part Number:
Total Findings: 1

This item is satisfactory - no work required

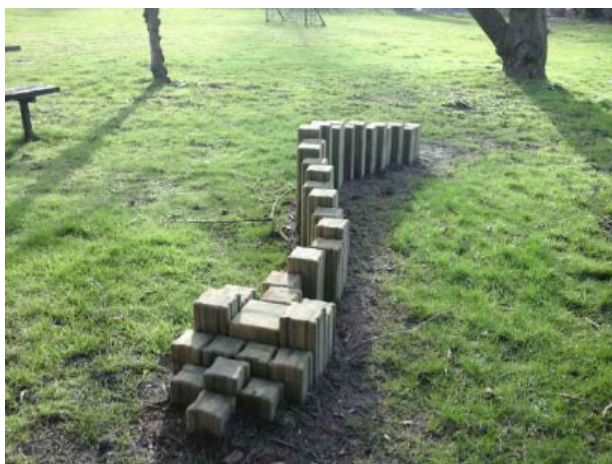
Item: Activity Equipment - Stepping Stones
Manufacturer: Not Identified
Surface Type: Grass
Equipment Compliance: Yes
Surface Area Compliance: Yes
Ref/Part Number:
Total Findings: 1

This item is satisfactory - no work required

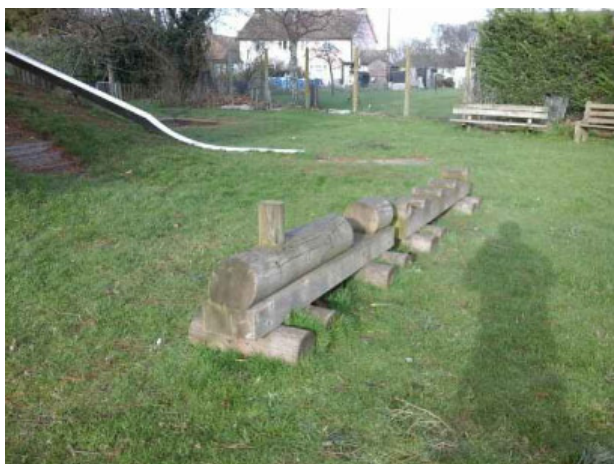
Item: Activity Equipment - Train
Manufacturer: Not Identified
Surface Type: Grass
Equipment Compliance: Yes
Surface Area Compliance: Yes
Ref/Part Number:
Total Findings: 1

This item is satisfactory - no work required

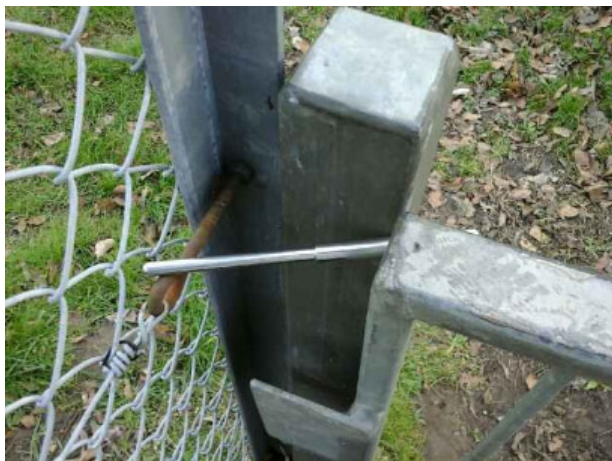
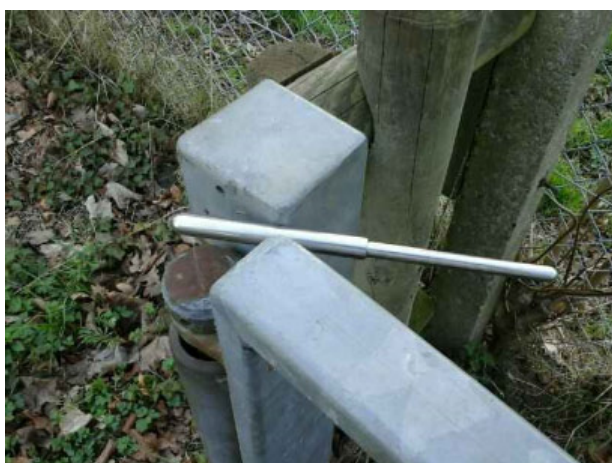
Item: Ancillary Items - Gate - Self Closing
Manufacturer: Not Identified

Finding: The opening between the gate and the post is less than 12mm and could trap users fingers
Action: Adjust gate to ensure a 12mm opening all around

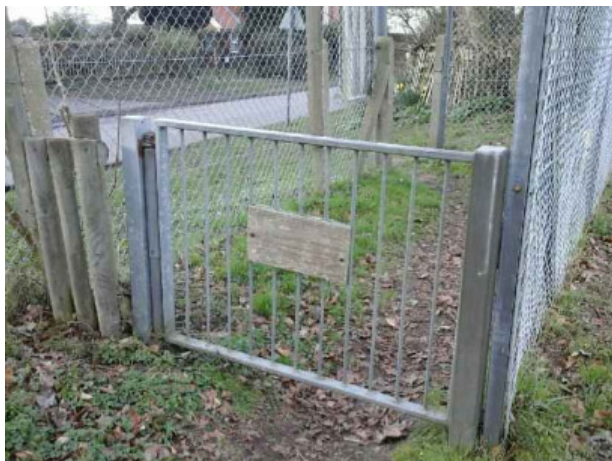
Item: Ancillary Items - Gate - Self Closing
Manufacturer: Not Identified

Finding: The gate is closing too quickly (less than 4 seconds)

Action: Take corrective action to ensure that the gate closes in 4-8 seconds

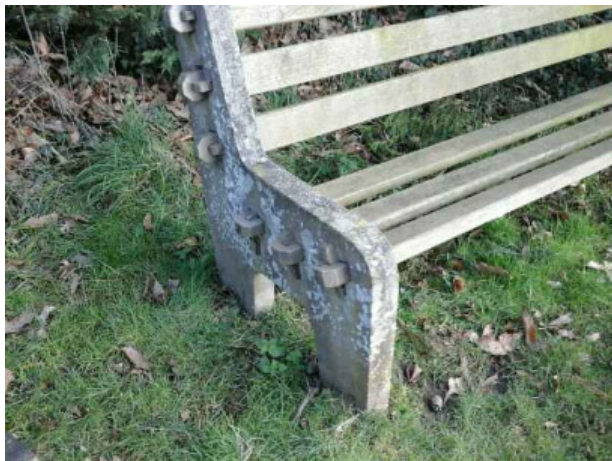
Item: Ancillary Items - Bench
Manufacturer: Owner/Operator

Finding: The bench is not securely fixed to the surface and there is some possibility of the item tipping or rolling over

Action: Secure the bench to the ground

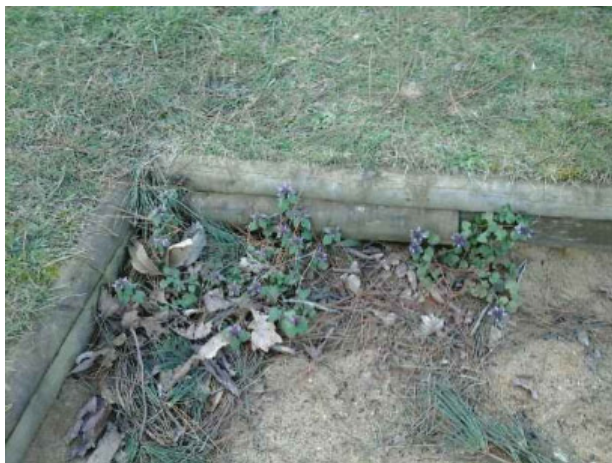
Item: Other - Sand Box
Manufacturer: Owner/Operator

Finding: There are weeds/vegetation growth between or around the edges of the surfacing

Action: Remove weeds/vegetation growth

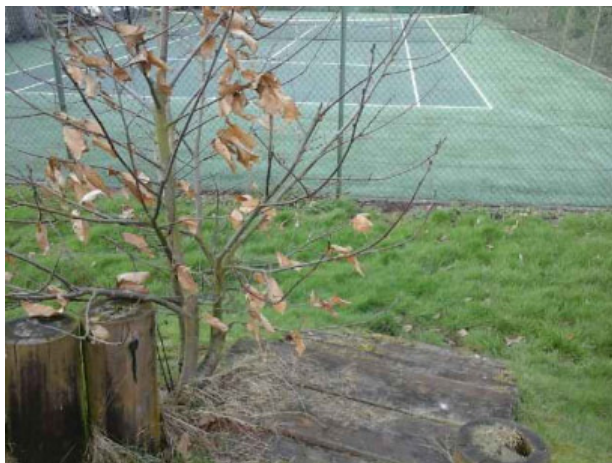
Item: Other - Natural Play Feature
Manufacturer: Not Identified

Finding: The tree canopy overhangs the equipment and is less than 2.0m away

Action: Lift tree canopy to ensure a minimum clearance of 2.0m from the equipment

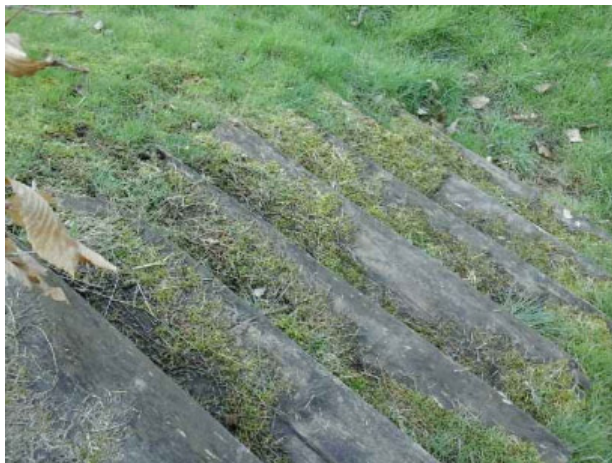
Item: Other - Natural Play Feature
Manufacturer: Not Identified

Finding: There is algae or moss on the surface of the equipment

Action: Clean and treat appropriately

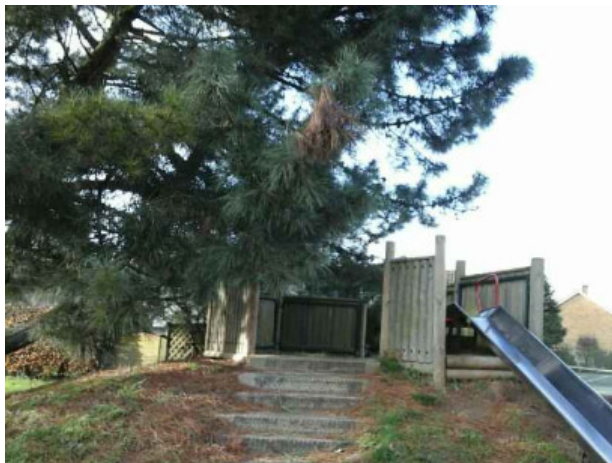
Item: Other - Embankment Slide
Manufacturer: Not Identified

Finding: The tree canopy overhangs the equipment and is less than 2.0m away

Action: Lift tree canopy to ensure a minimum clearance of 2.0m from the equipment

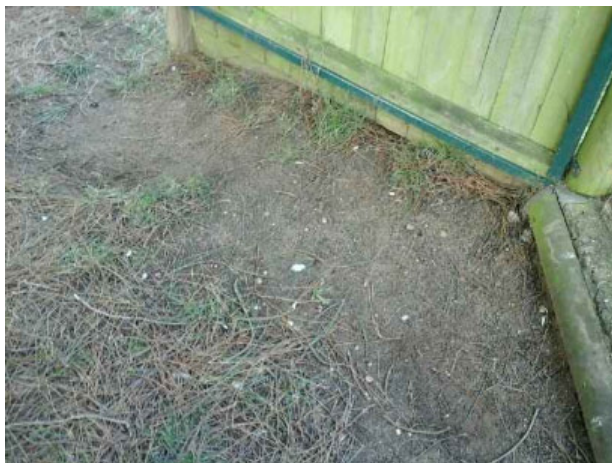
Item: Other - Embankment Slide
Manufacturer: Not Identified

Finding: The surface has eroded in some areas

Action: Reinstate the surface

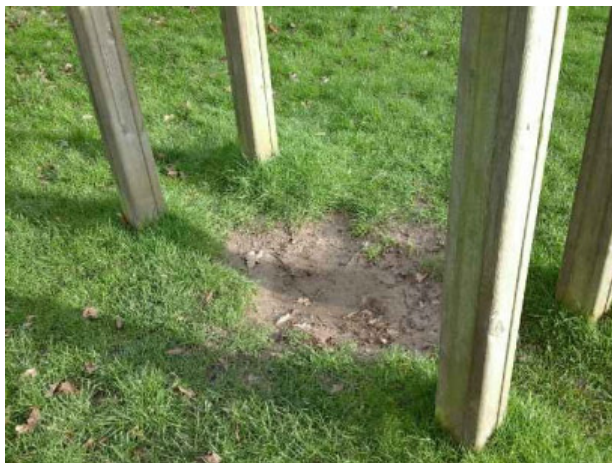
Item: Activity Equipment - Parallel Bars
Manufacturer: Not Identified

Finding: The surface has eroded in some areas

Action: Reinstate the surface
