Annual Inspection

Suffolk Coastal & Waveney Norse

Waldringfield Play Area

Annual Inspection - 03 May 2018 at 15:50 Inspector: David Fagan (RPII Outdoor Annual Inspector)

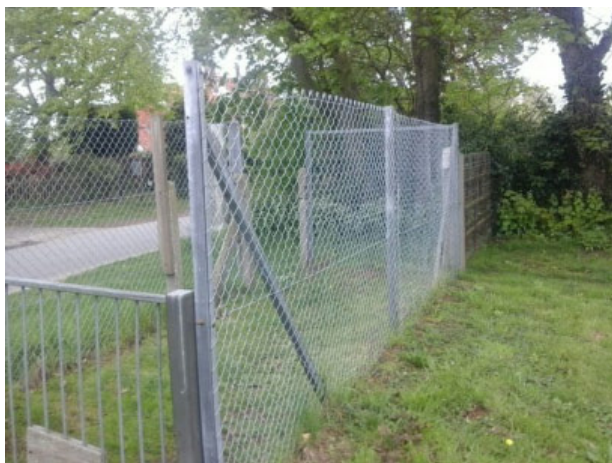
Item: Ancillary Items - Fence - Chainlink
Manufacturer: Owner/Operator
Surface Type: Grass
Equipment Compliance: N/A
Surface Area Compliance: N/A
Ref/Part Number:
Total Findings: 1

This item is satisfactory - no work required

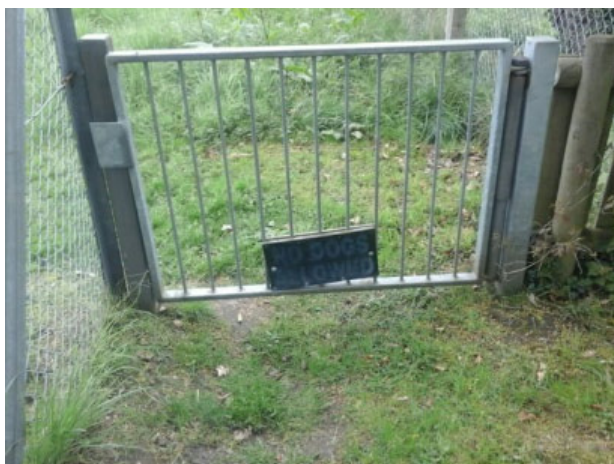
Item: Ancillary Items - Gate - Self Closing
Manufacturer: Not Identified
Surface Type: Grass
Equipment Compliance: N/A
Surface Area Compliance: N/A
Ref/Part Number:
Total Findings: 3

The opening between the gate and the post is less than 12mm and could trap users fingers - Adjust gate to ensure a 12mm opening all around

The area under the gate has eroded leaving uneven areas, or the concrete foundations exposed, resulting in trip hazards at the entrance/exit to the playground - Reinstate to level with surrounding surfaces

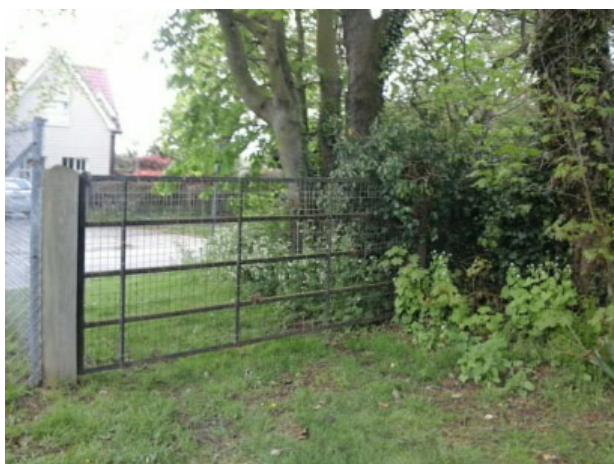
Item: Ancillary Items - Gate - Maintenance
Manufacturer: Not Identified
Surface Type: Grass
Equipment Compliance: N/A
Surface Area Compliance: N/A
Ref/Part Number:
Total Findings: 1

This item is satisfactory - no work required

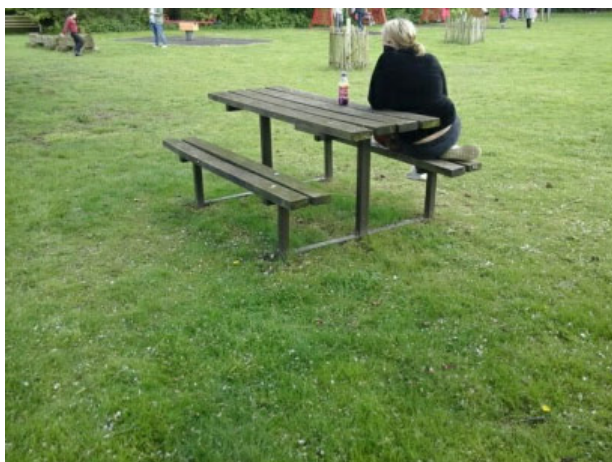
Item: Ancillary Items - Picnic Table
Manufacturer: Owner/Operator
Surface Type: Grass
Equipment Compliance: N/A
Surface Area Compliance: N/A
Ref/Part Number:
Total Findings: 1

There is algae or moss on the surface of the table - Clean and treat appropriately

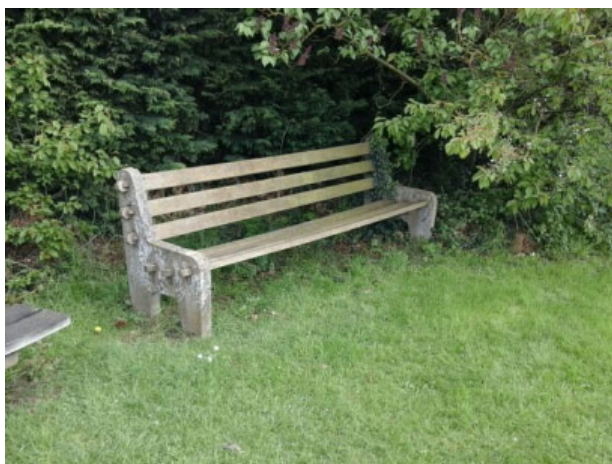
Item: Ancillary Items - Bench
Manufacturer: Owner/Operator
Surface Type: Grass
Equipment Compliance: N/A
Surface Area Compliance: N/A
Ref/Part Number:
Total Findings: 1

The adjacent foliage is overhanging - Cut back and maintain

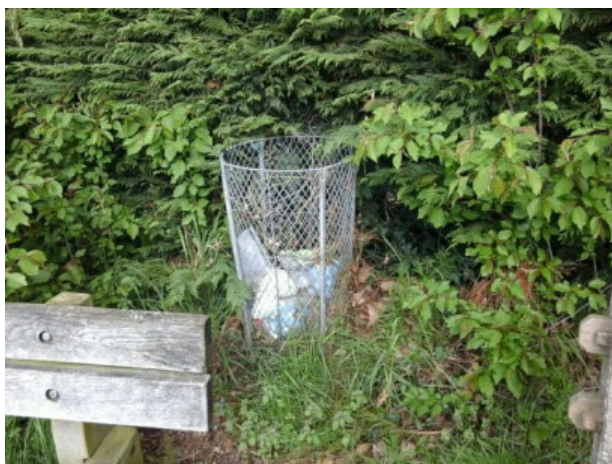
Item: Ancillary Items - Litter Bin
Manufacturer: Owner/Operator
Surface Type: Grass
Equipment Compliance: N/A
Surface Area Compliance: N/A
Ref/Part Number:
Total Findings: 2

The bin is not securely fixed to the surface and there is some possibility of the item tipping or rolling over - Secure the bin to the ground

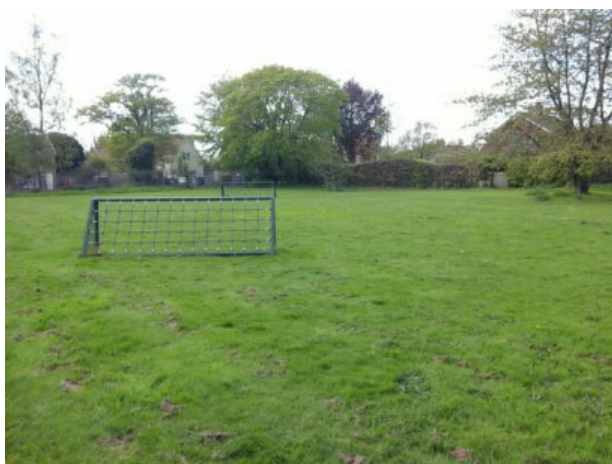
Item: Ancillary Items - Site General
Manufacturer: Owner/Operator
Surface Type: N/A
Equipment Compliance: N/A
Surface Area Compliance: N/A
Ref/Part Number:
Total Findings: 1

This item is satisfactory - no work required

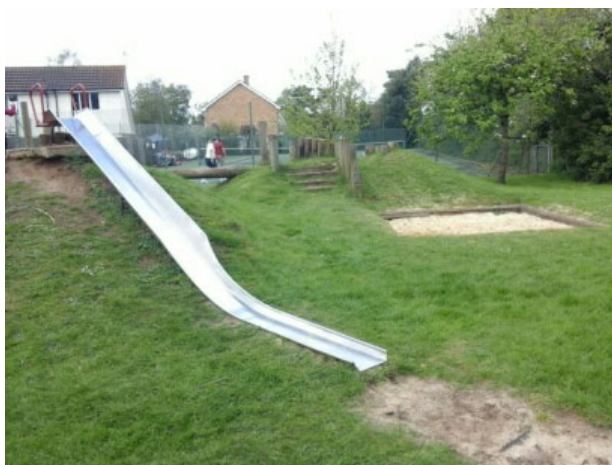
Item: Other - Embankment Slide
Manufacturer: Not Identified
Surface Type: Grass
Equipment Compliance: No
Surface Area Compliance: Yes
Ref/Part Number:
Total Findings: 6

There is a large amount of sand on the surface - Clean and maintain

The exposed foundations and steps form a hard object within the falling space of the equipment in contravention of the requirements of BS EN 1176 Part 1 - Reinstate the surface to cover the foundations and monitor the use of the steps

There are areas or parts of the timber on the structure that have rotted - Replace all affected timbers

Parts of the steel on this item have corroded excessively and the metal has perforated in places - Ensure all affected areas are treated and repaired

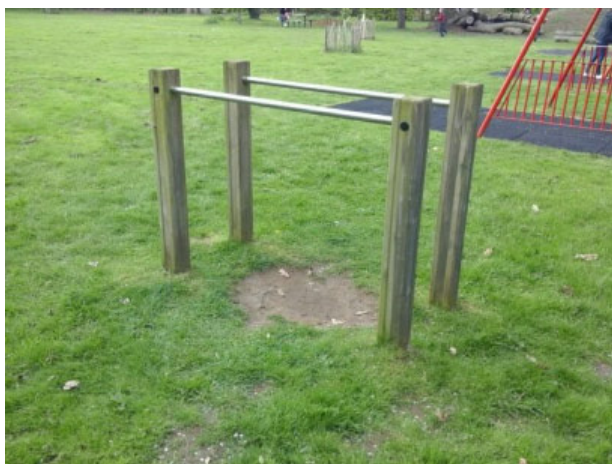
Item: Activity Equipment - Parallel Bars
Manufacturer: Not Identified
Surface Type: Grass
Equipment Compliance: Yes
Surface Area Compliance: Yes
Ref/Part Number:
Total Findings: 3

The surface has eroded in some areas - Reinstate the surface

There is some evidence of rot in the timber - Monitor for any further deterioration and replace as required

There is some strimmer damage apparent on the posts, this can penetrate the preservative applied to the timber and accelerate the rotting process - Monitor for any deterioration (rot) and replace as required

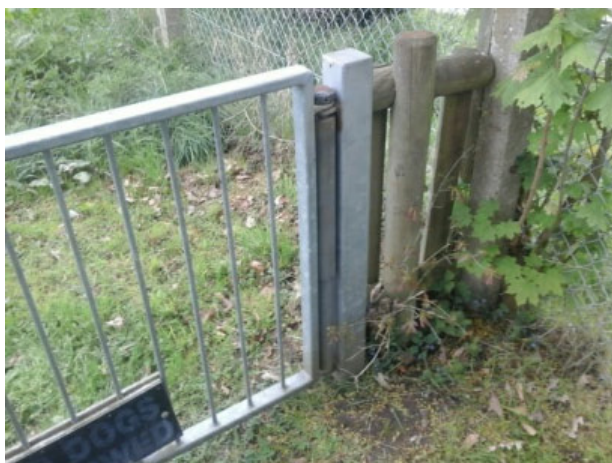
Item: Ancillary Items - Gate - Self Closing
Manufacturer: Not Identified

Finding: The gate is closing too quickly (less than 4 seconds)

Action: Take corrective action to ensure that the gate closes in 4-8 seconds

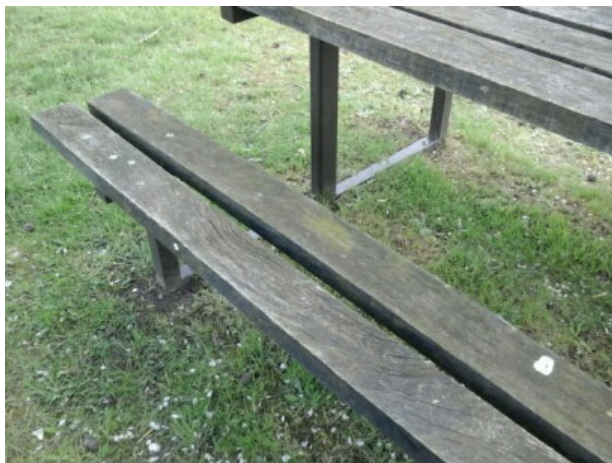
Item: Ancillary Items - Picnic Table
Manufacturer: Owner/Operator

Finding: There is algae or moss on the surface of the table

Action: Clean and treat appropriately

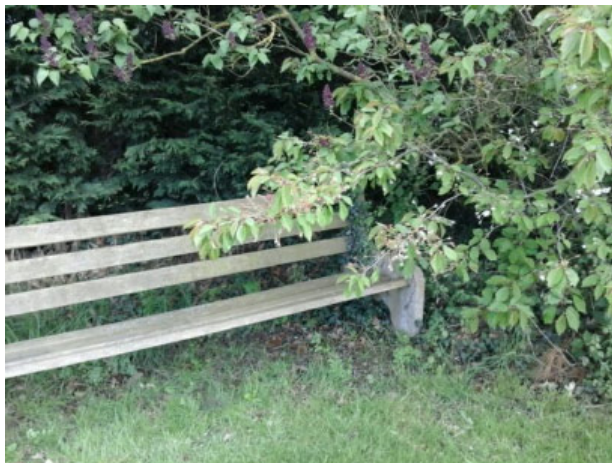
Item: Ancillary Items - Bench
Manufacturer: Owner/Operator

Finding: The adjacent foliage is overhanging

Action: Cut back and maintain

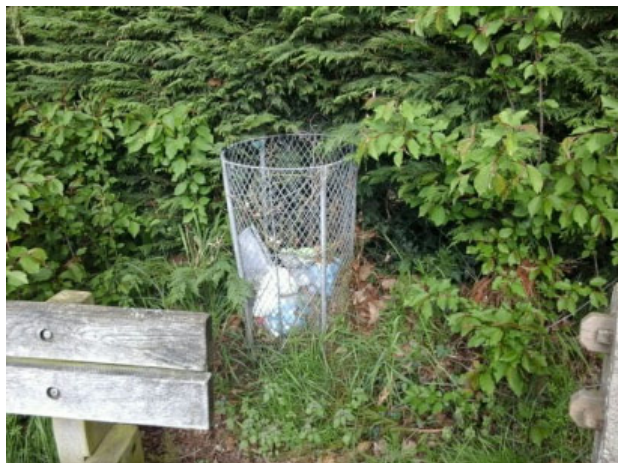
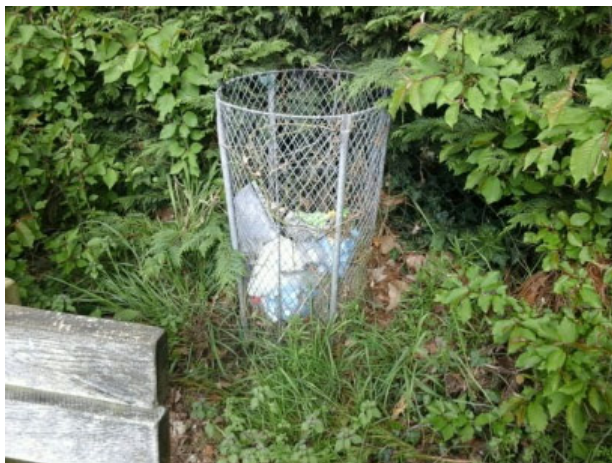
Item: Ancillary Items - Litter Bin
Manufacturer: Owner/Operator

Finding: The bin is not securely fixed to the surface and there is some possibility of the item tipping or rolling over

Action: Secure the bin to the ground

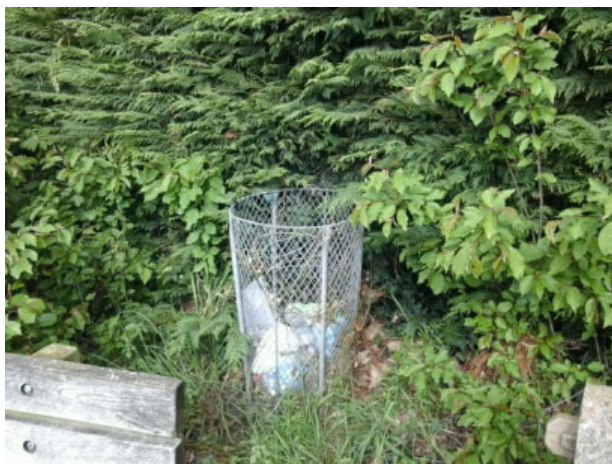
Item: Ancillary Items - Litter Bin
Manufacturer: Owner/Operator

Finding: The adjacent foliage is overhanging

Action: Cut back and maintain

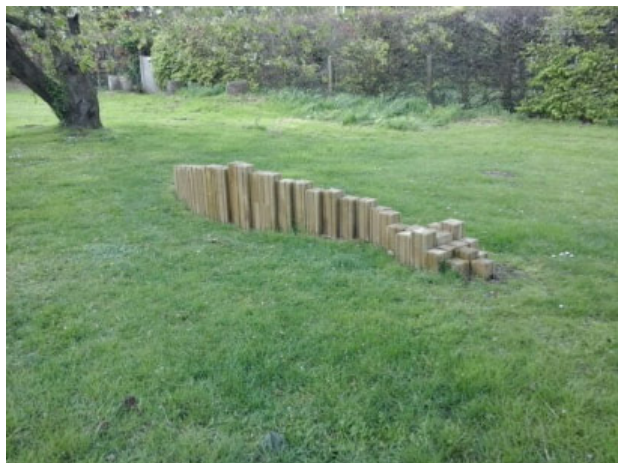
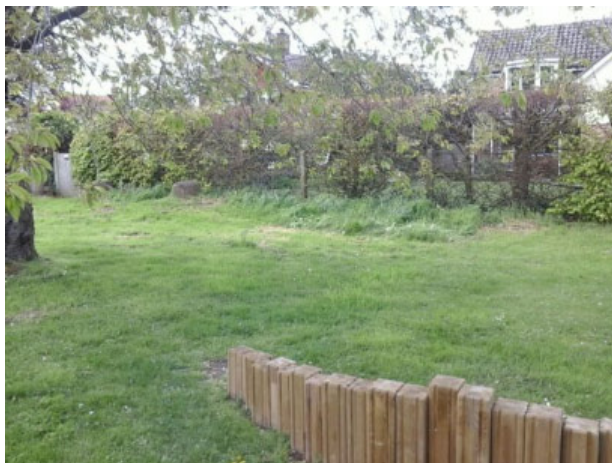
Item: Activity Equipment - Stepping Stones
Manufacturer: Not Identified

Finding: The tree canopy overhangs the equipment and is less than 2.0m away

Action: Lift tree canopy to ensure a minimum clearance of 2.0m from the equipment

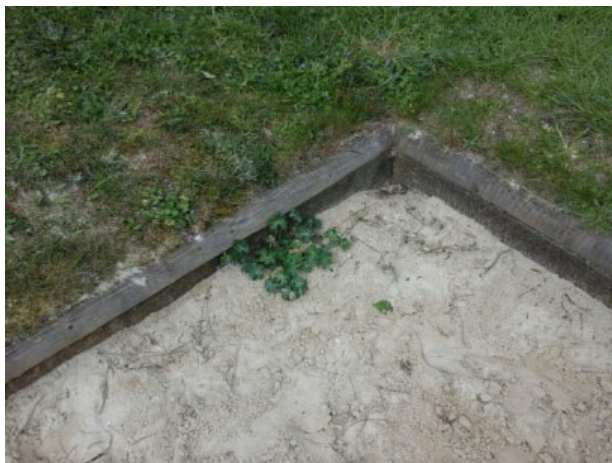
Item: Other - Sand Box
Manufacturer: Owner/Operator

Finding: There are weeds/vegetation growth between or around the edges of the surfacing

Action: Remove weeds/vegetation growth

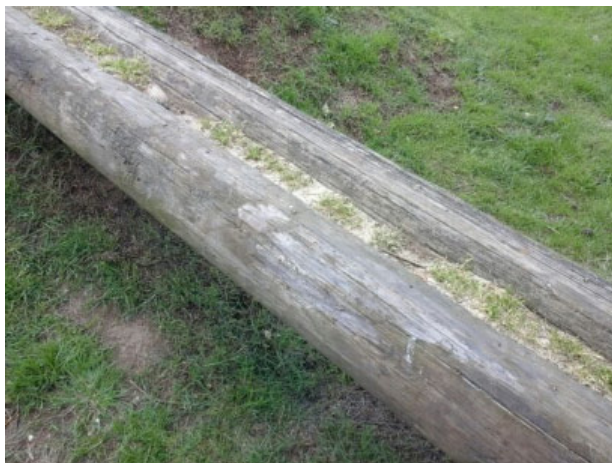
Item: Other - Natural Play Feature
Manufacturer: Not Identified

Finding: Parts of the timber are rough or splintered

Action: Remove all rough or sharp edges

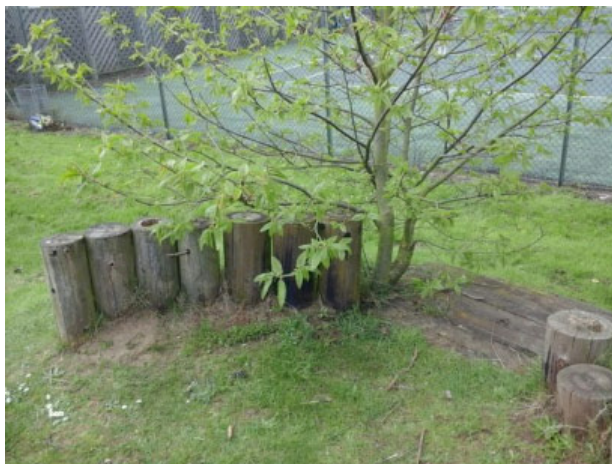
Item: Other - Natural Play Feature
Manufacturer: Not Identified

Finding: The tree canopy overhangs the equipment and is less than 2.0m away

Action: Lift tree canopy to ensure a minimum clearance of 2.0m from the equipment

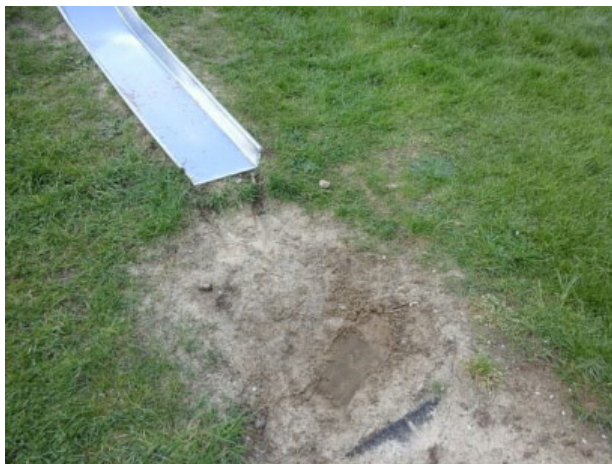
Item: Other - Embankment Slide
Manufacturer: Not Identified

Finding: There is a large amount of sand on the surface

Action: Clean and maintain

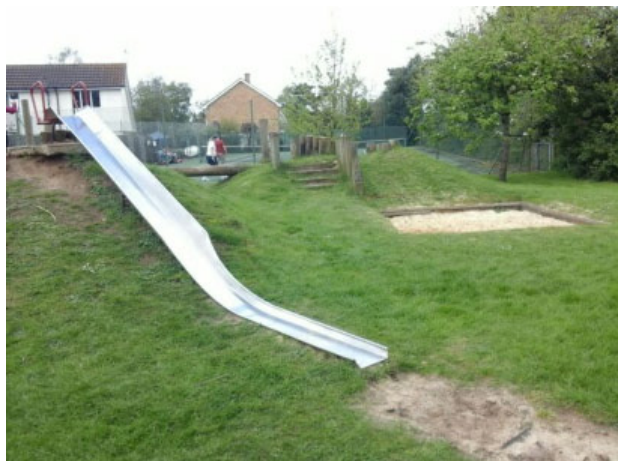
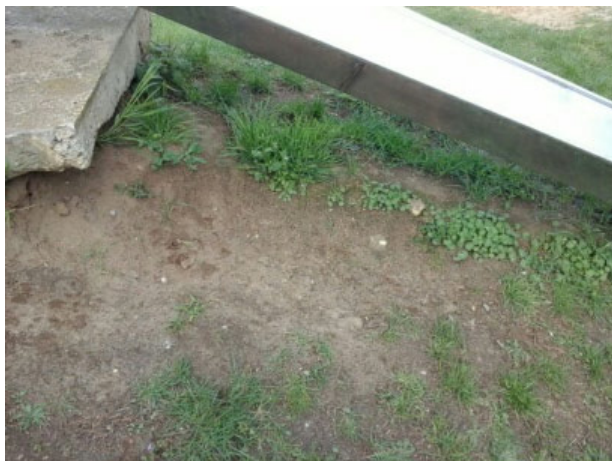
Item: Other - Embankment Slide
Manufacturer: Not Identified

Finding: The surface has eroded beside the slide

Action: Reinstate the surface

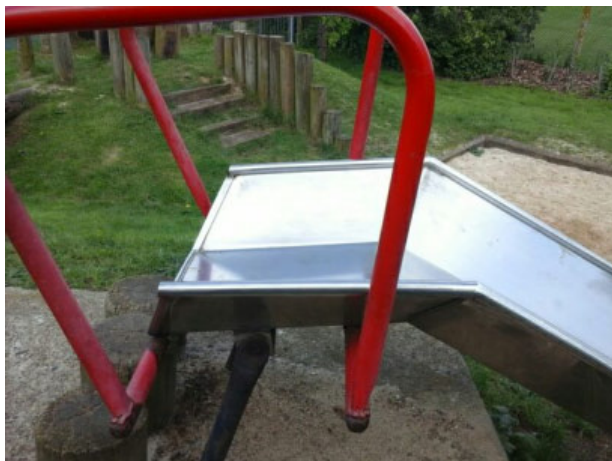
Item: Other - Embankment Slide
Manufacturer: Not Identified

Finding: The slide start section incline is not in the direction of travel; it should slope towards the direction of the sliding surface

Action: Monitor use

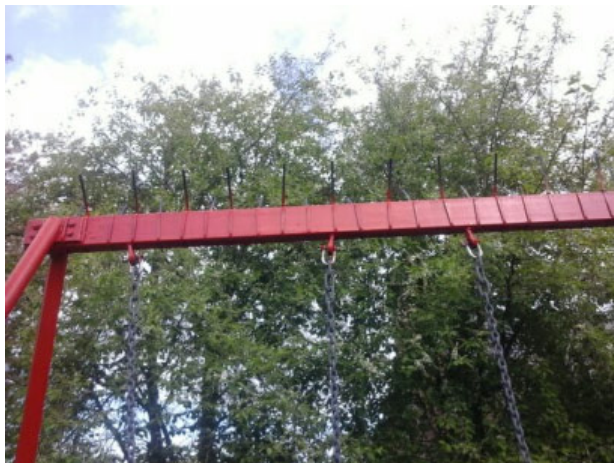
Item: Swings - 1 Bay 2 Seat (Cradle)
Manufacturer: Playquip

Finding: There are cable ties present on the crossbar

Action: Remove the cable ties

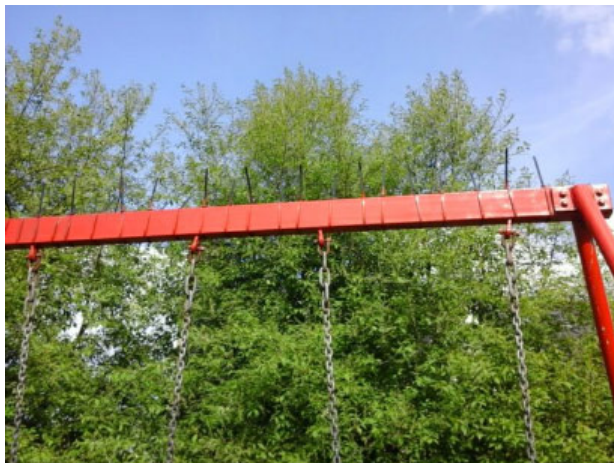
Item: Swings - 1 Bay 2 Seat (Flat)
Manufacturer: Playquip

Finding: There are cable ties present on the crossbar

Action: Remove the cable ties

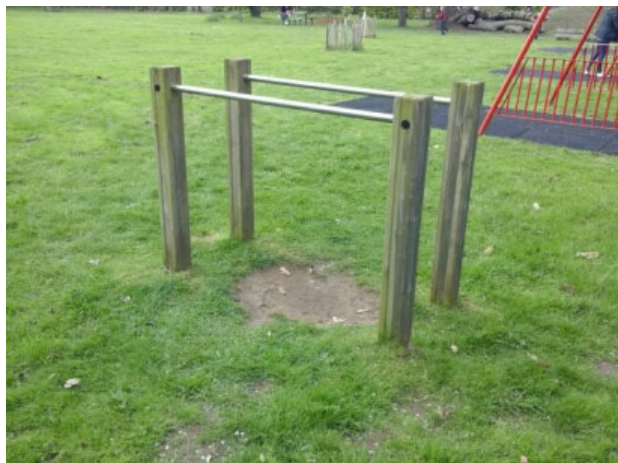
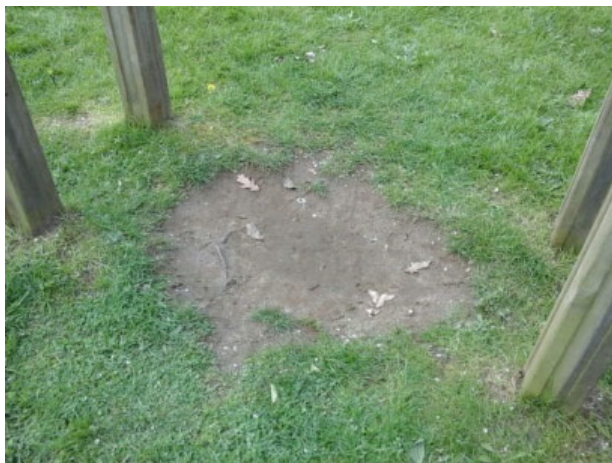
Item: Activity Equipment - Parallel Bars
Manufacturer: Not Identified

Finding: The surface has eroded in some areas

Action: Reinstate the surface
