Annual Inspection

Waldringfield Play Area

Inspection Ref: 877279

Inspected: 15 July 2019 at 09:24 Inspector: Alan Lingley RPII Annual Inspector

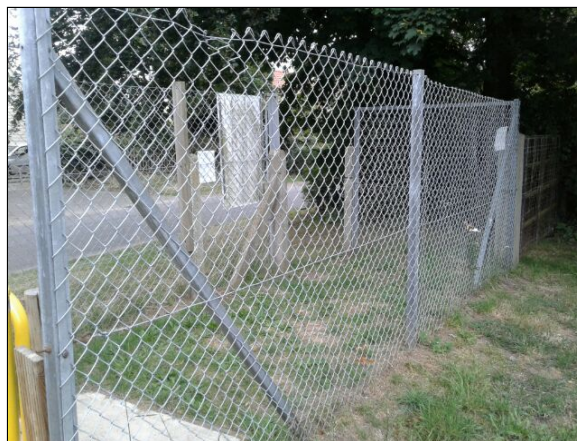
Item: Ancillary Items - Fence - Chainlink
Manufacturer: Owner/Operator
Comments

There are projecting bolt thread(s) present Remove excess thread length and deburr or provide cap

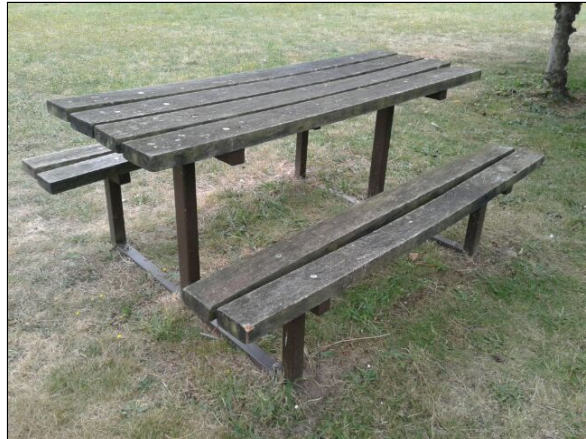
Item: Ancillary Items - Bench
Manufacturer: Owner/Operator
Comments

The adjacent foliage is overhanging Cut back and maintain

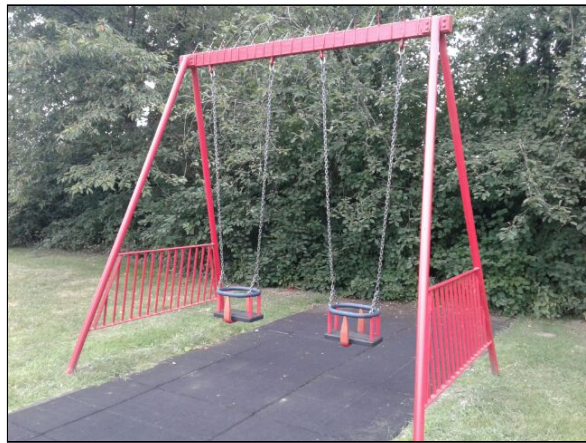
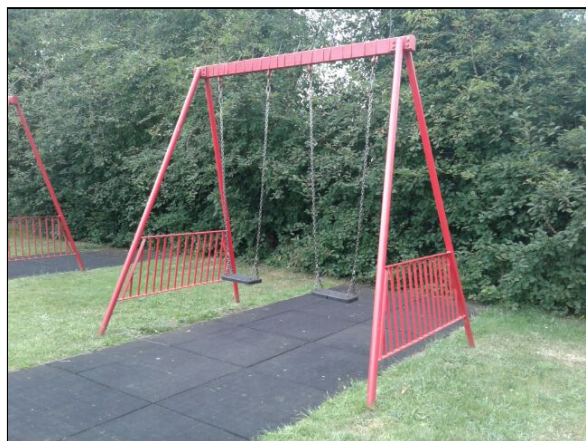
There are cable ties present on the crossbar Remove the cable ties

The hedge is overgrown Cut back and maintain

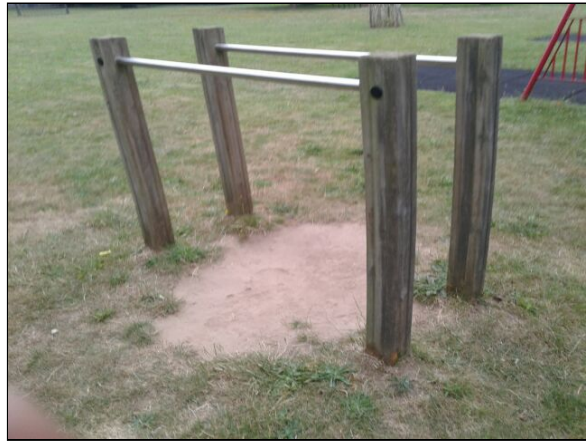
There is some strimmer / machinery damage apparent on the posts, this can penetrate the preservative applied to the timber and accelerate the rotting process Monitor for any deterioration (rot) and replace as required

The surface has eroded in some areas Reinststate the surface

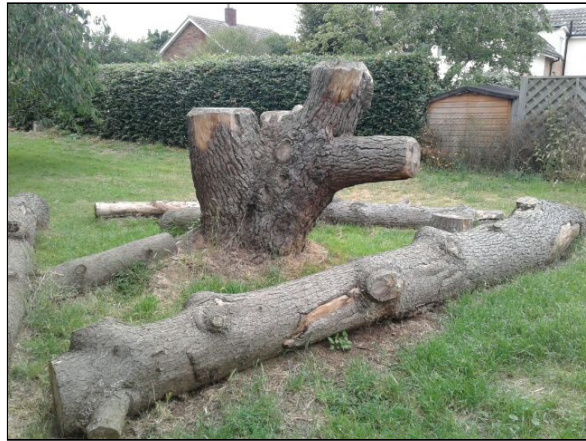
The lower logs forms a hard object within the impact area of the equipment in contravention of the requirements of BS EN 1176 Part 1 Remove all logs away from the equipment

Due to the dimensions of the timber it was not possible to ascertain the condition of the timber at its core without further testing. We recommend a Resi-PD survey to establish the condition of the timber at its core. Contact the Play Inspection Company office for further information

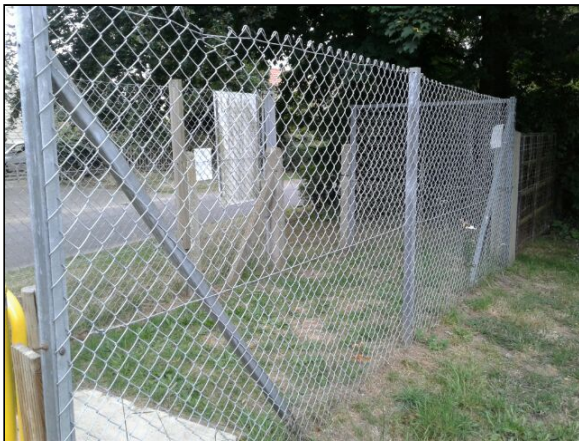
Item: Ancillary Items - Fence - Chainlink
Manufacturer: Owner/Operator

Finding: There are projecting bolt thread(s) present

Action: Remove excess thread length and deburr or provide cap

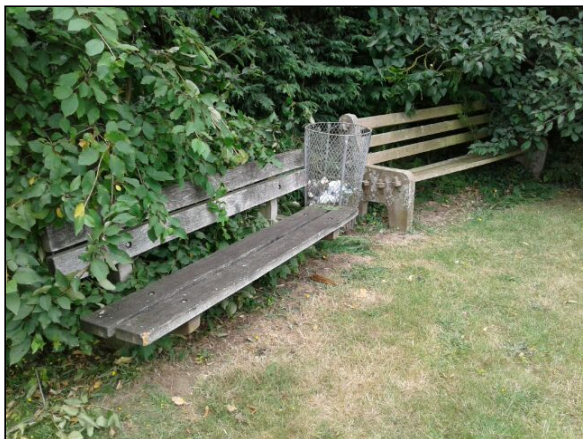
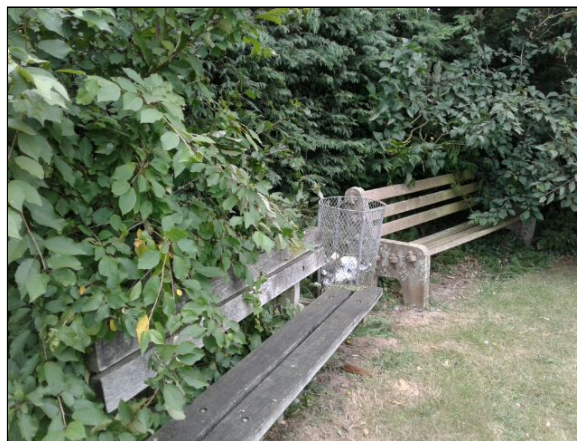
Item: Ancillary Items - Bench
Manufacturer: Owner/Operator

Finding: The adjacent foliage is overhanging
Action: Cut back and maintain

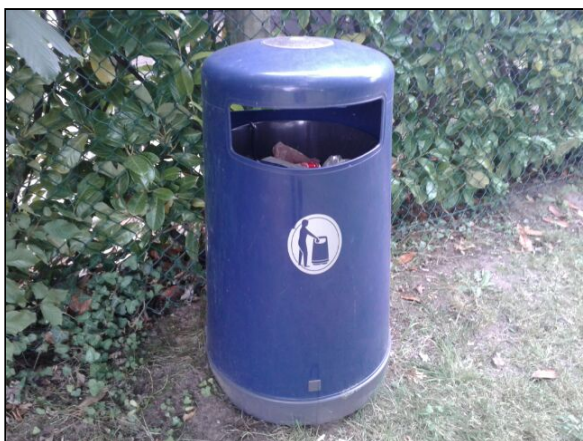
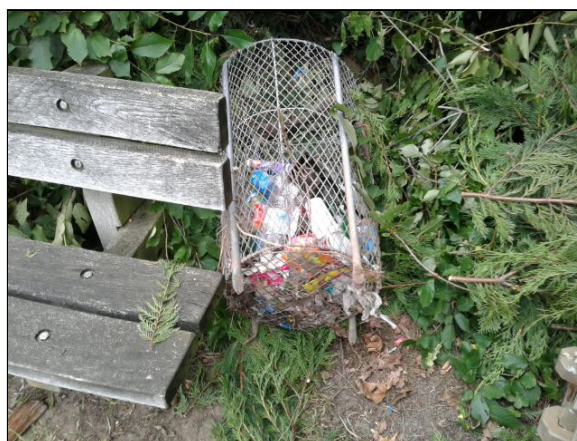
Item: Ancillary Items - Litter Bin
Manufacturer: Owner/Operator

Finding: The bin is not securely fixed to the surface and there is some possibility of the item tipping or rolling over
Action: Secure the bin to the ground

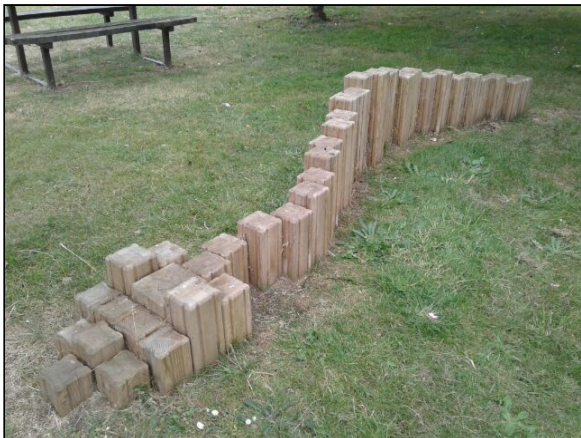
Item: Activity Equipment - Stepping Stones
Manufacturer: Not Identified

Finding: The tree canopy overhangs the equipment and is less than 2.0m away
Action: Lift tree canopy to ensure a minimum clearance of 2.0m from the equipment

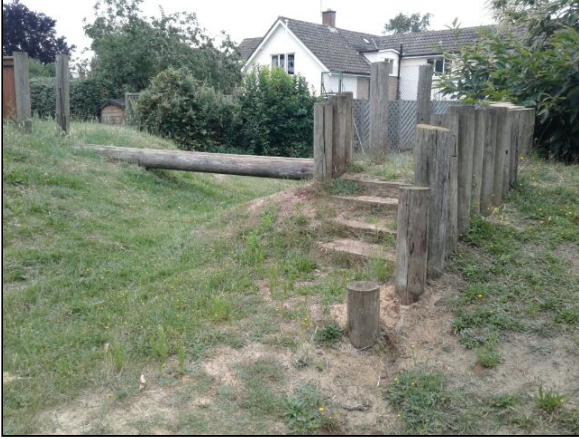
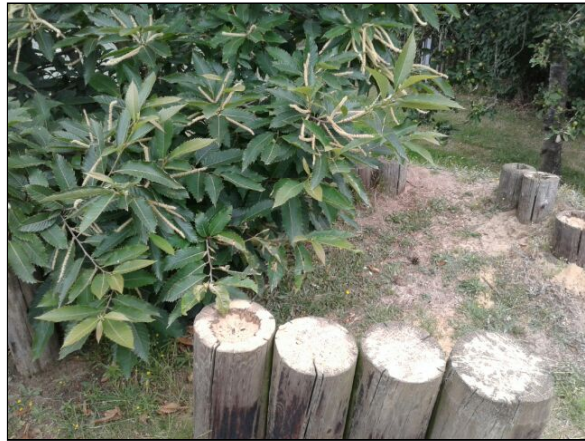
Item: Other - Natural Play Feature
Manufacturer: Not Identified

Finding: The tree canopy overhangs the equipment and is less than 2.0m away
Action: Lift tree canopy to ensure a minimum clearance of 2.0m from the equipment

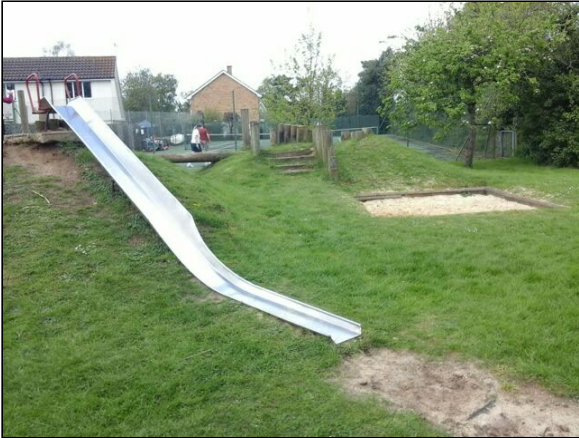
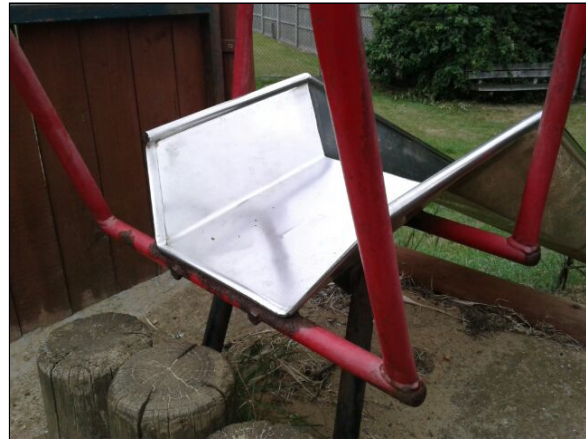
Item: Other - Embankment Slide
Manufacturer: Not Identified

Finding: The slide start section incline is not in the direction of travel; it should slope towards the direction of the sliding surface
Action: Monitor use

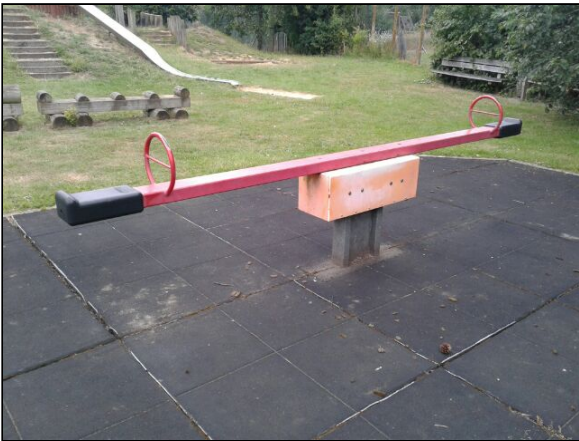
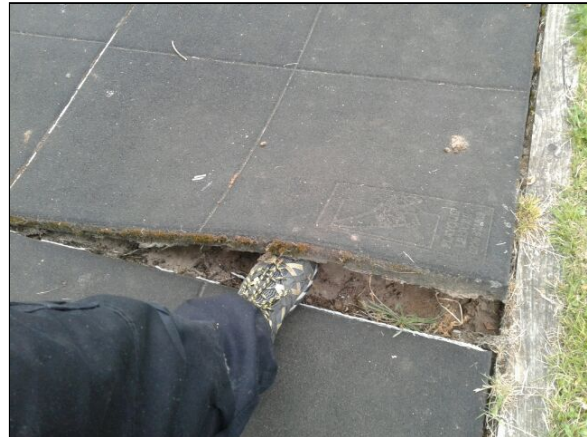
Item: Rocking Equipment - See Saw
Manufacturer: GL Jones

Finding: The tiles can easily be lifted or are lifting along the edges of the area
Action: Lift and re-glue tiles to secure

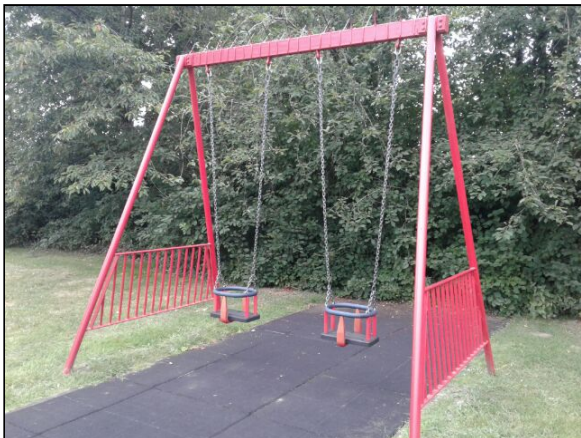
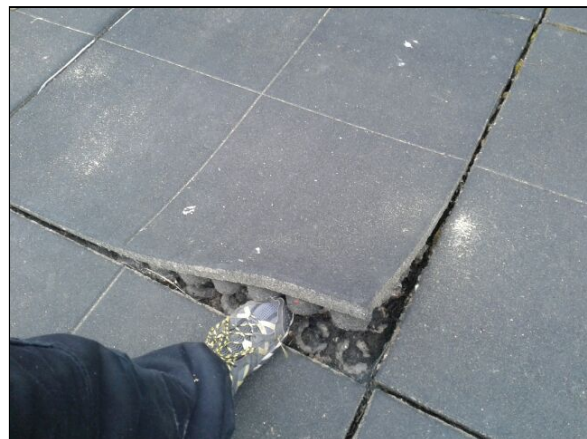
Item: Swings - 1 Bay 2 Seat (Cradle)
Manufacturer: Playquip

Finding: The tiles can easily be lifted or are lifting along the edges of the area
Action: Lift and re-glue tiles to secure

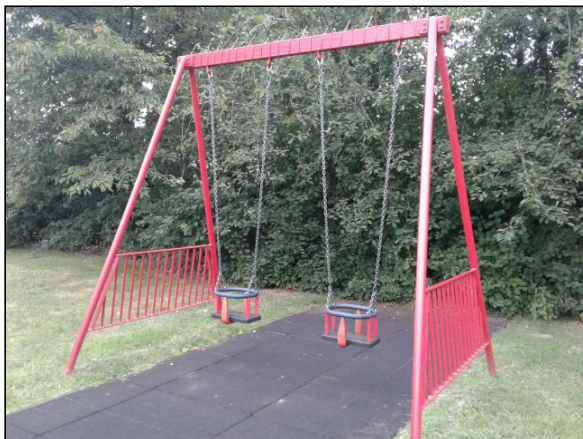
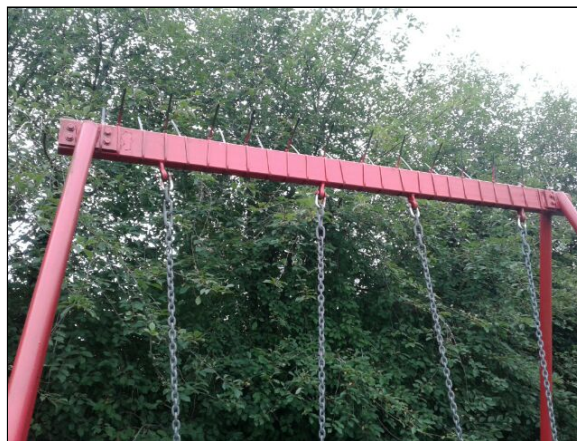
Item: Swings - 1 Bay 2 Seat (Cradle)
Manufacturer: Playquip

Finding: There are cable ties present on the crossbar
Action: Remove the cable ties

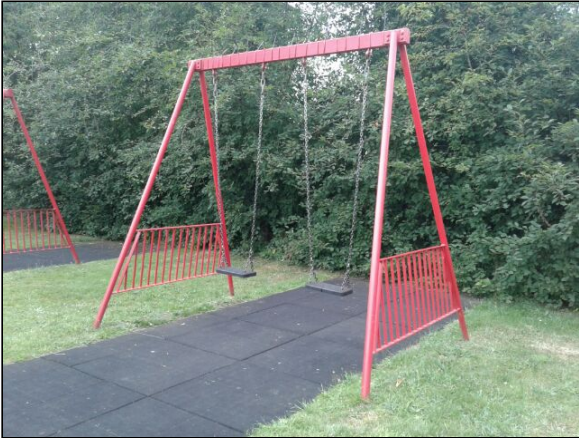
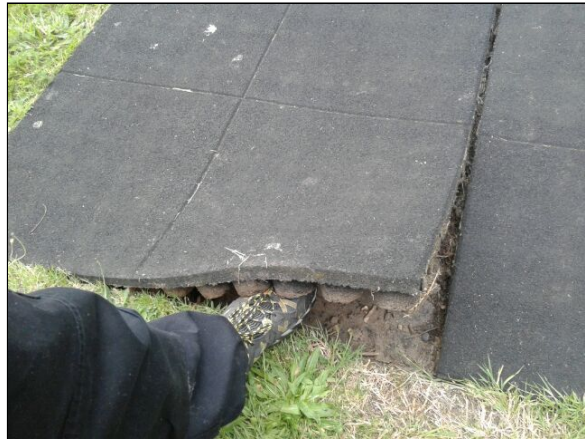
Item: Swings - 1 Bay 2 Seat (Flat)
Manufacturer: Playquip

Finding: The tiles can easily be lifted or are lifting along the edges of the area
Action: Lift and re-glue tiles to secure

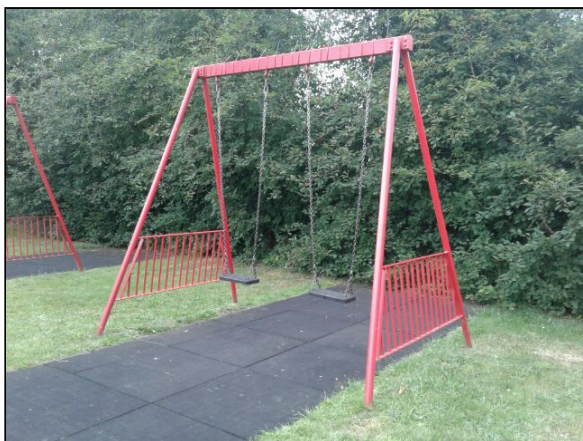
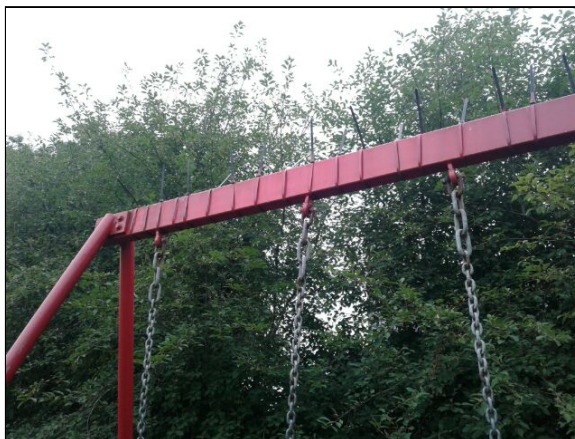
Item: Swings - 1 Bay 2 Seat (Flat)
Manufacturer: Playquip

Finding: There are cable ties present on the crossbar

Action: Remove the cable ties

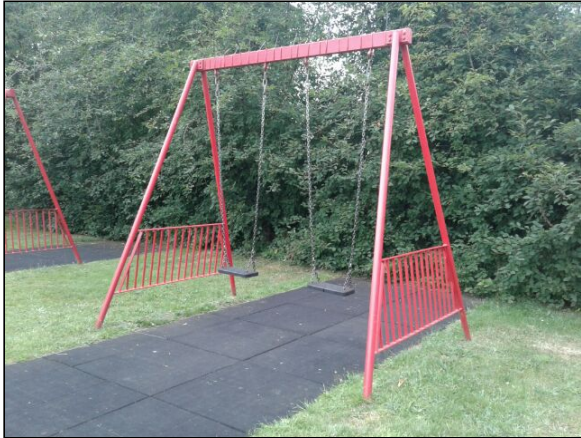
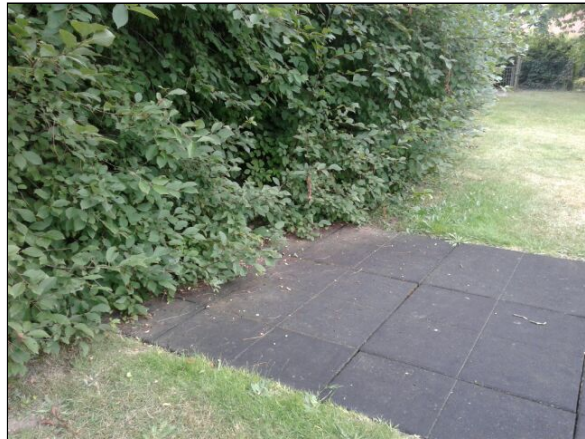
Item: Swings - 1 Bay 2 Seat (Flat)
Manufacturer: Playquip

Finding: The hedge is overgrown
Action: Cut back and maintain

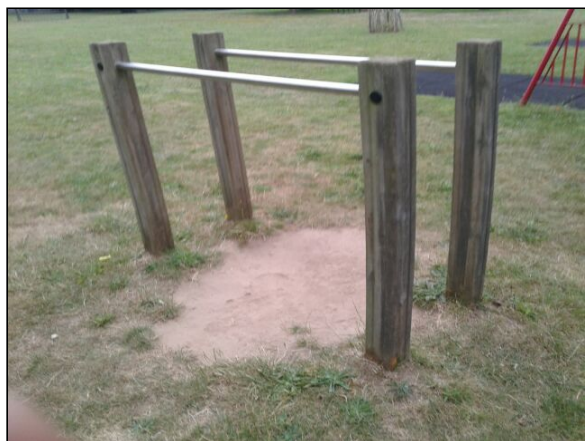
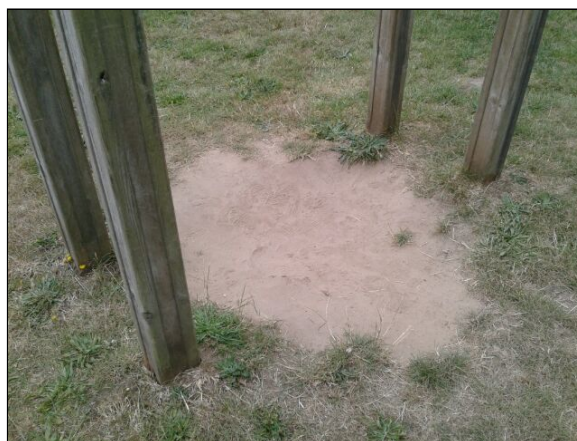
Item: Activity Equipment - Parallel Bars
Manufacturer: Not Identified

Finding: The surface has eroded in some areas
Action: Reinstate the surface

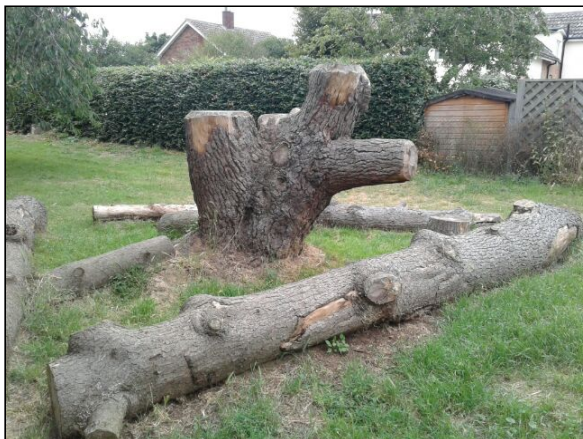
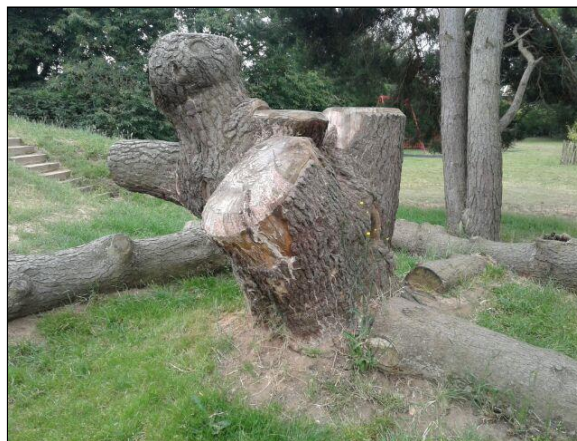
Item: Other - Natural Play Feature
Manufacturer: Natural Feature

Finding: The item of equipment has a fall height exceeding 1.50 metres and grass has been provided as a safety surface
Action: Provide a suitable impact attenuating surface

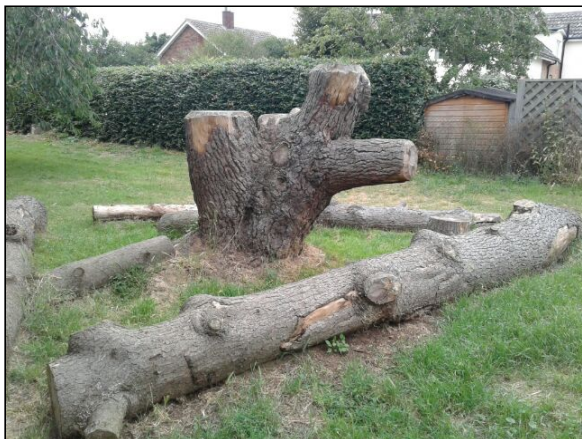
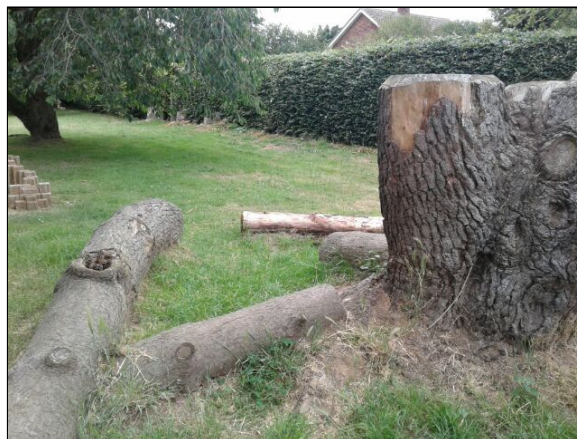
Item: Other - Natural Play Feature
Manufacturer: Natural Feature

Finding: The lower logs forms a hard object within the impact area of the equipment in contravention of the requirements of BS EN 1176 Part 1
Action: Remove all logs away from the equipment
