the **play inspection** company  
*the safest hands around playgrounds*

**Annual Inspection**

East Suffolk Norse

Cliff Road Waldringfield

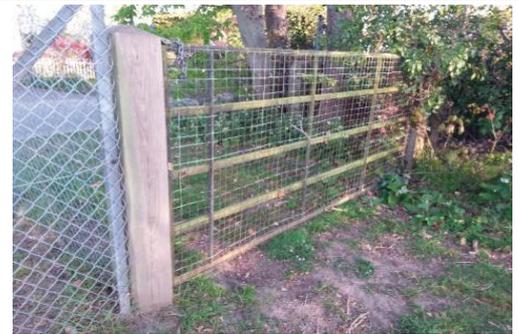
**Item:** Gate - Maintenance  
**Manufacturer:** Not Identified  
**Surface Type:** Grass  
**Item Quantity:** 1  
**Equipment Compliance:** N/A  
**Surface Area Compliance:** N/A

There are areas or parts of the timber slamming post that have rotted - Replace all affected timbers

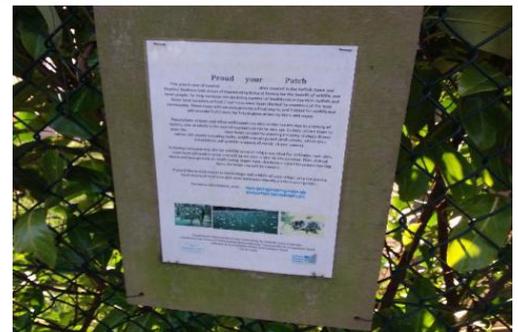
**Item:** Sign  
**Manufacturer:** Owner/Operator  
**Surface Type:** N/A  
**Item Quantity:** 1  
**Equipment Compliance:** N/A  
**Surface Area Compliance:** N/A

BS EN 1176 recommends that signage, with information including the site address, contact information for maintenance issues and emergency contact details are provided on the playground - Provide in accordance with the recommendations set out in BS EN 1176 Part 7

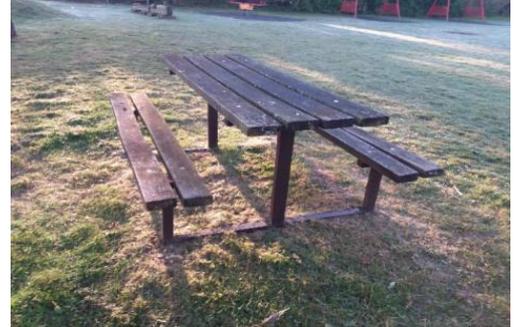
**Item:** Picnic Table  
**Manufacturer:** Owner/Operator  
**Surface Type:** Grass  
**Item Quantity:** 1  
**Equipment Compliance:** N/A  
**Surface Area Compliance:** N/A

There is algae or moss on the surface of the table - Clean and treat appropriately

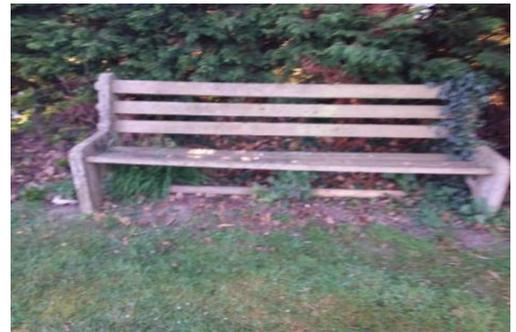
**Item:** Bench  
**Manufacturer:** Owner/Operator  
**Surface Type:** Grass  
**Item Quantity:** 2  
**Equipment Compliance:** N/A  
**Surface Area Compliance:** N/A

The adjacent foliage is overhanging the bench - Cut back and maintain

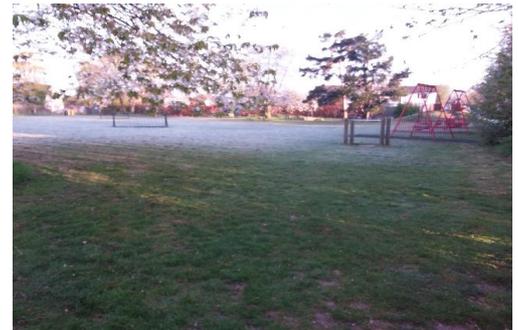
**Item:** Site General  
**Manufacturer:** Owner/Operator  
**Surface Type:** N/A  
**Item Quantity:** 1  
**Equipment Compliance:** N/A  
**Surface Area Compliance:** N/A

There are gaps opening in between the tiles - Repair as required

There is algae or moss growth on the safety surface resulting in slippery conditions - Clean and treat appropriately

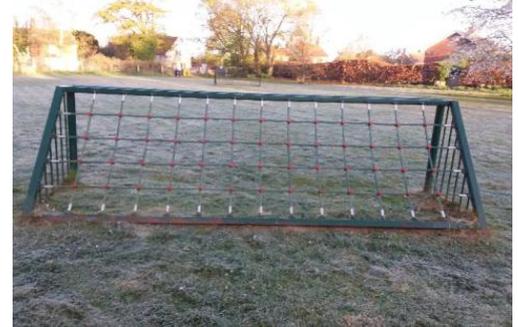
**Item:** 5 a side Goals  
**Manufacturer:** Not Identified  
**Surface Type:** Grass  
**Item Quantity:** 2  
**Equipment Compliance:** Yes  
**Surface Area Compliance:** N/A

The paintwork on this item has been damaged or worn exposing the metal underneath which is rusting - Treat any rusting components and repaint

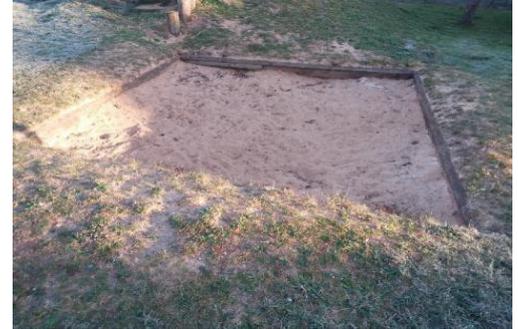
**Item:** Sand Box  
**Manufacturer:** Owner/Operator  
**Surface Type:** Sand  
**Item Quantity:** 1  
**Equipment Compliance:** N/A  
**Surface Area Compliance:** N/A

There are areas or parts of the timber edging boards that have rotted - Replace all affected timbers

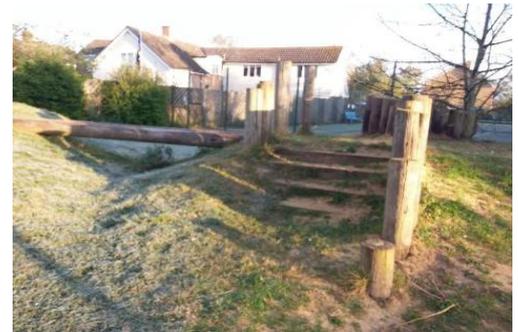
**Item:** Bridge  
**Manufacturer:** Not Identified  
**Surface Type:** Grass  
**Item Quantity:** 1  
**Equipment Compliance:** Yes  
**Surface Area Compliance:** Yes

The timber throughout this item has severe rot - Remove and replace all affected timber sections

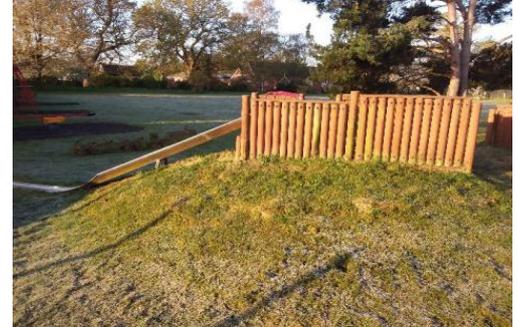
**Item:** Embankment Slide  
**Manufacturer:** Not Identified  
**Surface Type:** Grass  
**Item Quantity:** 1  
**Equipment Compliance:** No  
**Surface Area Compliance:** Yes

The timber has a number of splits/shakes or air cracks and this may affect the stability or allow water ingress which will accelerate the rotting process - Monitor to ensure the splits do not cross through fixing points of the structure and/or cause any instability

The slide start section incline is not in the direction of travel; it should slope towards the direction of the sliding surface to meet the requirements of BS EN 1176 Part 3 - Monitor - No remedial work recommended

The paintwork on this item has been damaged or worn exposing the metal underneath which is rusting - Treat any rusting components and repaint

There are areas or parts of the timber stepping stones that have rotted - Replace all affected timbers

There are areas or parts of the timber steps that have rotted - Replace all affected timbers

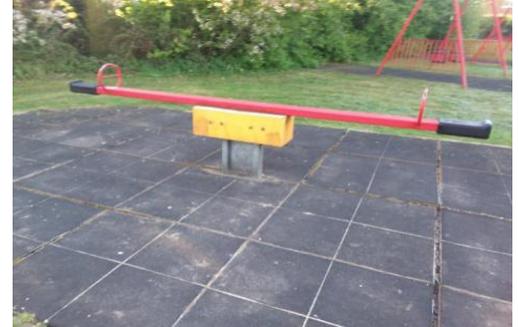
**Item:** See Saw  
**Manufacturer:** GL Jones  
**Surface Type:** Rubber Tiles  
**Item Quantity:** 1  
**Equipment Compliance:** Yes  
**Surface Area Compliance:** Yes

The paintwork on this item has been damaged or worn exposing the metal underneath which is rusting - Treat any rusting components and repaint

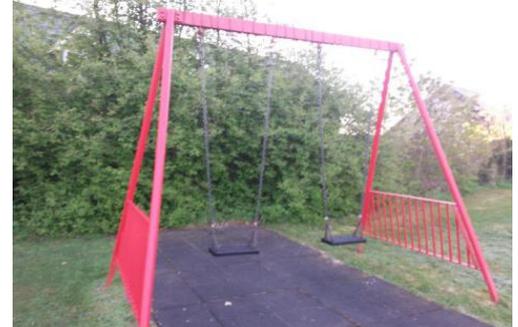
**Item:** 1 Bay 2 Seat (Flat)  
**Manufacturer:** Playquip  
**Surface Type:** Rubber Tiles  
**Item Quantity:** 1  
**Equipment Compliance:** No  
**Surface Area Compliance:** No

The surfacing width under each seat is less than 1.75 metres and fails the requirements of BS EN 1176 Part 2 - Monitor - No remedial work recommended

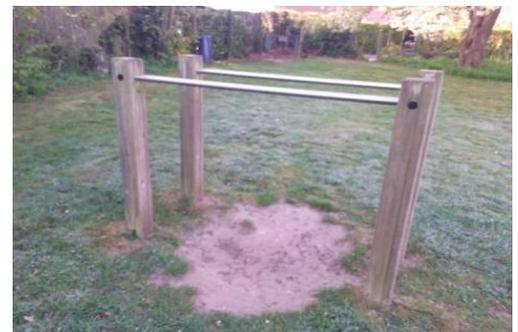
**Item:** Parallel Bars  
**Manufacturer:** Not Identified  
**Surface Type:** Grass  
**Item Quantity:** 1  
**Equipment Compliance:** Yes  
**Surface Area Compliance:** Yes

The area around the item has eroded and may become slippery - Reinststate eroded area

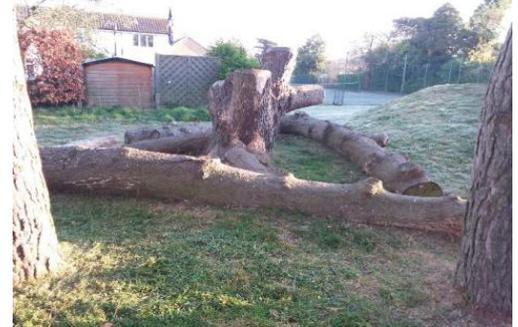
**Item:** Tree Trunk  
**Manufacturer:** Natural Feature  
**Surface Type:** Grass  
**Item Quantity:** 1  
**Equipment Compliance:** N/A  
**Surface Area Compliance:** N/A

There are falls in excess of 600mm between adjacent components on the structure, in contravention of the recommendations set out in BS EN 1176 Part 1; 4.2.8.4 - Monitor - No remedial work recommended
