PLAY AREA SAFETY INSPECTION REPORT

SC Town & Parish Councils

15 February 2016

Site Owner : **SC Town & Parish Councils**
Site Name : Waldringfield PC - Cliff Road
Date of Inspection : 15 February 2016
Inspected by : Bob Wallace

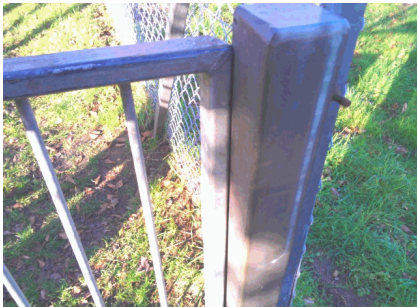
Facilities				
Litter Bins Risk Score : 3 Risk Level : Very Low	Bins	Satisfactory		
Seating x 2 Risk Score : 3 Risk Level : Very Low	Seating	Satisfactory		
Horticulture				
Planting Risk Score : 3 Risk Level : Very Low	Borders	Satisfactory		
Perimeter				
Gates x 3 Risk Score : 3 Risk Level : Very Low	Entrance	<p>Finding : Entrapment on side(s) of gate</p> <p>Finding Date : 15/02/2016</p> <p>Notes : Roadside gate, pinch / crush points.</p>

<p>Task : Adjust gate/posts/fit new rubber buffer to ensure a spacing of at least 12mm throughout the range of the gate to remove the entrapment. The 12 mm gap also should apply on the hinge side of the gate</p>	Medium	8
Site				
Sign - Info Risk Score : 2 Risk Level : Very Low	Signage	<p>Satisfactory</p>

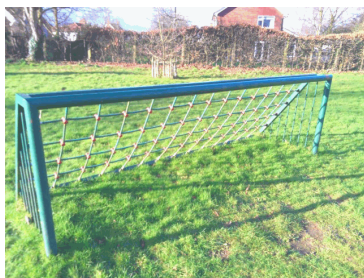
Goal Posts - 5-A-Side

The item fails to meet the requirement of the relevant standard.

Comments, action or control required		Risk Level	Risk Score ‡
Equipment			
Finding :	A warning notice should be fitted to all sports related equipment with the words "Do not climb on the framework or nets", "Do not hang on the ring" (if provided), "Do not wear rings or other jewellery as these can get caught and cause injury"	Low	6
Task :	Fit warning notice		
Surfacing - Grass			
Finding :	Mole Hills	Low	6
Task :	Rake/Dig Over surface		
The overall risk for this item at the time of inspection:		Low	6
‡ For Risk Score see Report Notes

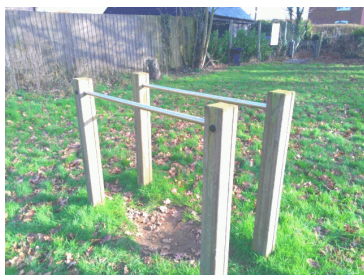
Parallel Bars - Twin

The item meets with the requirements of the relevant standard where this may be tested on site without dismantling or destruction.

Comments, action or control required		Risk Level	Risk Score ‡
Equipment	No remedial maintenance work is required at this time.		
Surfacing - Grass	No remedial maintenance work is required at this time.		
The overall risk for this item at the time of inspection: ‡ For Risk Score see Report Notes		Low	6

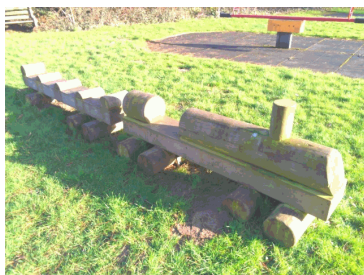
Play Train - With Carriage

The item meets with the requirements of the relevant standard where this may be tested on site without dismantling or destruction.

Comments, action or control required		Risk Level	Risk Score ‡
Equipment	No remedial maintenance work is required at this time.		
Surfacing - Grass	No remedial maintenance work is required at this time.		
The overall risk for this item at the time of inspection: ‡ For Risk Score see Report Notes		Very Low	2

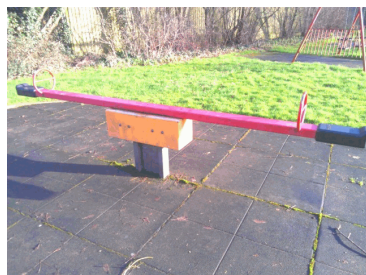
Rocker - Seesaw

The item meets with the requirements of the relevant standard where this may be tested on site without dismantling or destruction.

Comments, action or control required		Risk Level	Risk Score ‡
Equipment	No remedial maintenance work is required at this time.		
Surfacing - Rubber Tiles	No remedial maintenance work is required at this time.		
The overall risk for this item at the time of inspection: ‡ For Risk Score see Report Notes		Low	5

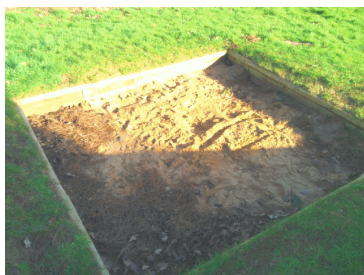
Sand Pit

The item meets with the requirements of the relevant standard where this may be tested on site without dismantling or destruction.

Comments, action or control required		Risk Level	Risk Score ‡
Equipment	No remedial maintenance work is required at this time.		
Surfacing - Grass	No remedial maintenance work is required at this time.		
The overall risk for this item at the time of inspection: ‡ For Risk Score see Report Notes		Very Low	2

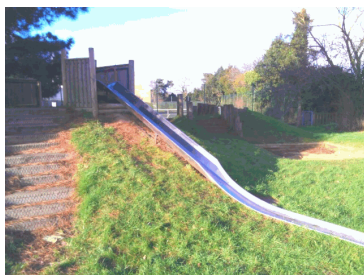
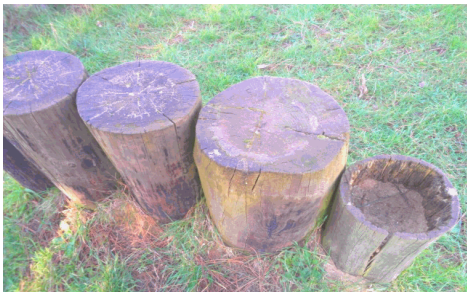
Slide - Embankment - With Platform - With Steps & Beam

Comments, action or control required		Risk Level	Risk Score ‡
Equipment			
Finding :	There is decay to timber components which may affect structural integrity	Low	6

Task :	Replace decayed components where possible, and plan replacement of item. Check on a routine basis, especially at ground or foundation level		
Surfacing - Grass			
Finding :	Ground erosion evident.	Low	6
Task :	A grass matting system is recommended to help prevent erosion and puddling.		
The overall risk for this item at the time of inspection:		Low	6
‡ For Risk Score see Report Notes

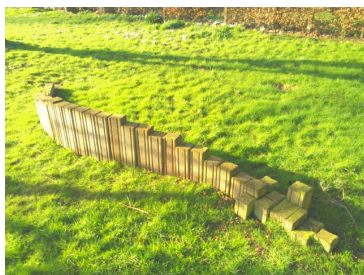
Stepping Logs - Wave

Recommended Maintenance and Risk Assessment Evaluation		Risk Level	Risk Score ‡
Comments, action or control required			
Equipment			
Finding :	Surface - Slippery	Medium	9
Notes :	Clean timber.		
Task :	Power Wash		
Surfacing - Grass			
No remedial maintenance work is required at this time.			
The overall risk for this item at the time of inspection:		Medium	9
‡ For Risk Score see Report Notes

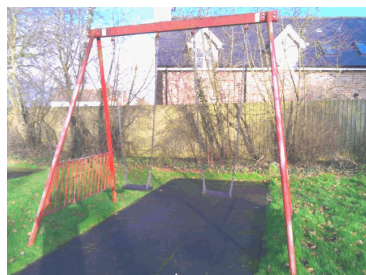
Swing - Junior - 1 Bay 2 Seat (2800 mm)

The item fails to meet the requirement of the relevant standard.

The surface fails to meet the requirement of the relevant standard.

Recommended Maintenance and Risk Assessment Evaluation		Risk Level	Risk Score ‡
Equipment			
Finding :	Paintwork in poor condition	Very Low	3
Task :	De-scale and coat with lead free paint, using appropriate precautions		
Finding :	The supports are within the falling / free space area	Low	4
Task :	Monitor and check on a routine basis		
Surfacing - Rubber Tiles			
Finding :	Insufficient protective surfacing has been provided	Low	5
Task :	Consider increasing surfacing area depending upon risk assessment		
The overall risk for this item at the time of inspection:		Low	5
‡ For Risk Score see Report Notes

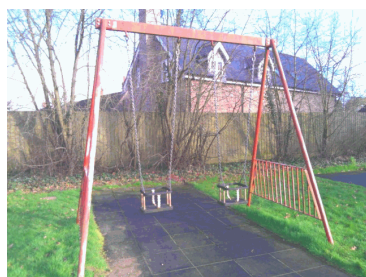
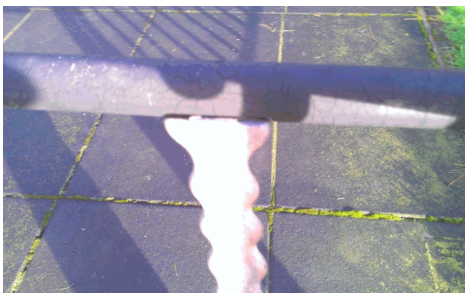
Swing - Toddler - 1 Bay 2 Seat (2800 mm)

The item fails to meet the requirement of the relevant standard.

The surface fails to meet the requirement of the relevant standard.

Comments, action or control required		Risk Level	Risk Score ±
Equipment			
Finding :	Some chain wear	Low	7
Notes :	Lower Y-links.		
Task :	Monitor for further deterioration and replace at 40% wear		
Finding :	The central strap is loose/missing/damaged.	Low	6
Finding Date :	15/02/2016		
Notes :	Tighten strap fixings.

Task :	Replace/Repair strap		
Finding :	The supports are within the falling / free space area	Low	4
Task :	Monitor and check on a routine basis		
Finding :	Paintwork in poor condition	Low	5
Task :	De-scale and coat with lead free paint, using appropriate precautions		
Surfacing - Rubber Tiles			
Finding :	Insufficient protective surfacing has been provided	Low	5
Task :	Consider increasing surfacing area depending upon risk assessment
