Safety Inspection Report

Annual Inspection

Waldringfield Playing Field

Waldringfield Parish Council

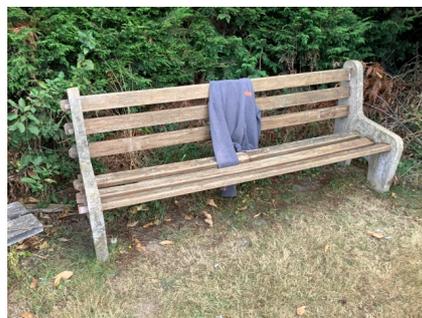
Loose in ground.

Partial timber bench is loose in the ground and our inspector recommends permanently fixing the bench to the ground reducing the risk of the bench toppling over.

Timber bench is loose in the ground on one side. Reset.

Read the notes for further action.

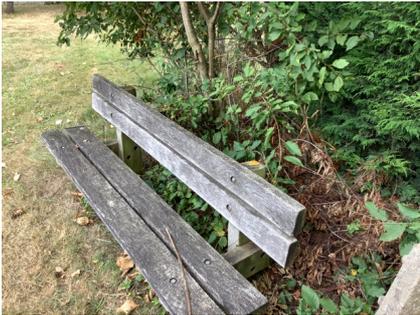
Encroaching vegetation or trees.

Remove.

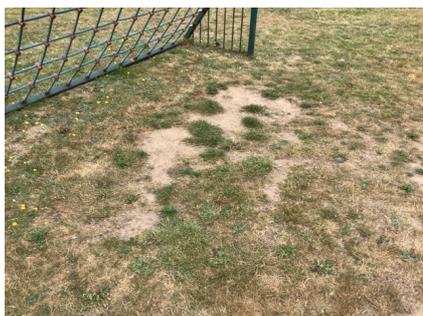
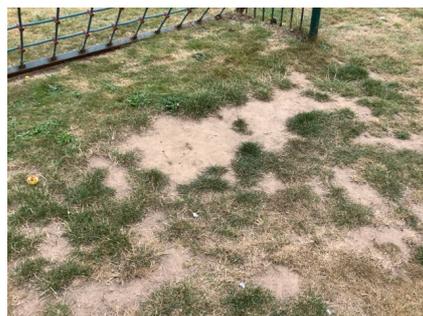
Ground erosion present.

Around goal mouths.

Repair the worn areas.

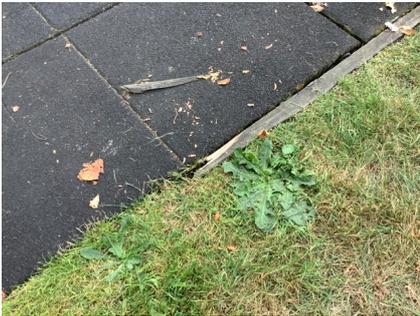
Item has some parts missing.

Sections of timber edge boarding are missing and decayed. Replace affected areas.

Replace the missing parts.

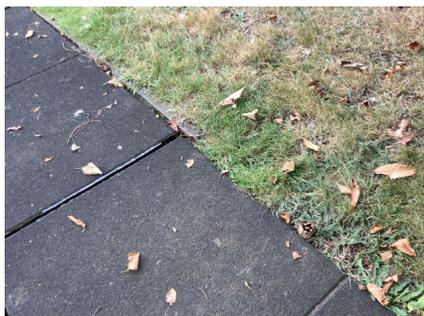
Item has some parts missing.

Sections of timber edge boarding are missing and decayed. Replace affected areas.

Replace the missing parts.

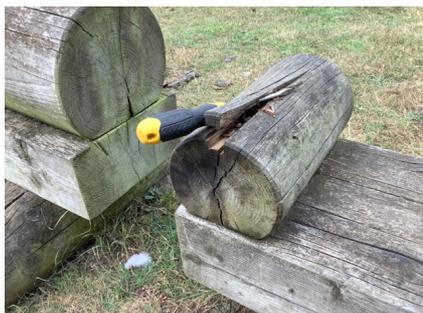
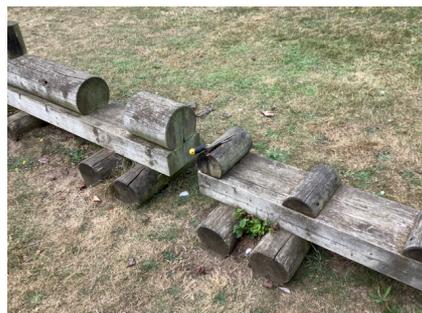
Timber is decayed.

Timber log on carriage is decayed through on top. Replace. Monitor all timbers throughout the year due to timbers starting to soften.

Check on a routine basis., Replace affected parts.

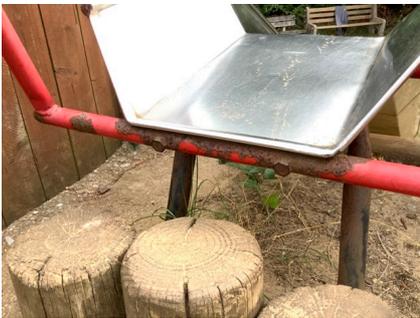
There is significant corrosion on this item.

Descale and repaint framework.
Consider replacing vertical support due to levels of corrosion.

De-scale back to good metal and coat with lead free paint, using appropriate precautions. Repairs may be necessary where corrosion is severe., Read the notes for further action.

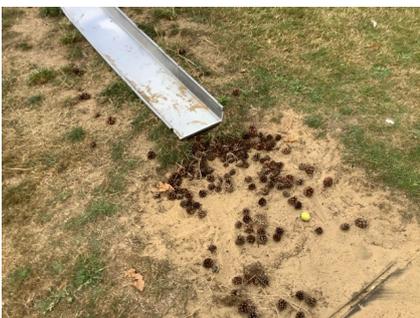
Debris on surface.

Sweep away debris on a routine basis.

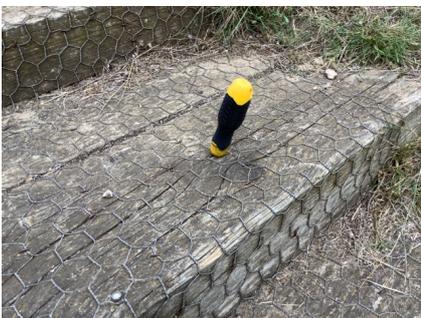
Timber is decayed.

Multiple access step sleepers are decayed on tops. Replace affected timbers.

Check on a routine basis., Replace affected parts.

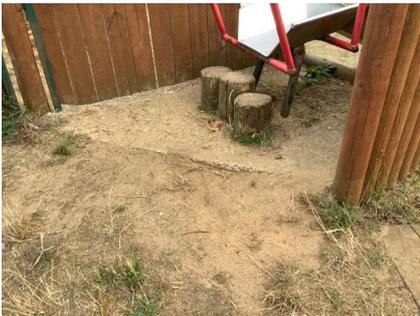
Trip points on the surface.

Slight trip point present around entrance to the embankment slide.

Make level.

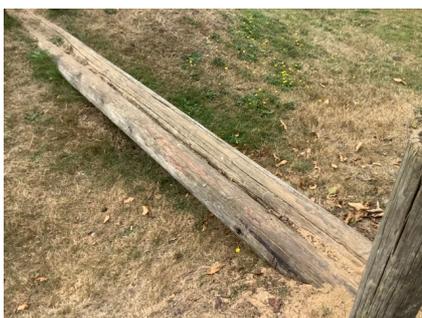
The top of the beam should be made non-slip by the addition of surface textures or cross-cutting.

Make the top of the beam non-slip by the addition of surface textures or cross-cutting.

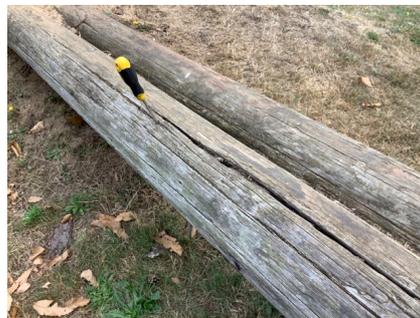
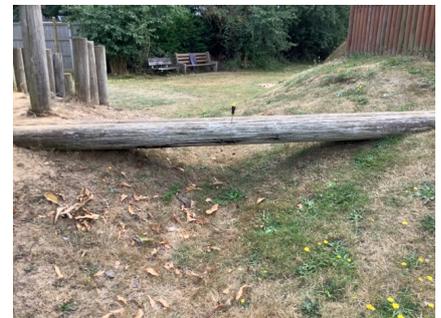
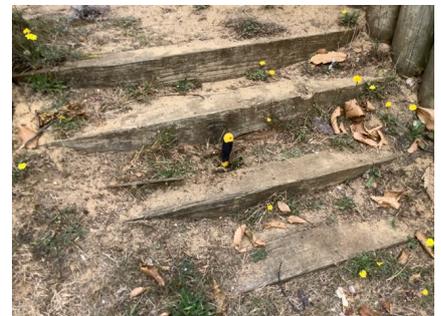
Timber is decayed.

Several post tops are decayed through. Consider replacing.
Access steps leading to bridge section are decayed. Replace.
Beams on bridge are decaying on tops. Monitor and replace when necessary.

Check on a routine basis., Replace affected parts., We recommend resistance penetration testing to determine the internal condition of the timber. We can undertake this testing at additional cost. Please contact us for details.

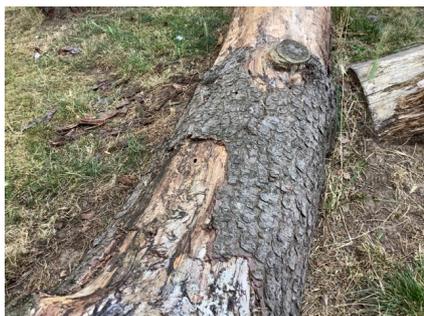
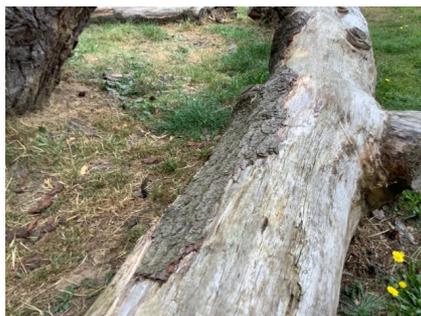
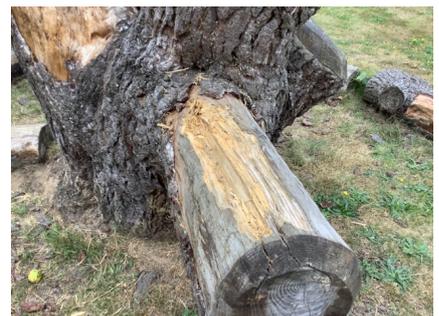
Hard or sharp projections.

Our inspector recommends removing the bark from the logs due to the bark creating sharp edges and projections.

Remove hard, pointed and sharp projections.

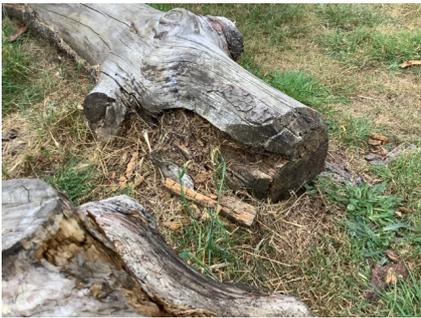
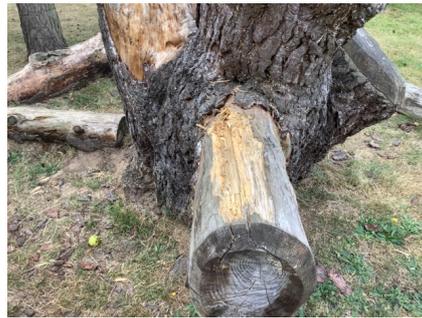
Timber is decayed.

Tree logs and stumps are decaying and splintered.

Check on a routine basis., Replace affected parts.
